TECHNICAL REPORTS FOR 2002–2009 GEOLOGIC HAZARDS PROGRAM

COMPILED BY ASHLEY H. ELLIOTT

Report of Investigation 269
Utah Geological Survey
a division of
Utah Department of Natural Resources
2010

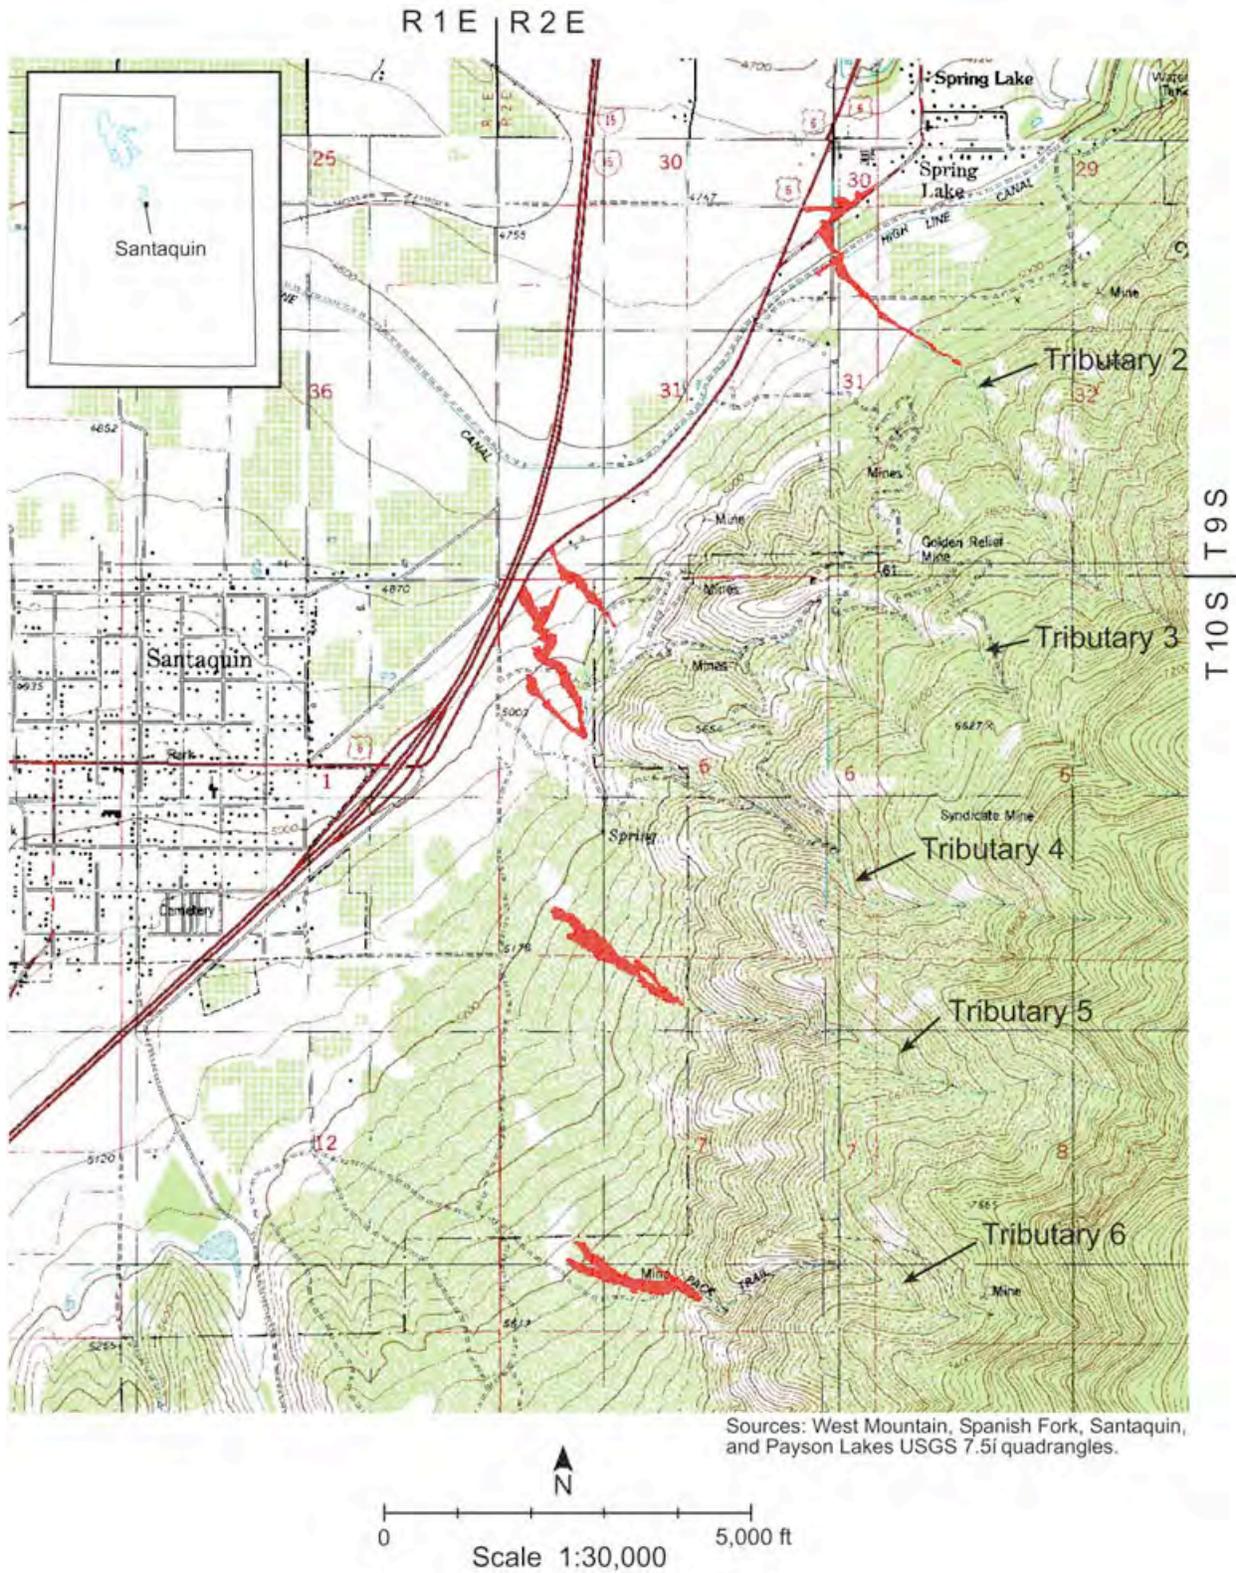
Figure 1. Approximate extent of September 12, 2002, debris-flow deposits and alluvial-fan flooding (red).

- The debris flows were triggered by intense thunderstorm precipitation on the upper burned slopes of Dry Mountain, which eroded soil by sheetwash and rilling. Runoff rapidly concentrated into channels, eroding and bulking sediment to a debris-flow sediment-water concentration. The flows continued to grow by accumulating channel sediment until they reached the canyon mouths where they spread out and deposited debris on alluvial fans.

- Water-repellent soils and diminished vegetation in the tributaries caused by the Mollie fire contributed to the debris flows of September 12, 2002. Because it takes several years for soil and vegetation in burned watersheds to recover to pre-burn conditions, the short-term debris-flow hazard will be heightened for several years.

- The guidelines and recommendations outlined in Pietramali (2002), Solomon (2001), Rasely (2001), and U.S. Forest Service (2001, 2002) BAER reports to manage the debris-flow hazard should be followed.

- A debris-flow hazard existed before the fire and will remain after the drainage basin vegetation recovers to pre-burn conditions. Therefore, measures will also need to be taken to reduce the long-term non-fire-related debris-flow hazard.

- Future development will likely encroach farther onto the alluvial fans, exposing more property to hazards. Evaluation of the hazards and implementation of hazard-reduction measures are more easily accomplished prior to development and should therefore be considered now as part of the long-term planning of east Santaquin and Spring Lake.

- Designs to reduce hazards should include evaluation of the drainage basins for potential debris-flow-volume yields and consider the long-term maintenance of any structures.

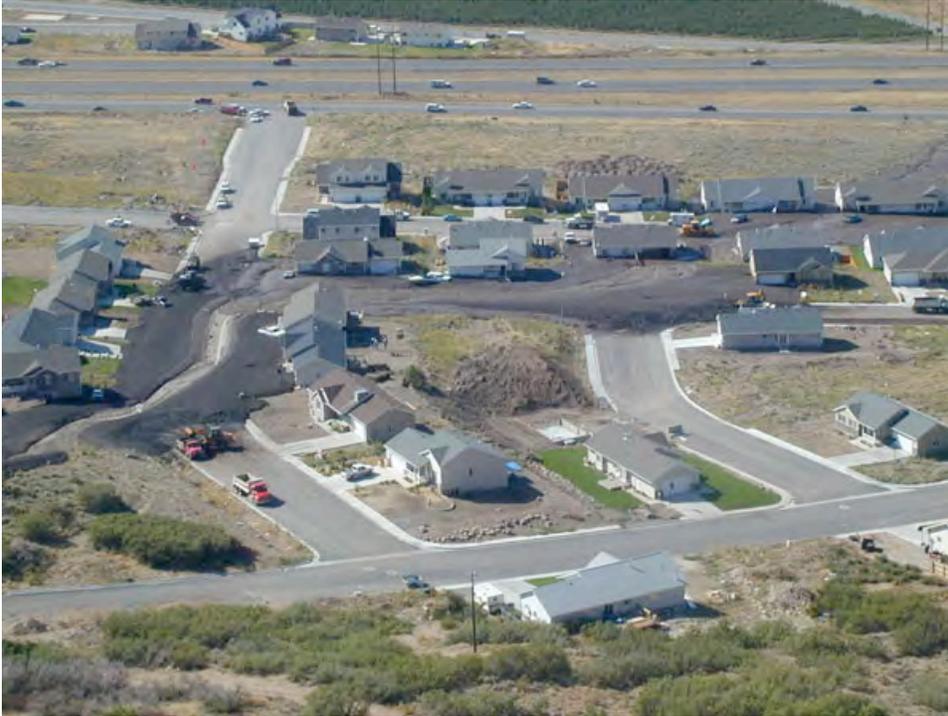
*(a) View looking west of tributary 4 north deposit in Santaquin subdivision.
Photo by Dale Deiter, U.S. Forest Service.*

The debris flow from tributary 4 was the most damaging of the five. When the flow reached the mouth of tributary 4, it split into two lobes. The larger, north lobe flowed through the Santaquin subdivision causing substantial property damage (figure 4a, figure 5). Most of the north lobe did not follow city streets but established a direct path down the alluvial fan. Subsequent floodwater traveled down roadways. The south lobe flowed down an undeveloped portion of the fan and deposited debris on a newly excavated subdivision road south of the existing development.

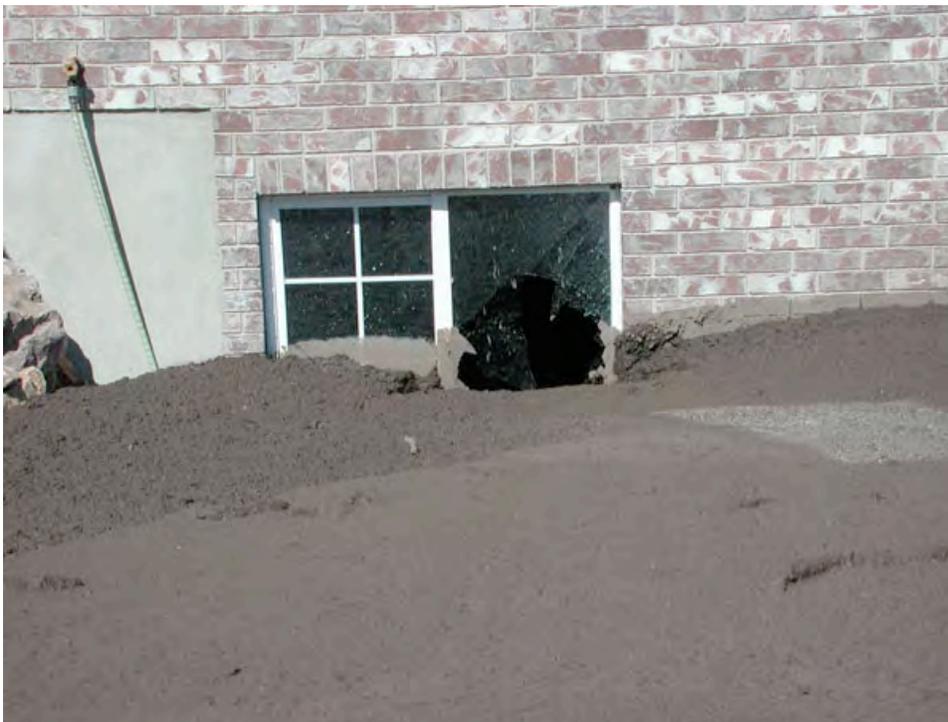
(b) The debris-flow impact broke through this basement window of a house on Apple View Street.

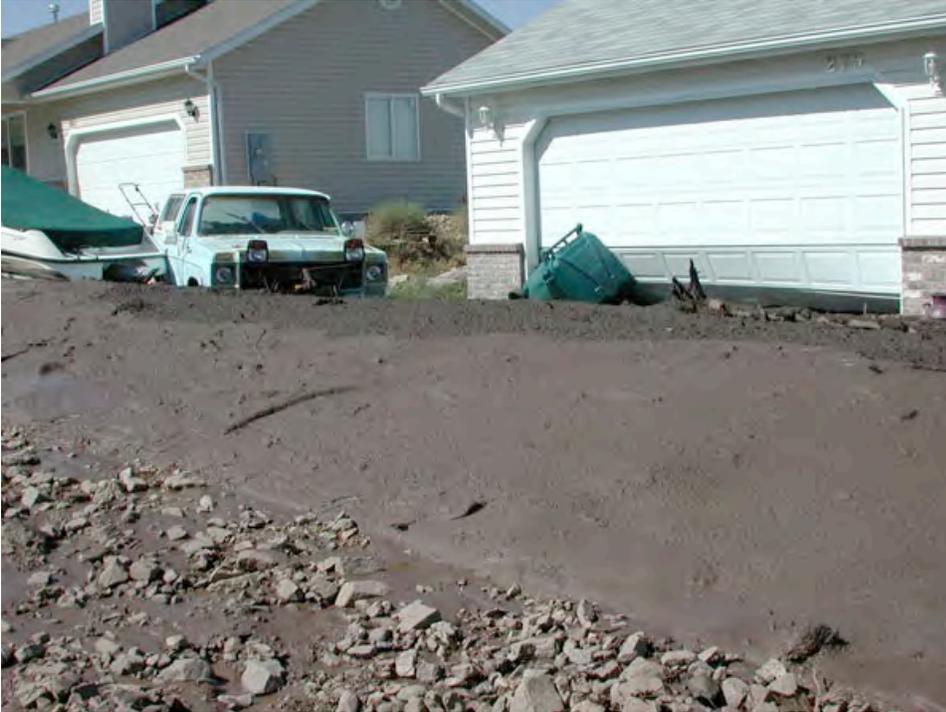
(c) Debris-flow damage to garage doors of house on Peach Street.

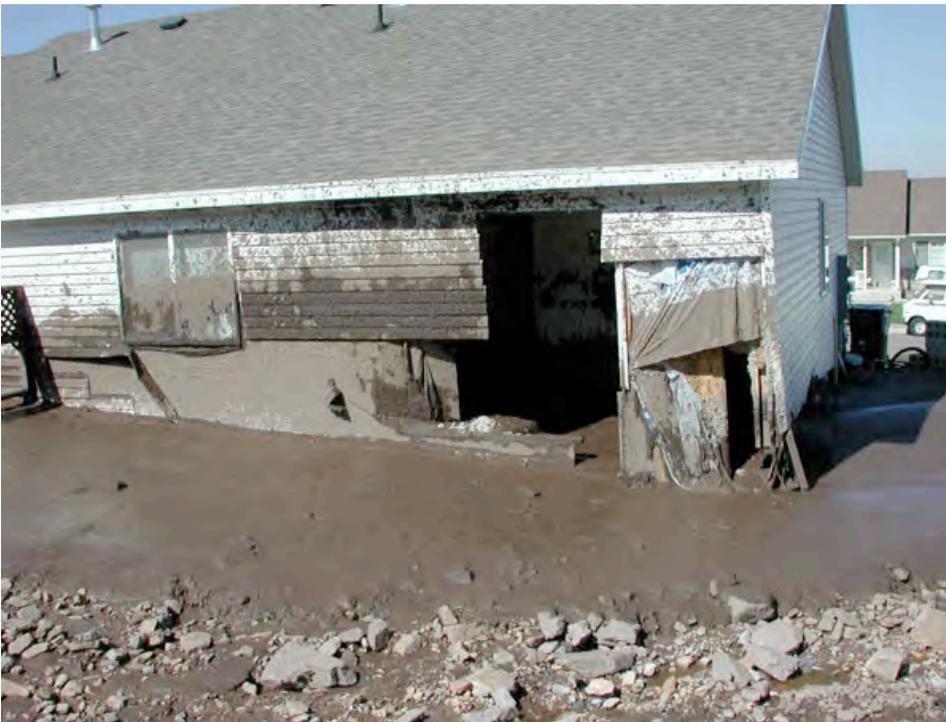
(d) Debris-flow damage to the back wall of house on Peach Street.

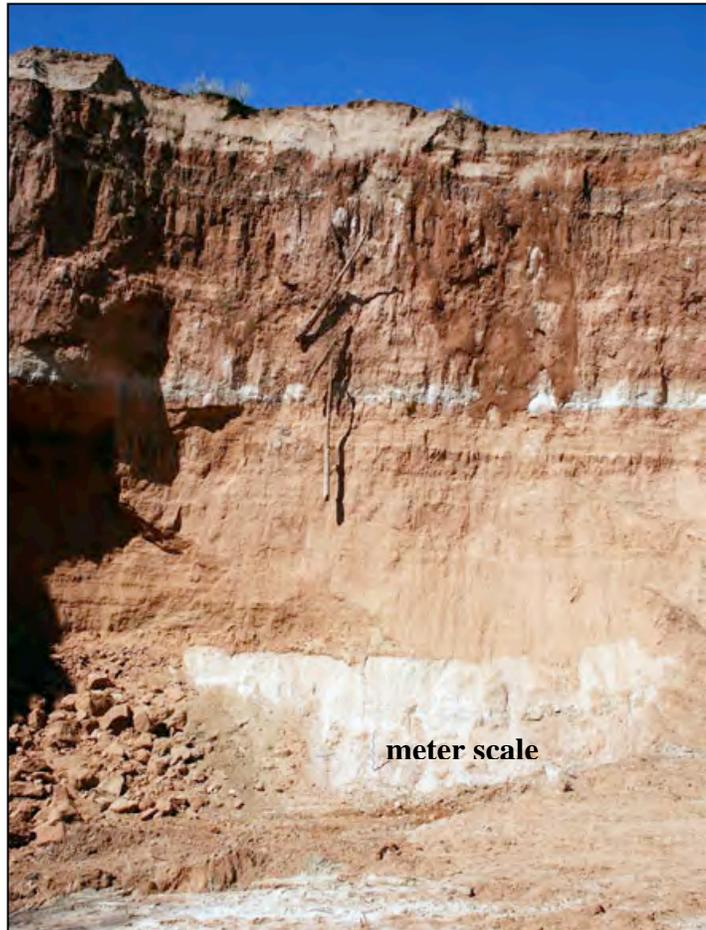
Figure 1. This approximately 60-foot-high arroyo wall failed on March 12, 2005, creating an earth-fall landslide that buried one child and partially buried two others. Alternating layers of sand, silty sand, and silty clay comprise the majority of the stream cut.

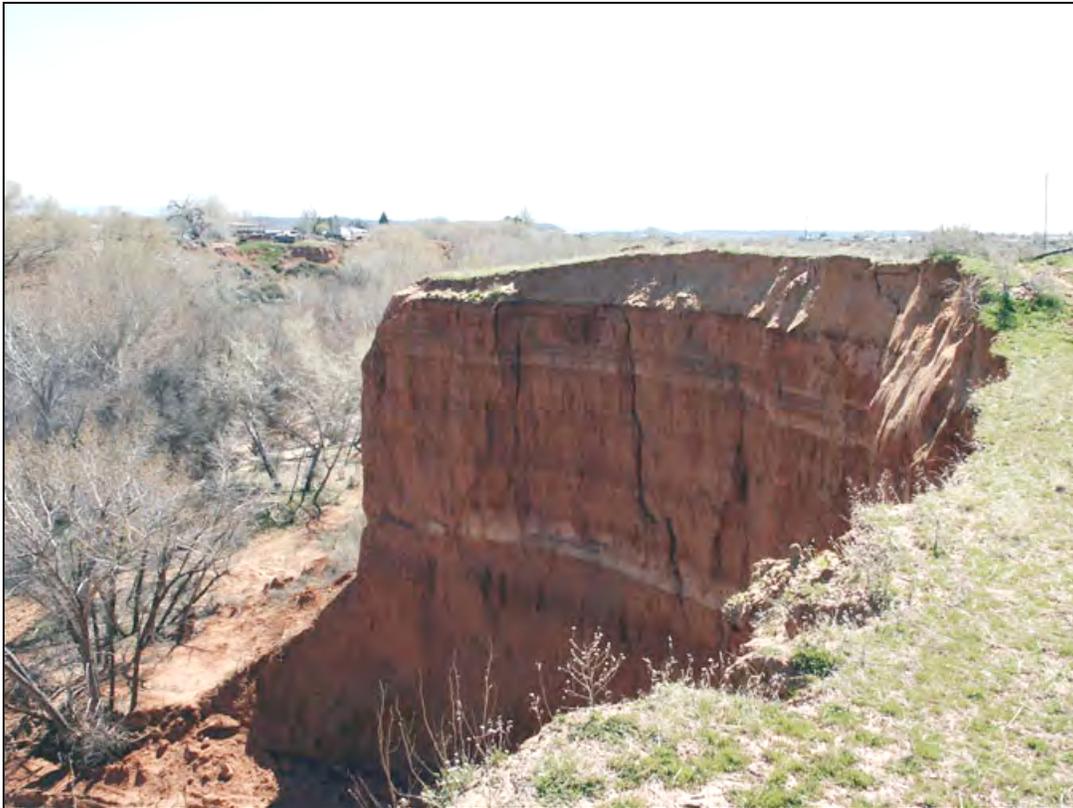
Figure 4. Deep, vertical cracks parallel to the arroyo wall along which a section of the wall detached creating an earth-fall landslide.

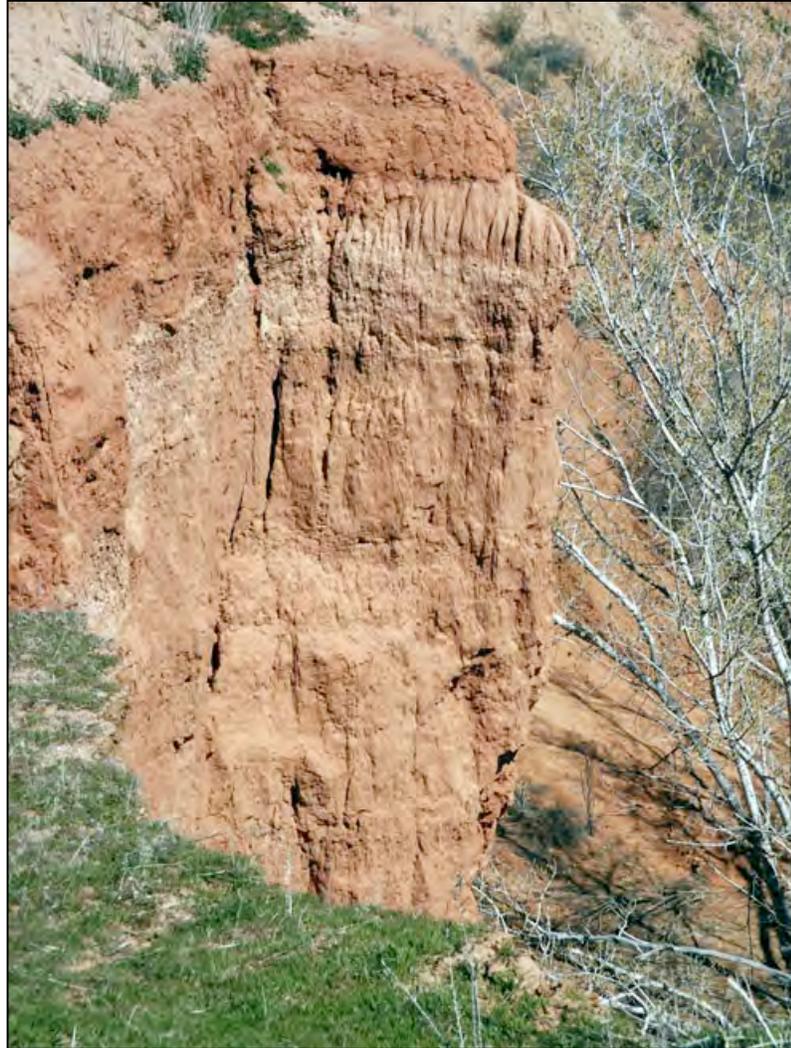
Figure 5. Vertical cracks parallel to the arroyo wall in an area adjacent to the landslide that has not yet failed; such cracks are typical where arroyo walls are vertical.

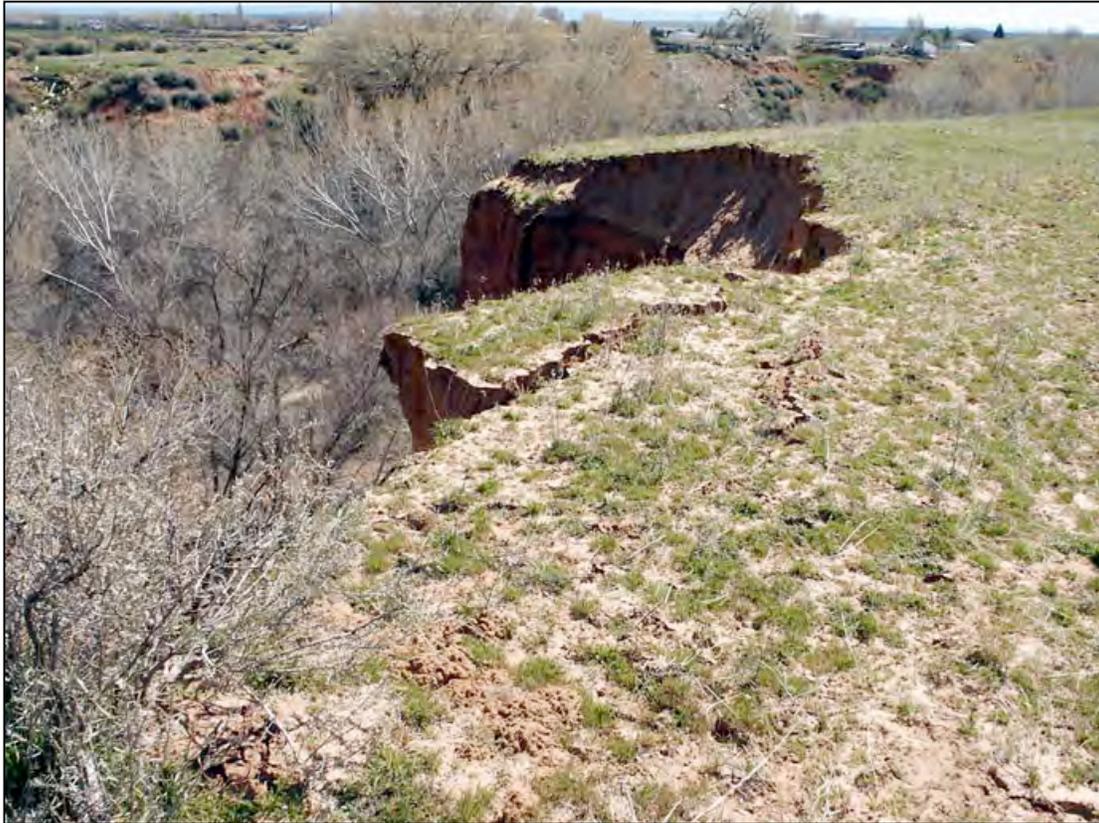
Figure 6. Partially detached section of the arroyo wall where additional failure is imminent.

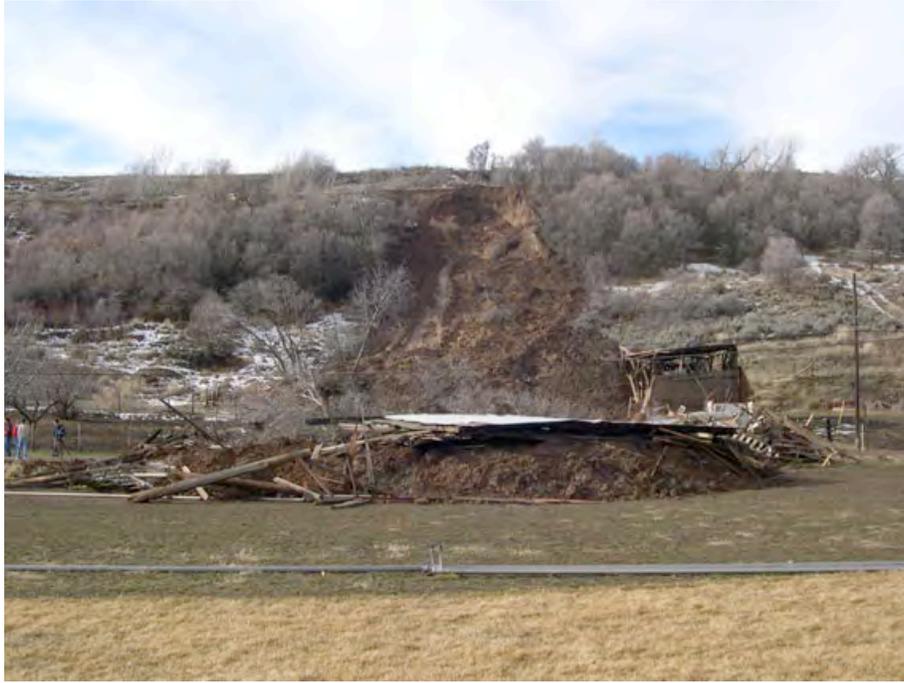
Figure 2. View to the south showing the landslide main scarp in the Davis-Weber Canal embankment, the demolished barn (right foreground), and runout onto the field.

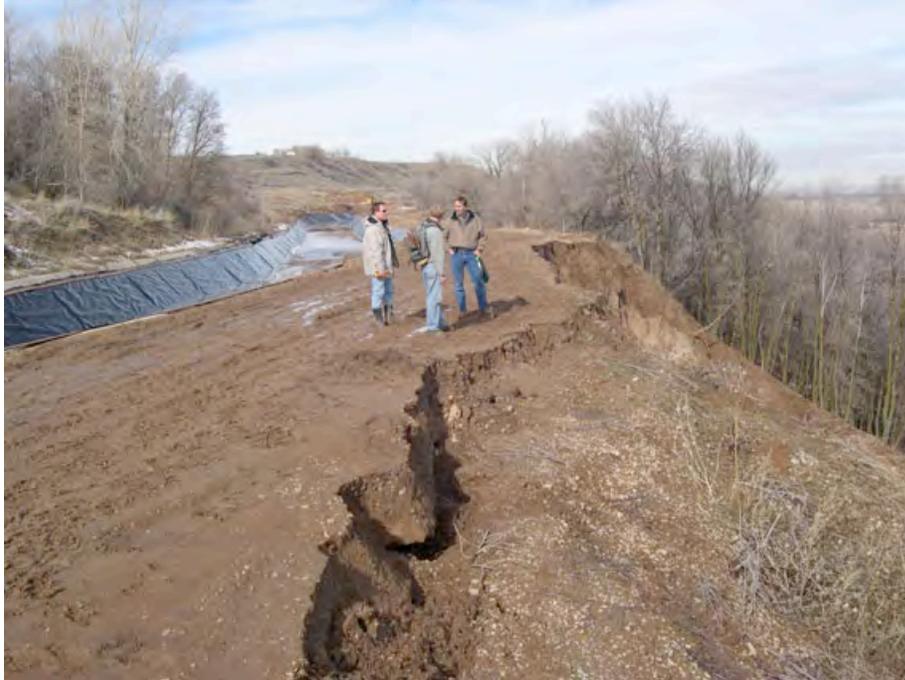
Figure 5. View west of the landslide crown, the Davis-Weber Canal, and the landslide main scarp. Eastward extension of the main scarp in the foreground indicates movement in the slope east of the landslide.

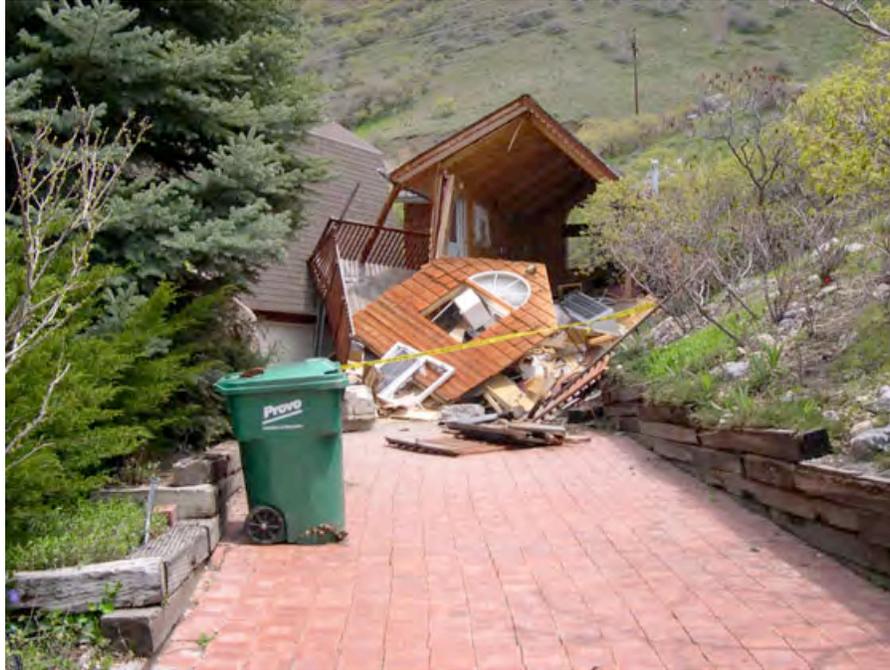
Figure 3. Damage to the guest house. The damaging rock is on the left behind the trash can, against the base of the tree. Parts of the concrete house foundation are behind and to the right of the trash can.

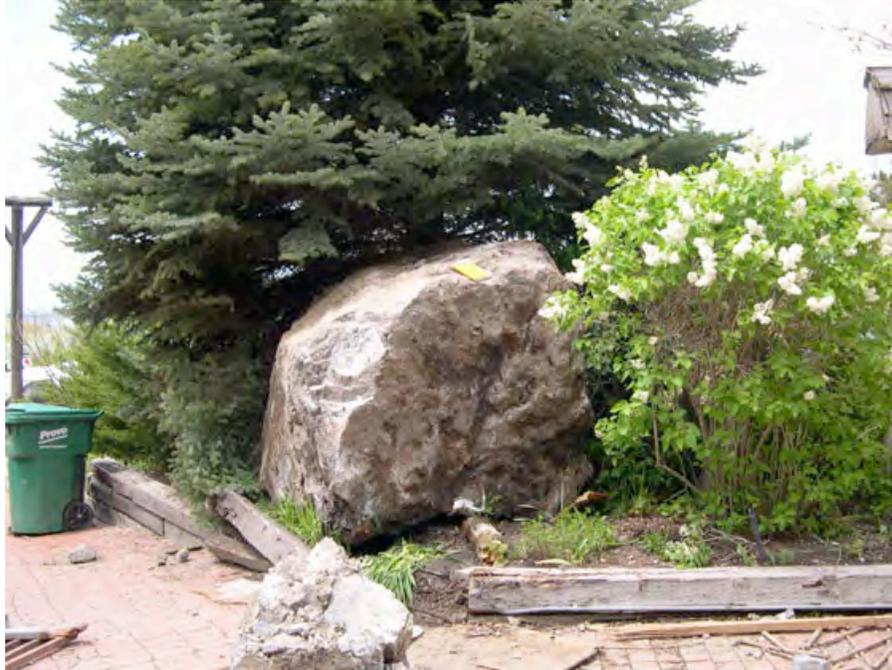
Figure 5. The rock that damaged the guest house. Part of the concrete house foundation wall is in the foreground.

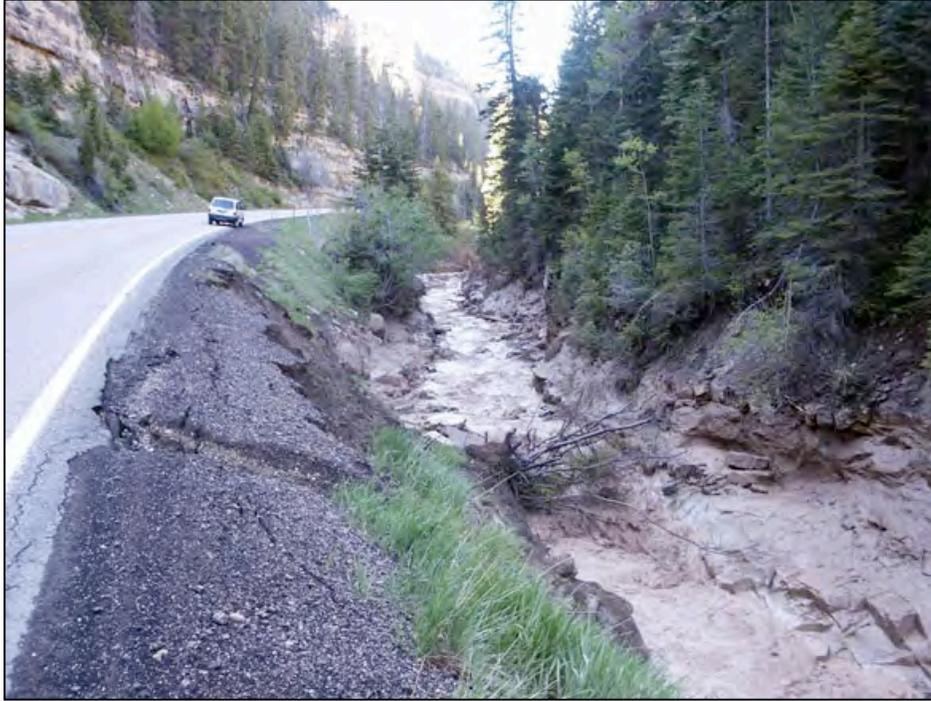
Figure 4. *Small slope failure in the roadbed of SR-14 caused by undercutting and erosion of the stream bank by the Black Mountain debris flow.*

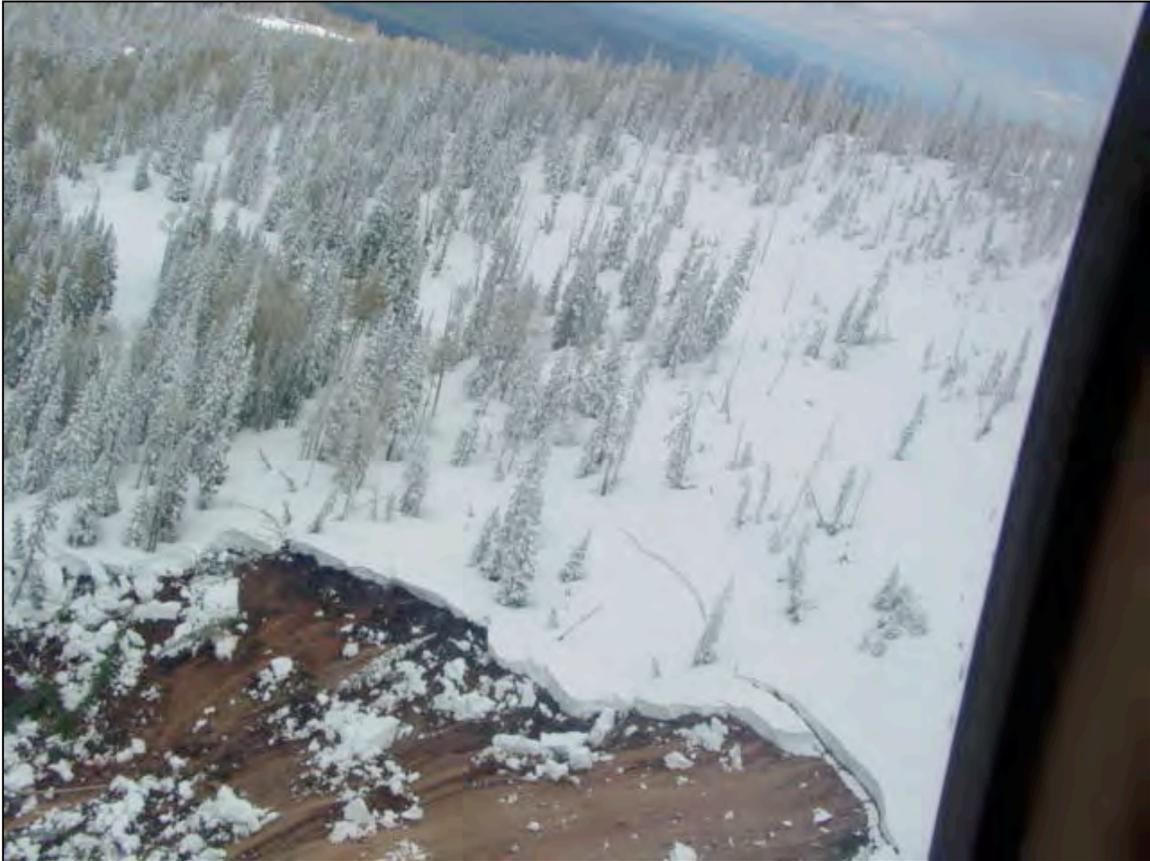
Figure 6. Cracks in the snow upslope from and parallel to the crown scarp of the landslide on Black Mountain from which the Black Mountain debris flow originated (UHP photograph).

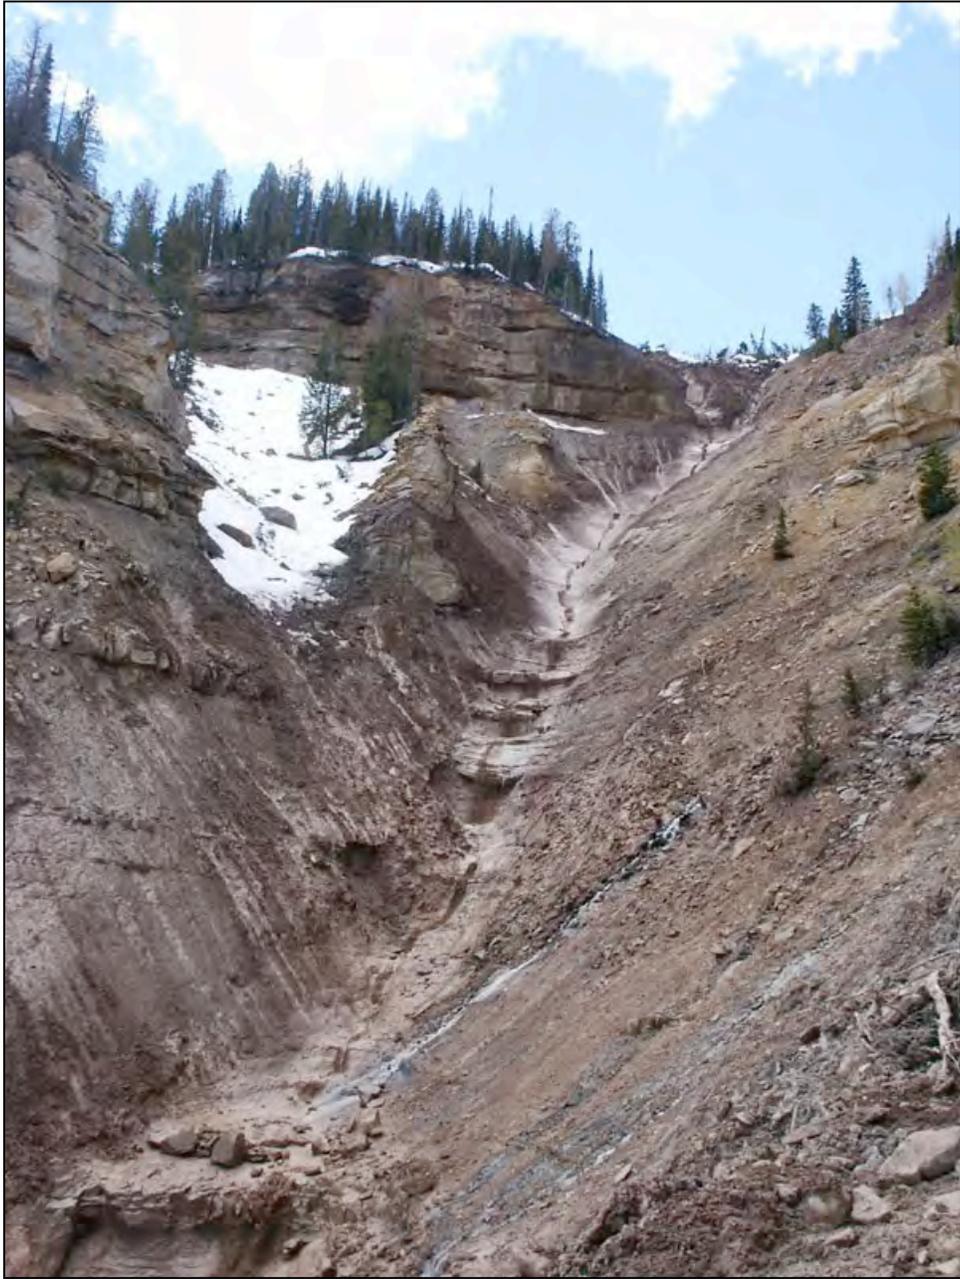
Figure 7. *Headwaters of the un-named drainage on Black Mountain scoured to bedrock by the passage of the Black Mountain debris flow (photograph taken from observation point shown on figure 1).*

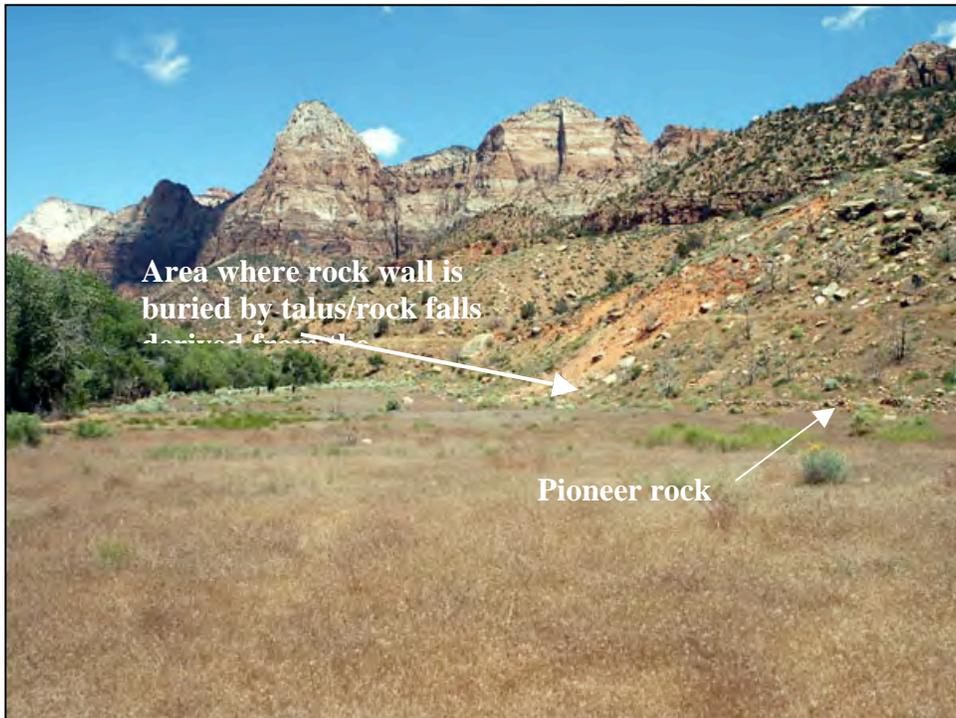
Figure 8. *Pioneer rock wall at the base of the slope is buried by talus/rock falls adjacent to the landslide, but has not been displaced by the landslide toe indicating the landslide rupture surface is shallow at the toe and does not extend beneath the wall.*

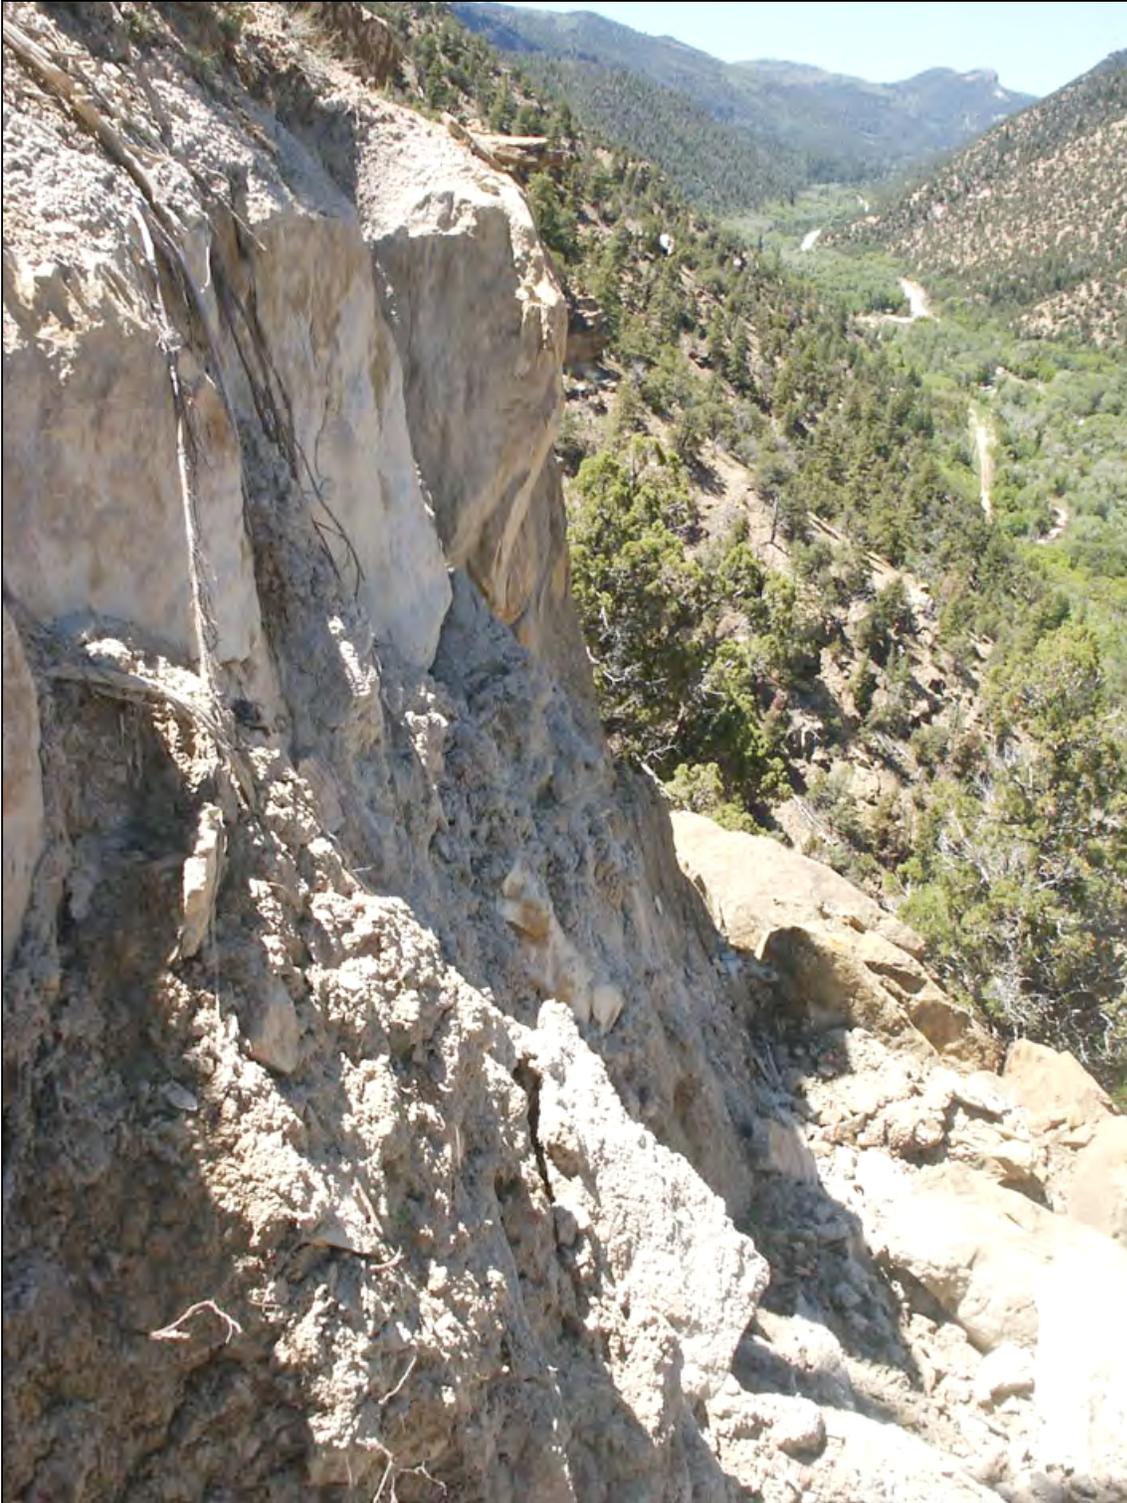
Figure 3. *Approximately 15-foot-high sandstone ledge with thin interbedded shale lenses on the east side of Parowan Canyon where a rock topple initiated the rock fall that damaged the Parowan City penstock. The ledge is approximately 360 feet above the canyon bottom.*

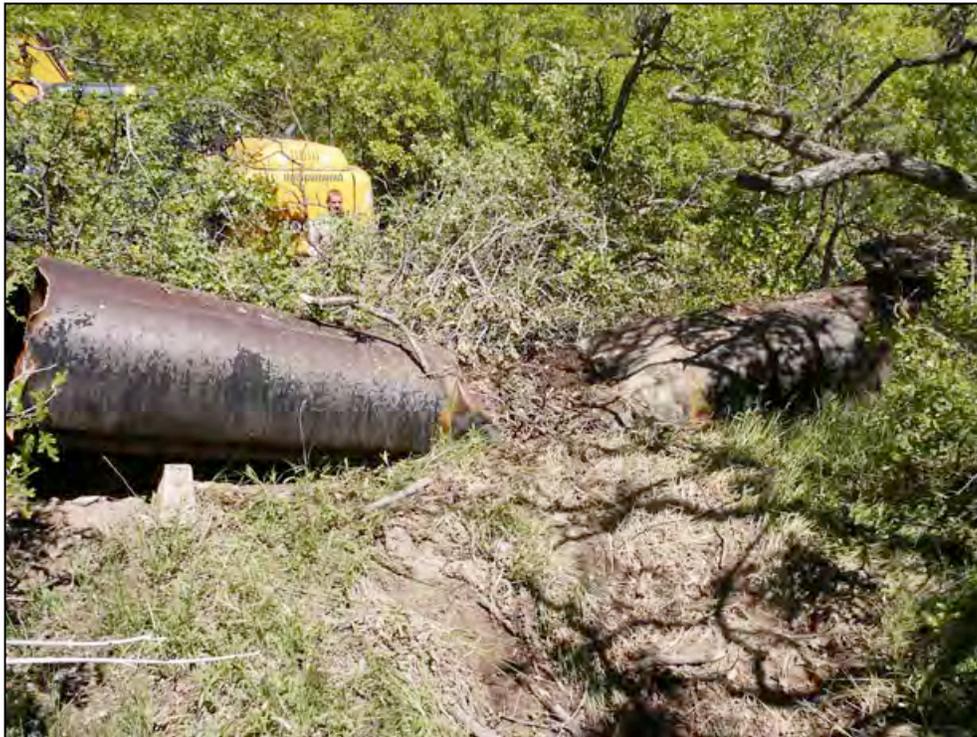
Figure 7. *Ruptured Parowan City penstock where it was struck by a second rock-fall boulder weighing approximately 10 tons. After striking the penstock, the boulder continued toward Parowan Creek for an additional approximately 50 feet.*

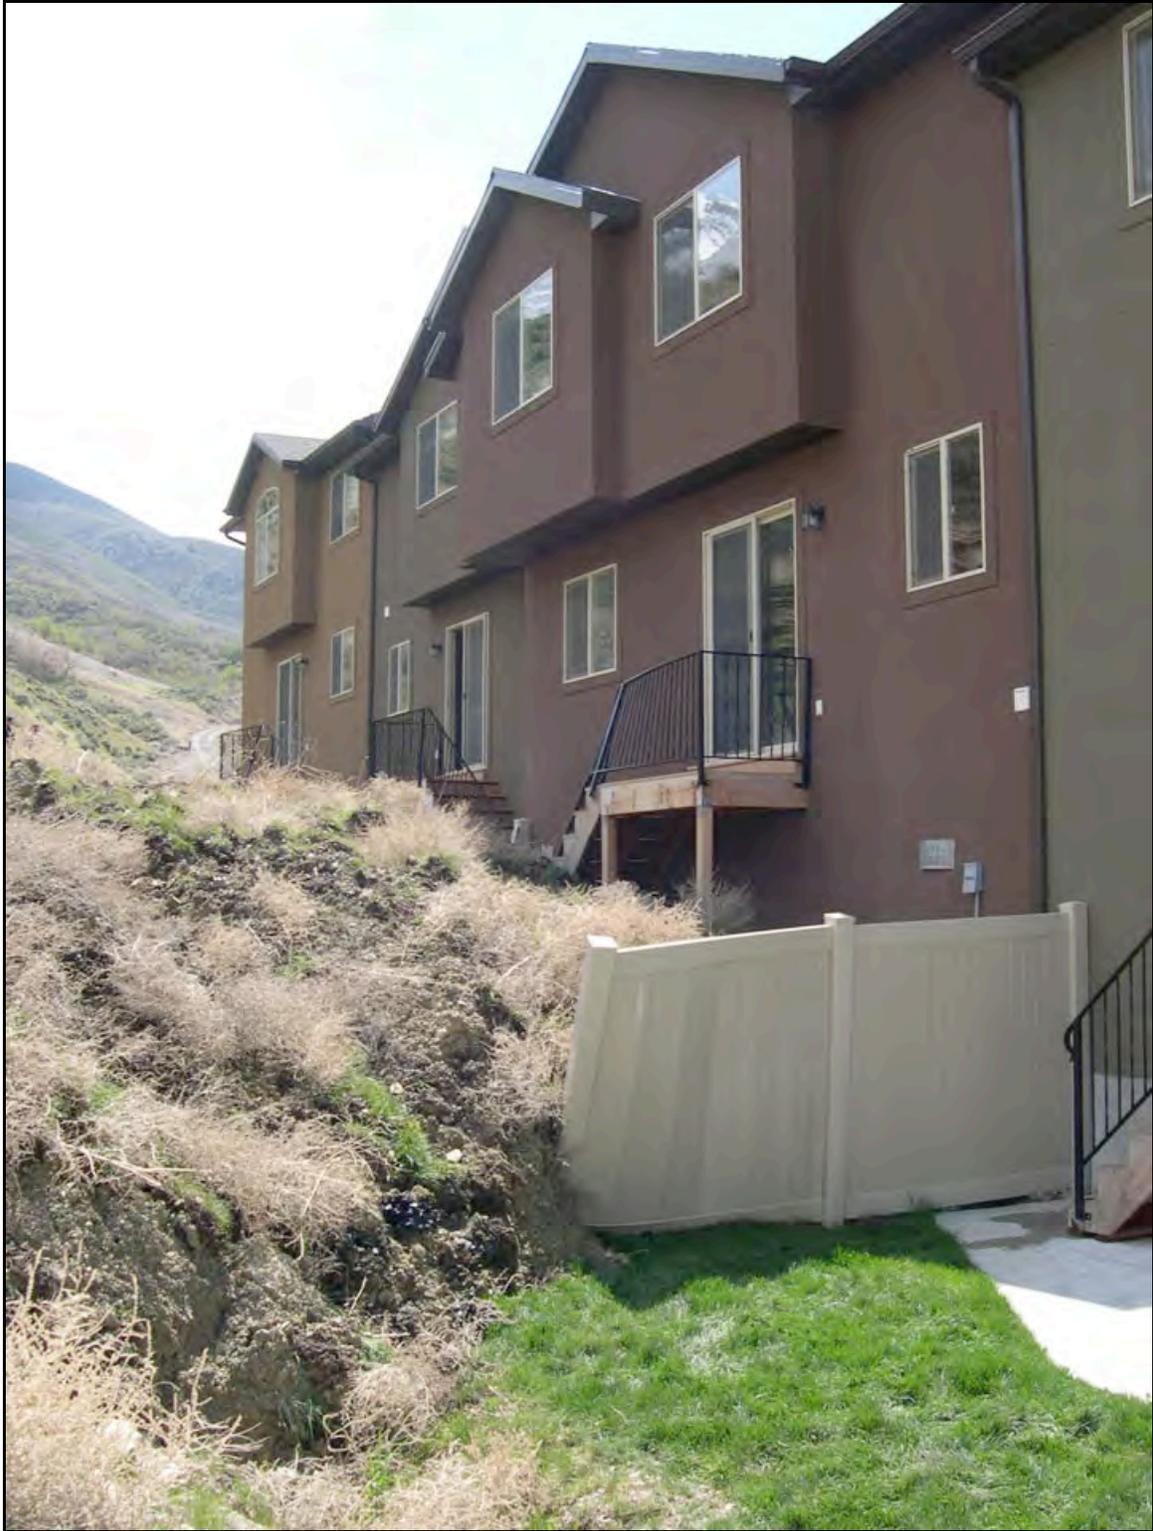
Figure 5. View of the disrupted soil at toe of the landslide and damage to back of townhouse on April 29, 2005.

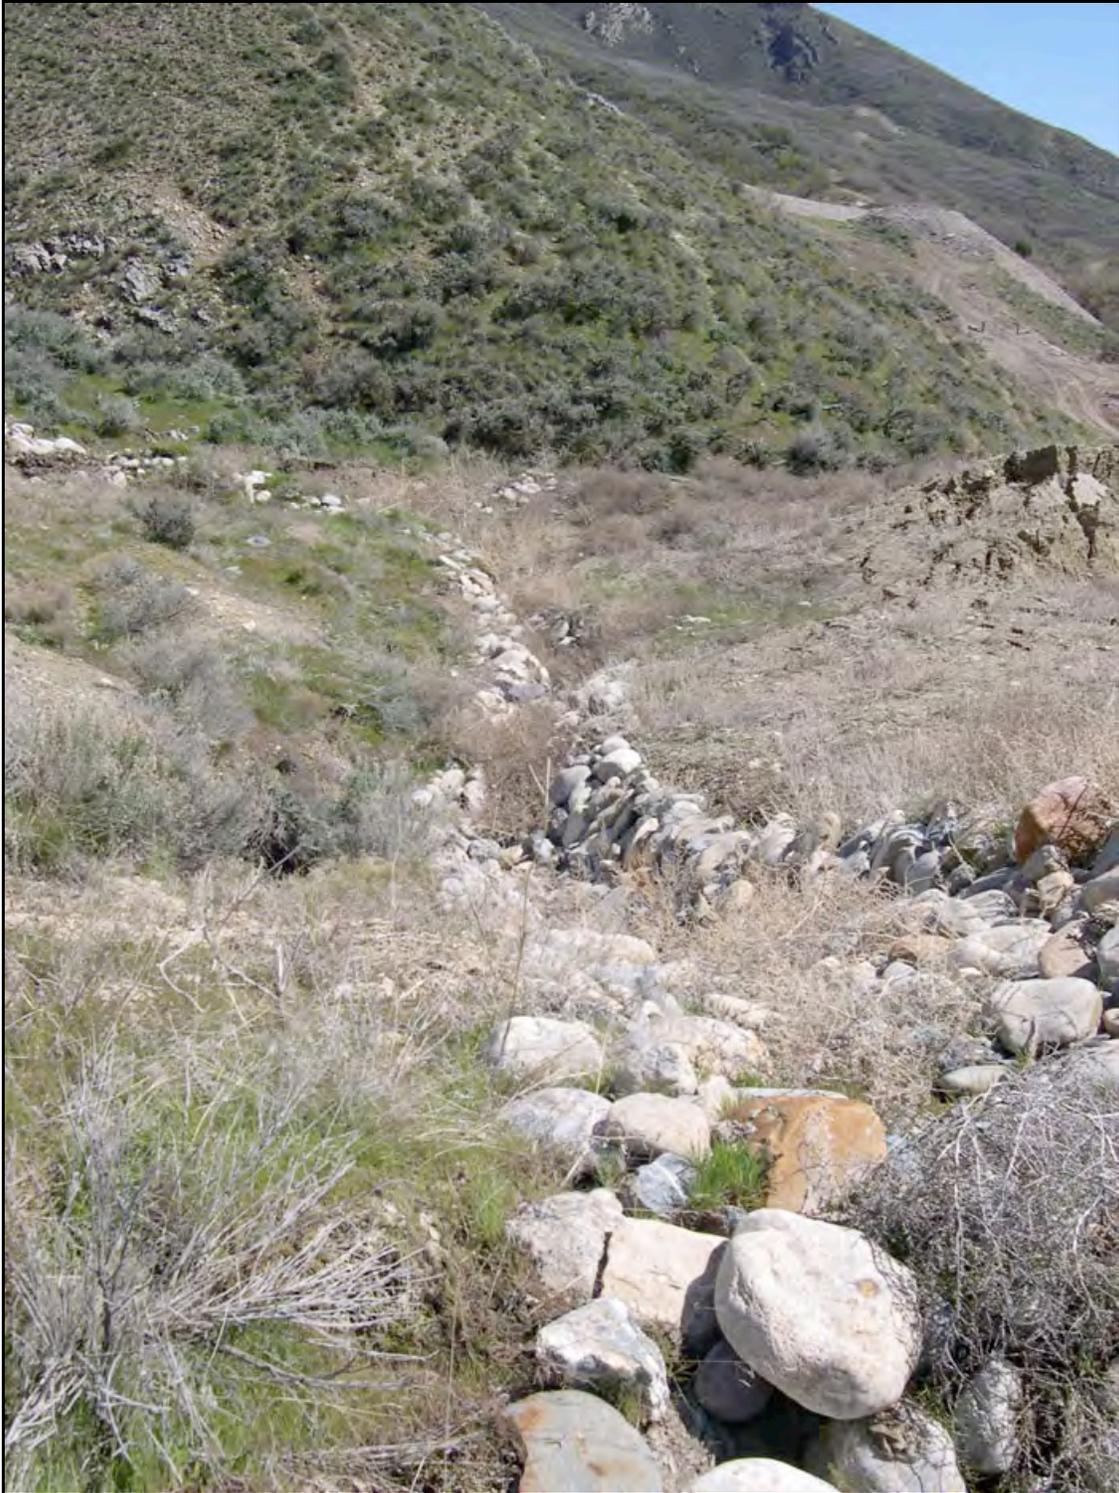
Figure 6. View of relatively intact, translated blocks near the middle of the landslide. Cobble-lined drainage ditch that was originally atop cut slope is translated downslope but relatively undeformed.

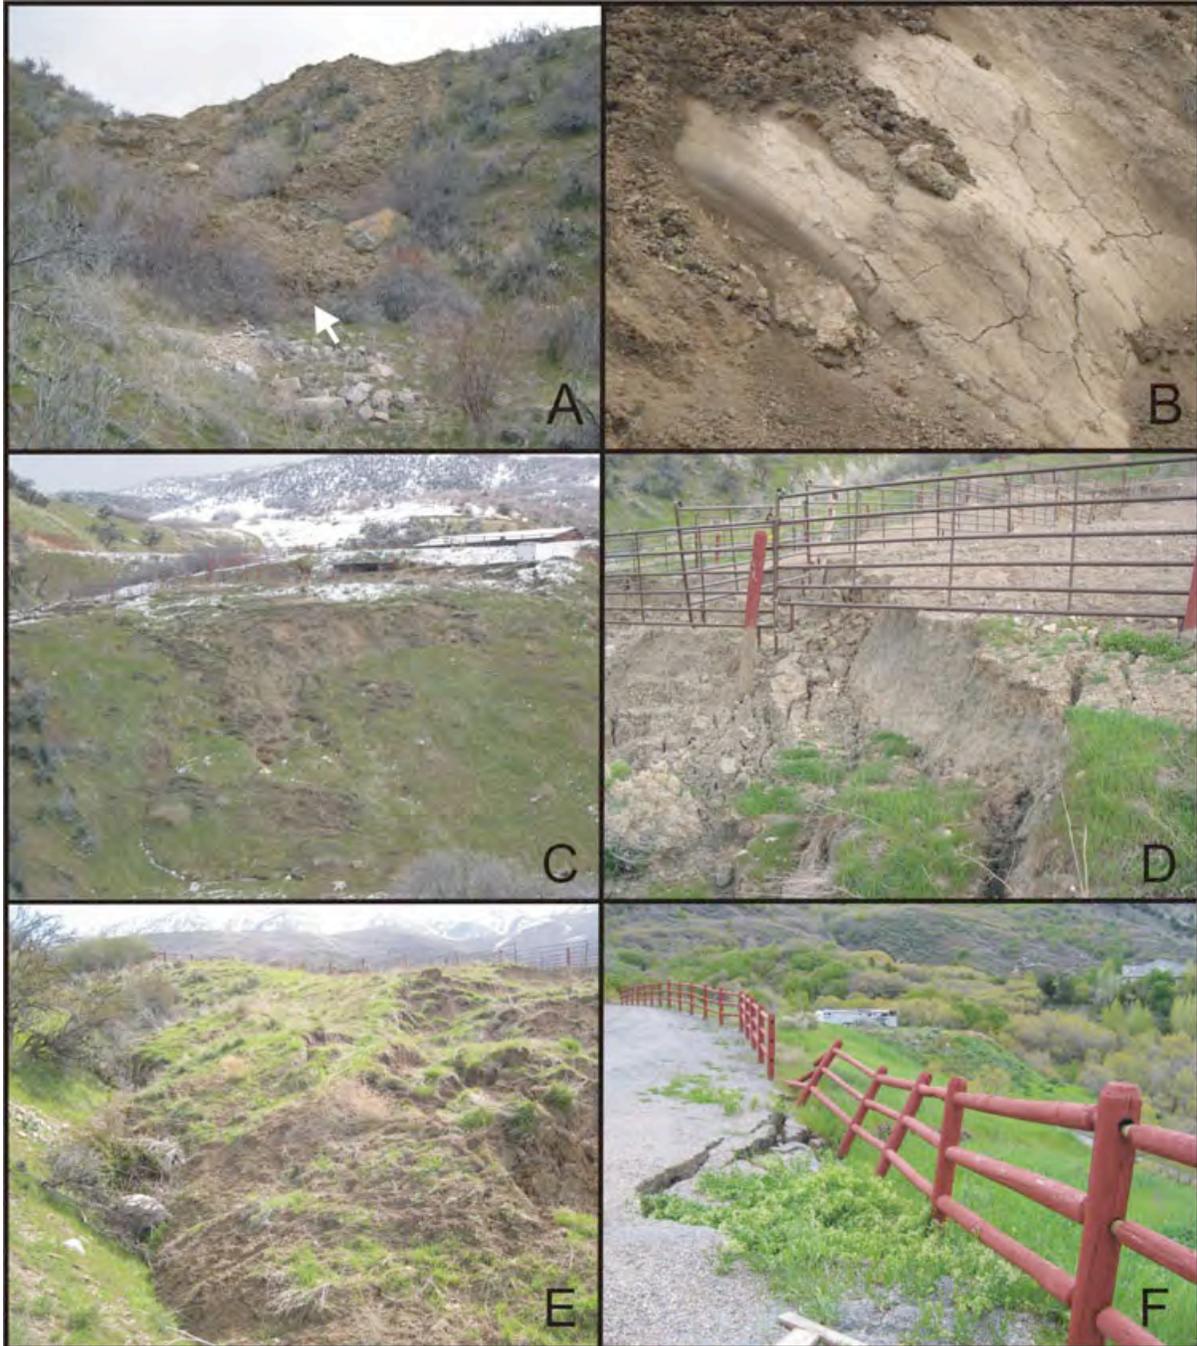
Figure 6. Ground deformation in the main landslide, March 17 to May 12, 2005. (A) View to the northeast of earth-flow toe (arrow) on March 17. (B) Slickensided clay in north part of landslide on March 17. (C) View to the north of south part of landslide on March 29. (D) View to the northwest of large internal scarp that crossed horse corral on April 18. (E) View to the northeast of north edge of landslide on April 18. (F) View to the east of damage to fence due to offset of main scarp of south part of landslide on May 12.
