TECHNICAL REPORTS FOR 2002–2009 GEOLOGIC HAZARDS PROGRAM

COMPILED BY ASHLEY H. ELLIOTT

Report of Investigation 269
Utah Geological Survey
a division of
Utah Department of Natural Resources
2010

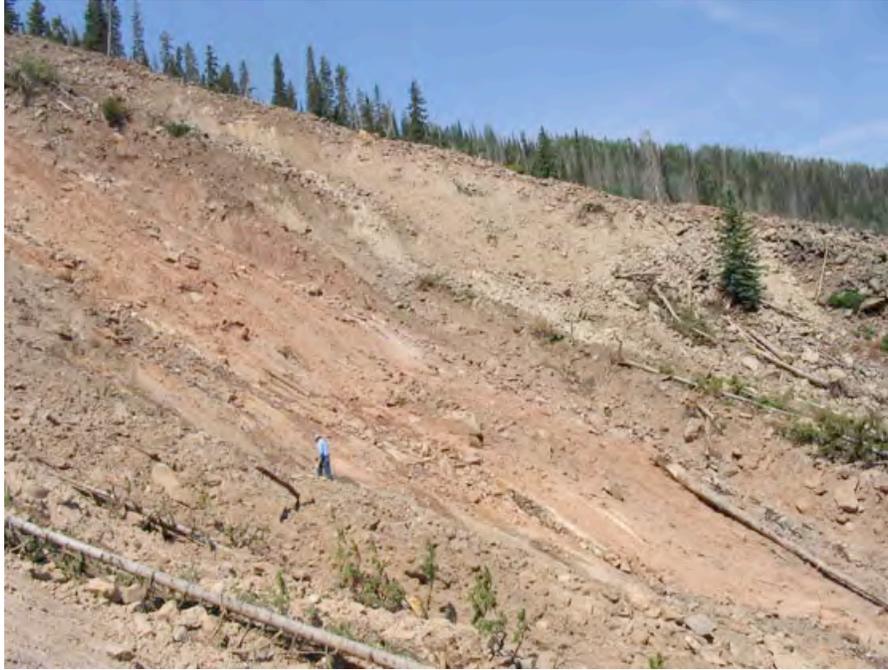
Figure 5. View west into the evacuated area of the lower landslide. The estimated evacuated volume is 50,000 to 60,000 yd³. The landslide left flank (upper part of photo) exposes basalt talus. The reddish colored material is weathered shale and mudstone and is the landslide rupture surface.

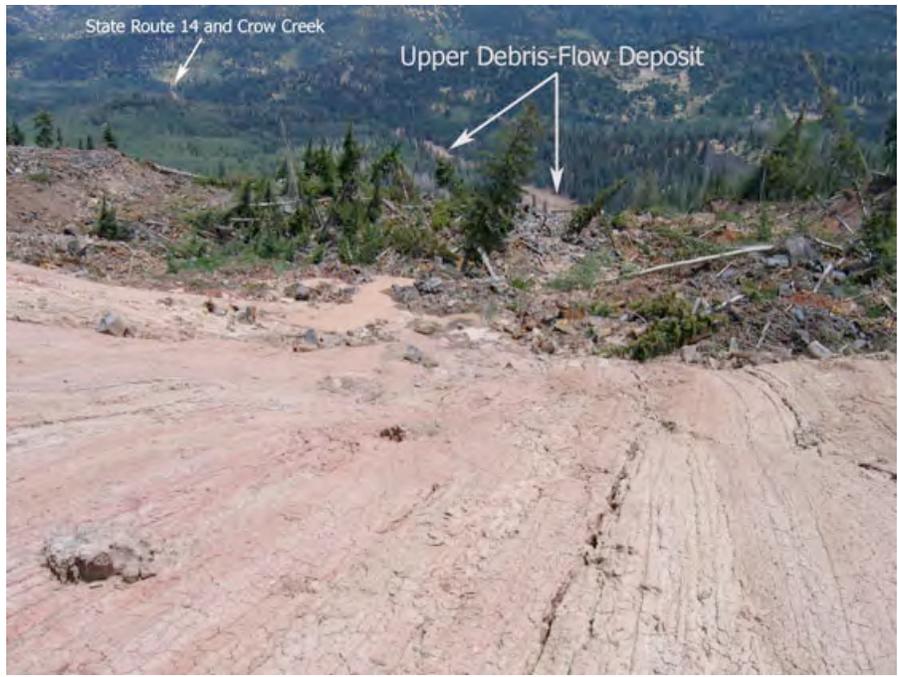
Figure 7. View from the landslide main scarp toward Crow Creek and SR-14. The main scarp is covered with slickensides. The debris-flow path and deposits are evident in the unnamed tributary stream valley to Crow Creek.

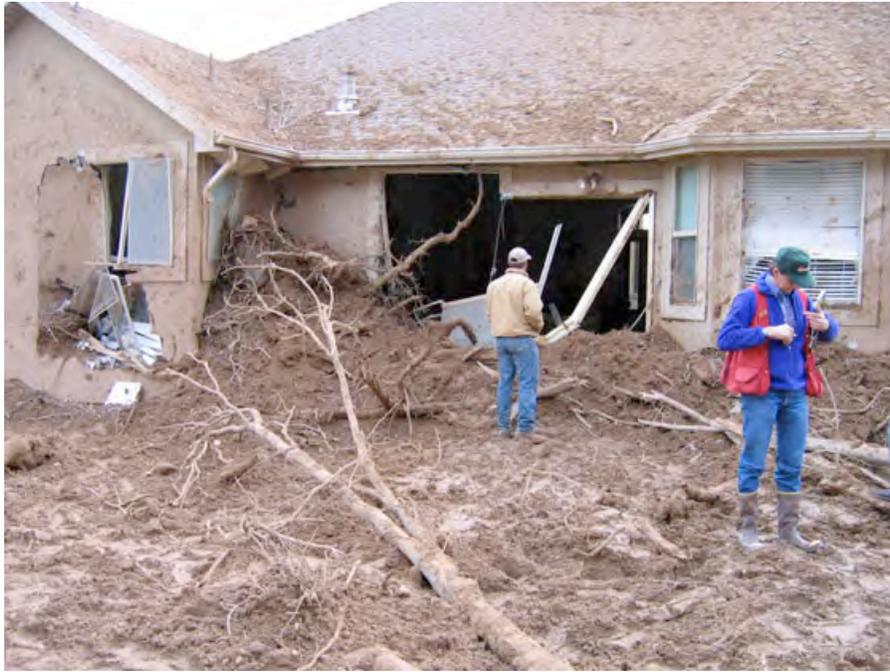
Figure 3. Landslide damage to the house at 1650 East 7687 South.

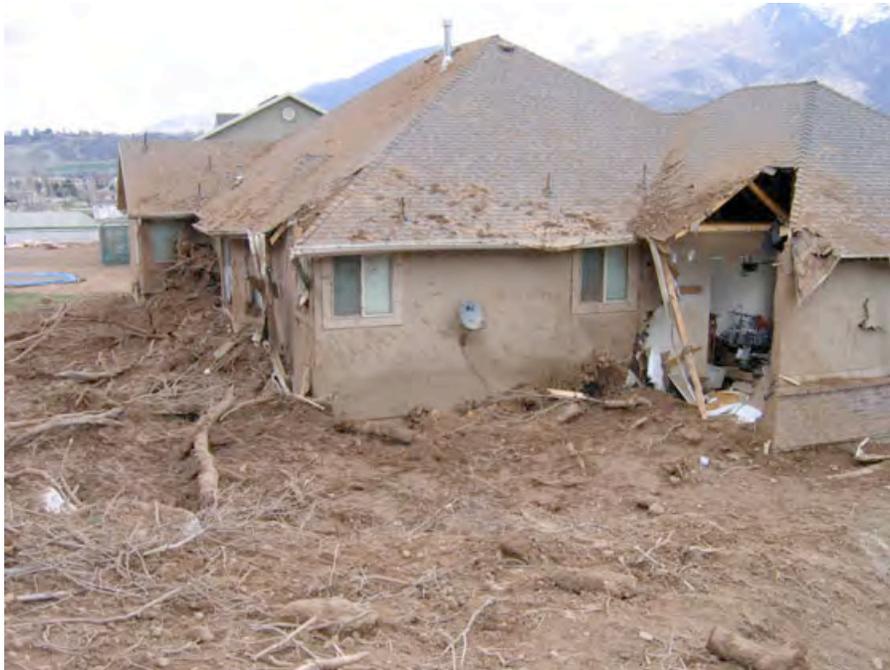
Figure 4. Damage to the house and garage at 1650 East 7687 South.

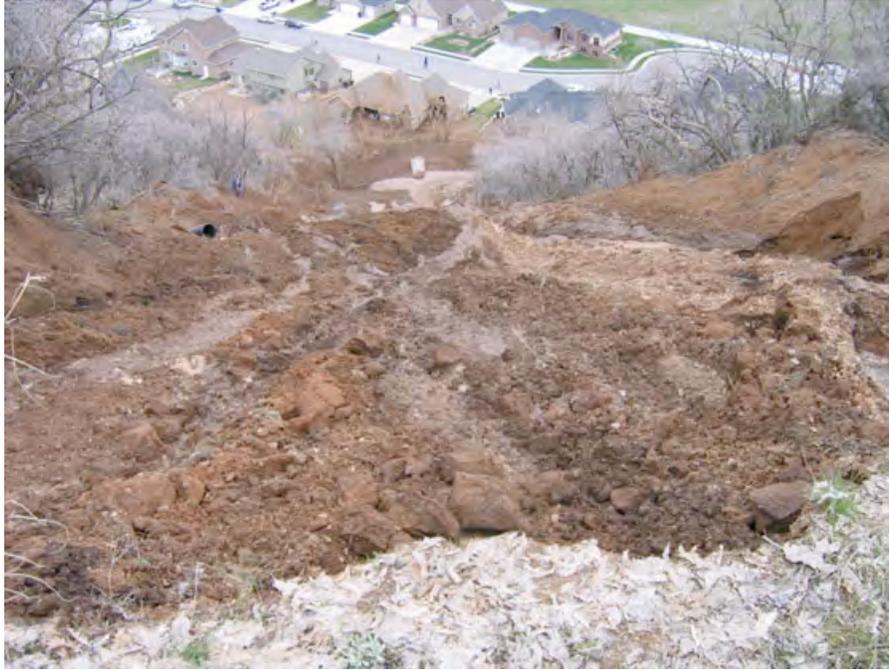
Figure 7. View looking down the landslide flow path at the damaged house at 1650 East 7687 South. The culvert in the lower slide path above the house was originally in the gravel pit. Subsequent water flow eroded the right side of the landslide.

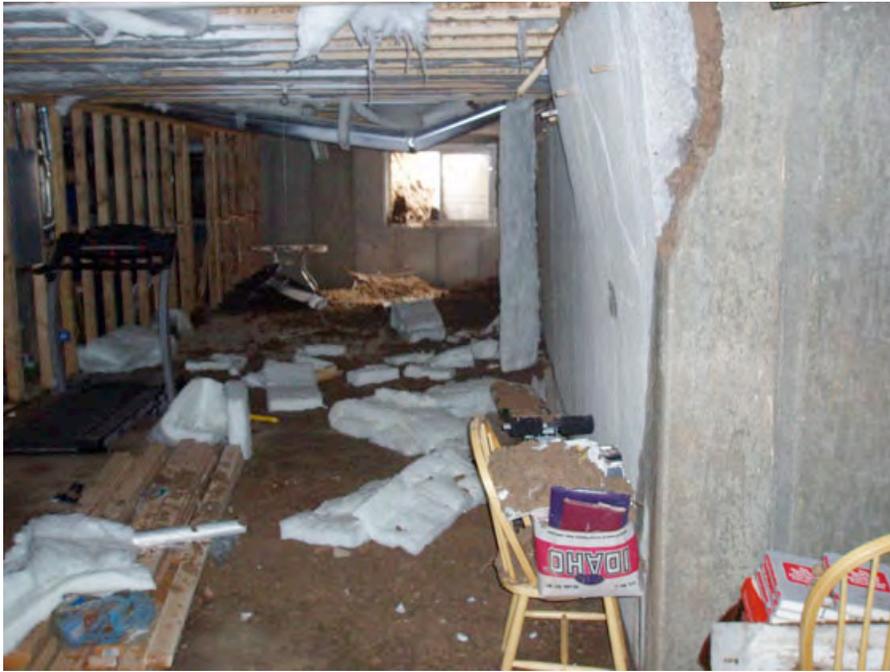
Figure 8. Basement at 1650 East 7687 South showing upper foundation wall (right side of photo) broken by landslide impact.

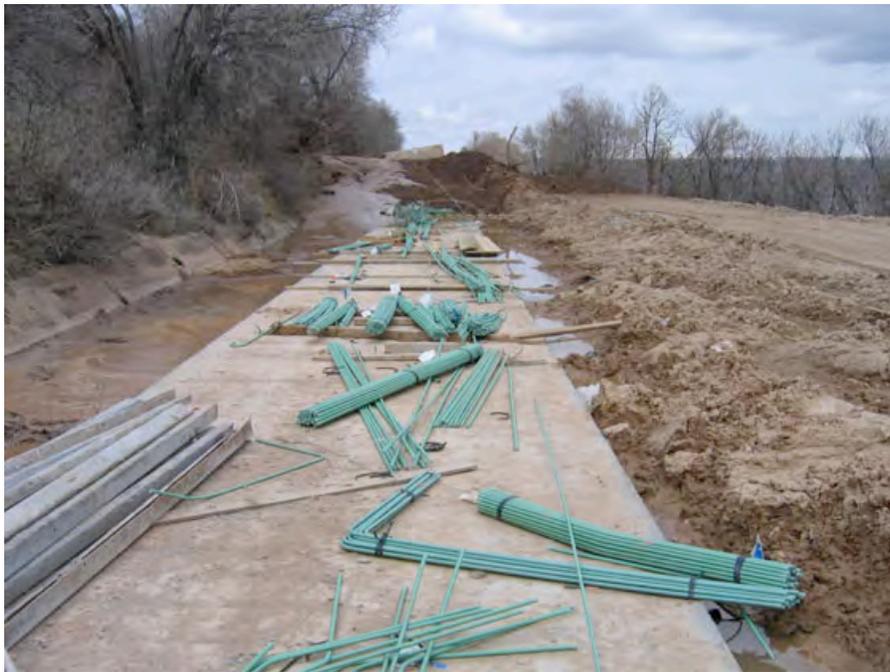
Figure 9. View looking northwest of Davis-Weber Canal showing landslide material deposited on the box culvert and canal access road. Following the landslide water and sediment flowed into the canal left of the box culvert.

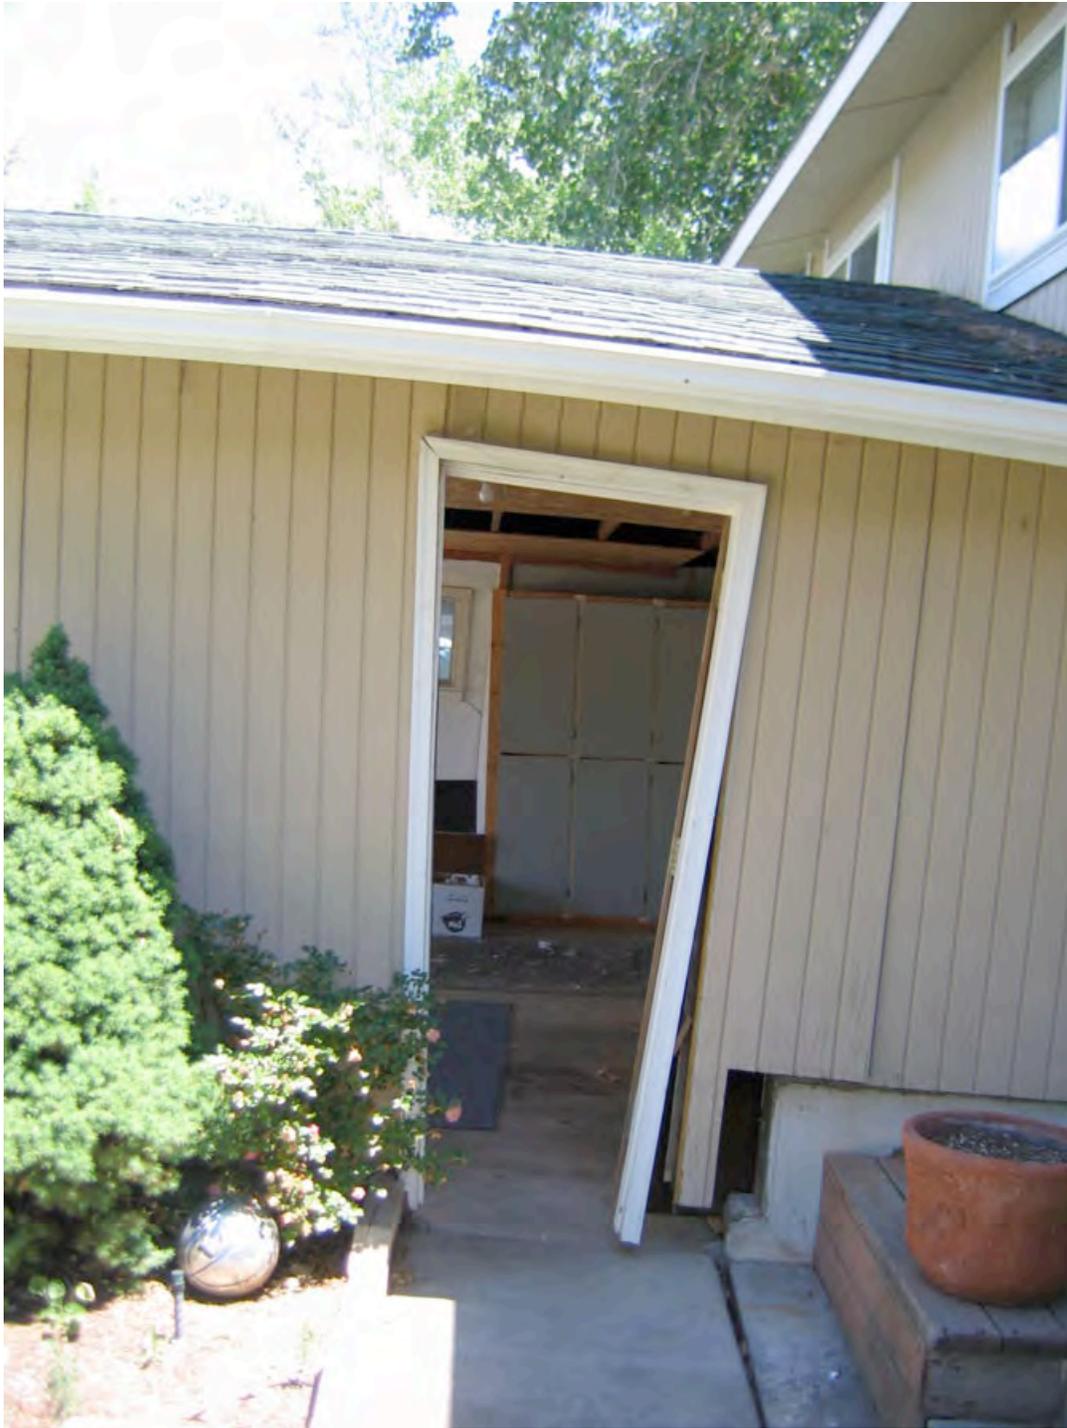
Figure 3. *Damage to garage attached to a house at 157 South Valley View Drive. House was subsequently demolished. Photograph taken in June 2006.*

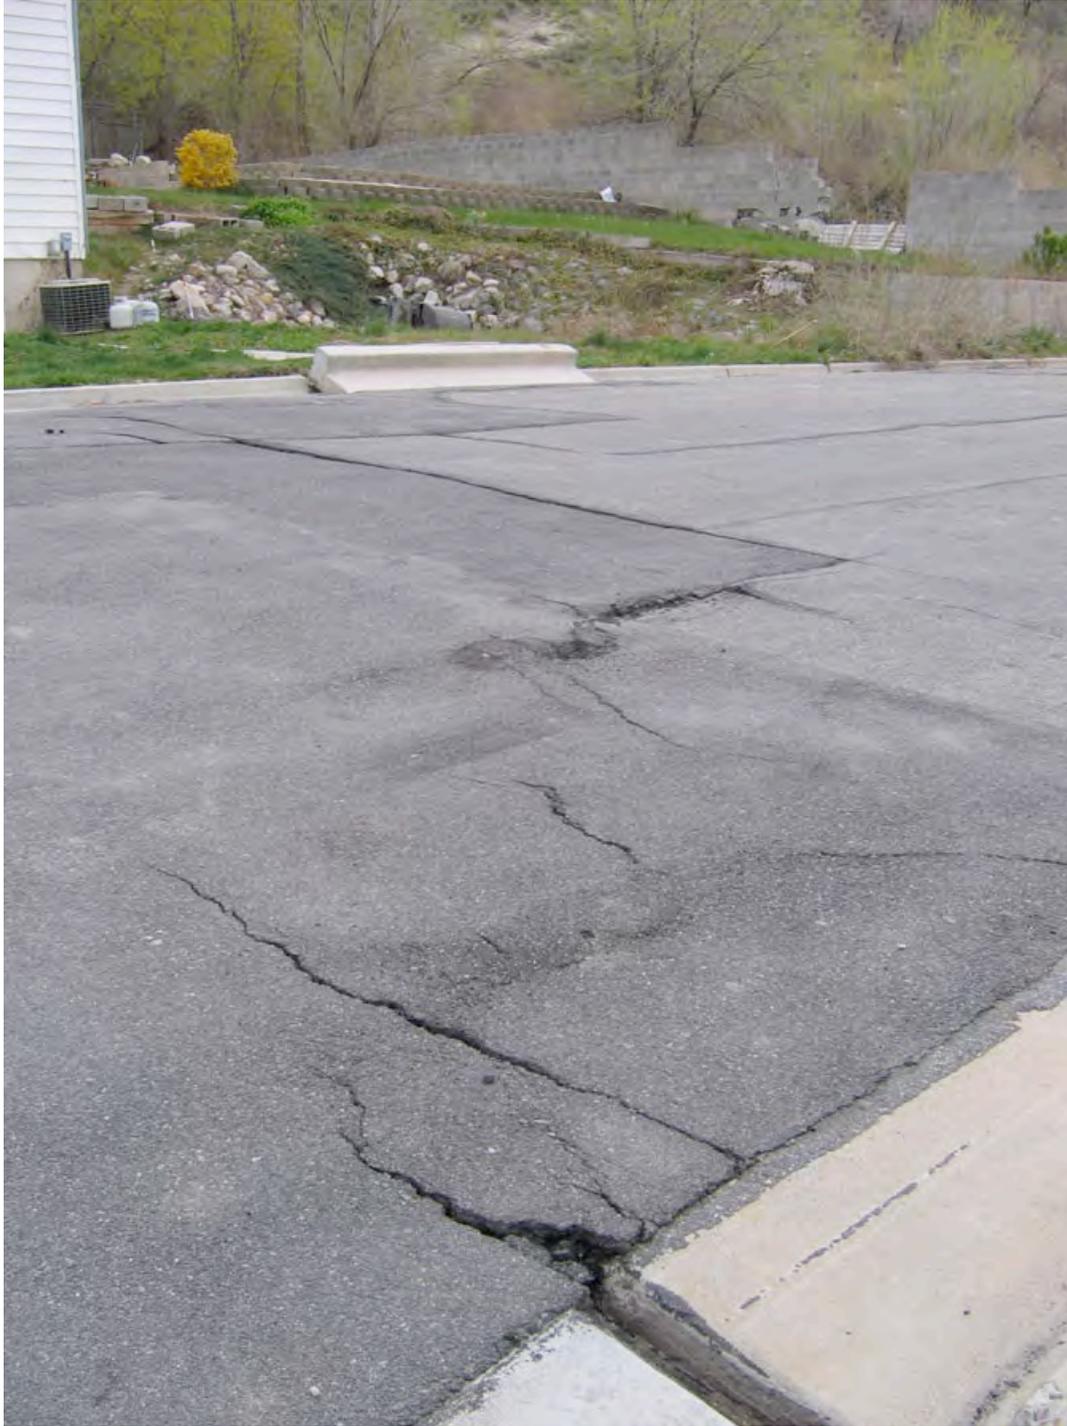
Figure 4. Road damage to south end of Springhill Drive along south-flank shear zone. View is upslope and to the southeast. Tilted and displaced curb and gutter visible on opposite side of road. Ground on left side of photograph is moving downslope (toward bottom-left edge of photograph). Photograph taken in May 2008.

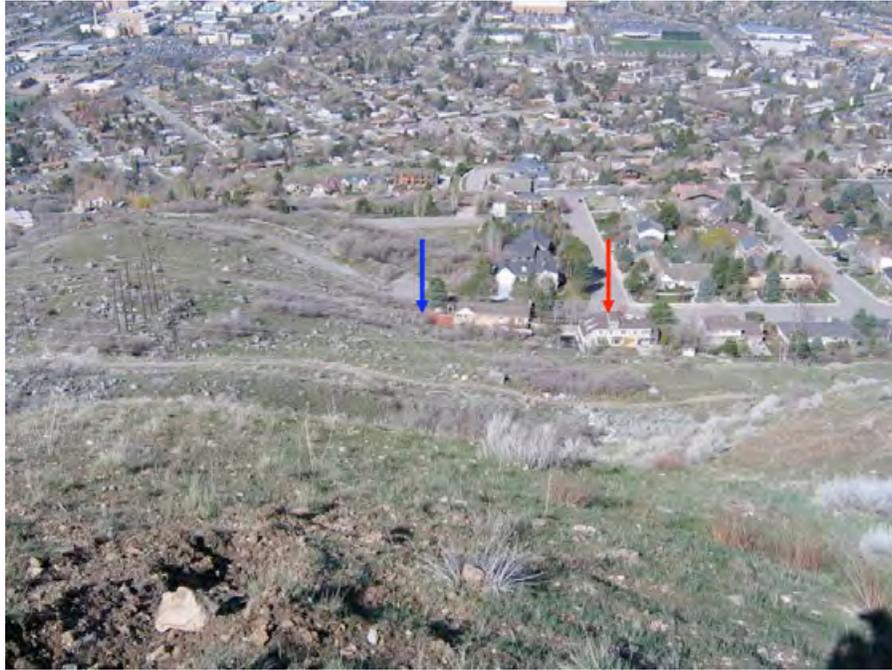
Figure 9. Previous guest house location destroyed by the 2005 rock fall (blue arrow) and the house damaged by the 2009 rock fall (red arrow). Rock-fall boulders on the alluvial fan left of the blue arrow and the slope above the impacted houses show the distribution and size of historical and prehistorical rock fall and the proximity of houses to the hazard.
