# **GEOLOGIC HAZARDS OF THE ZION NATIONAL PARK GEOLOGIC-HAZARD STUDY AREA, WASHINGTON AND KANE COUNTIES, UTAH**

**SPECIAL STUDY 133**  
**UTAH GEOLOGICAL SURVEY**  
*a division of*  
**UTAH DEPARTMENT OF NATURAL RESOURCES**  
**2010**

This chapter is part of Utah Geological Survey Special Study 133, *Geologic Hazards of the Zion National Park Geologic-Hazard Study Area, Washington and Kane Counties, Utah*.

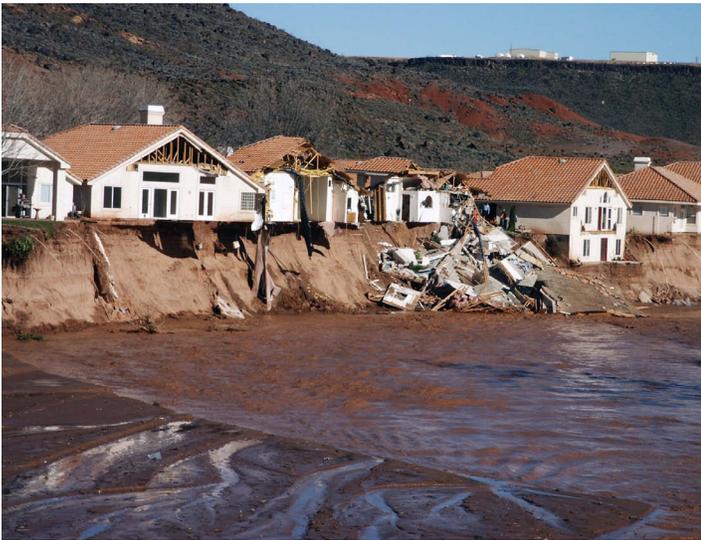
**Figure 2.1.** Damage to homes caused by flooding on the Santa Clara River near St. George, Utah, in January 2005.

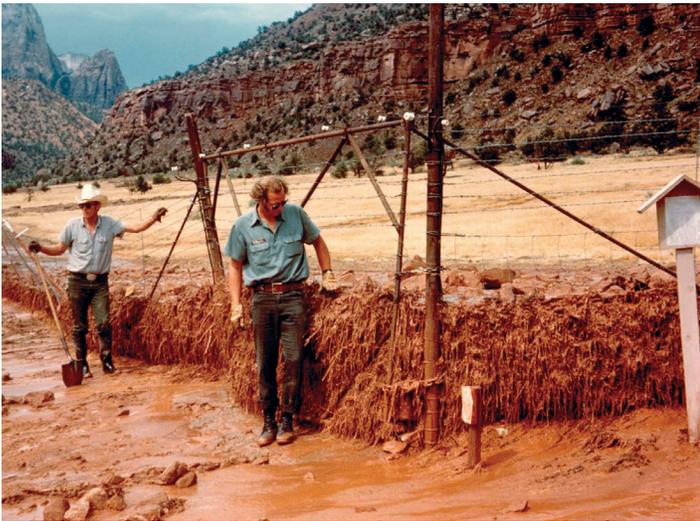
**Figure 2.3.** Sediment deposited by a small debris flow that discharged from an ephemeral drainage north of the Watchman housing area in 1979 (photo courtesy of NPS).

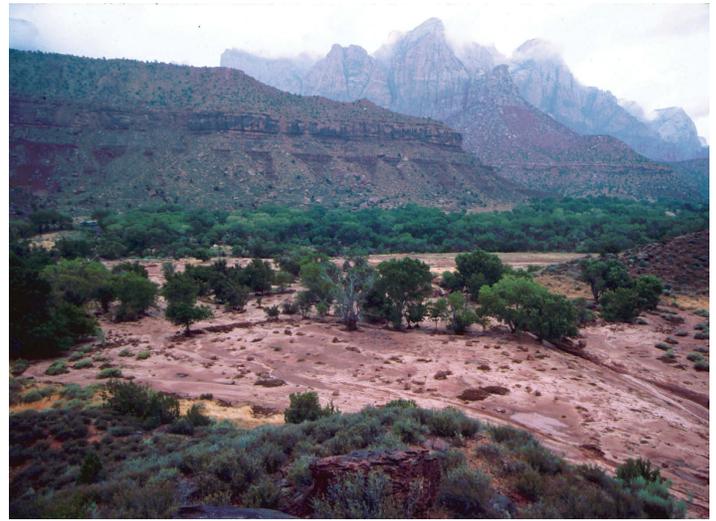
**Figure 2.4.** The 1998 Sammy's Canyon debris flow inundated the current site of the Zion National Park shuttle bus maintenance facility, visitor center, and part of the Watchman campground (photo courtesy of NPS).

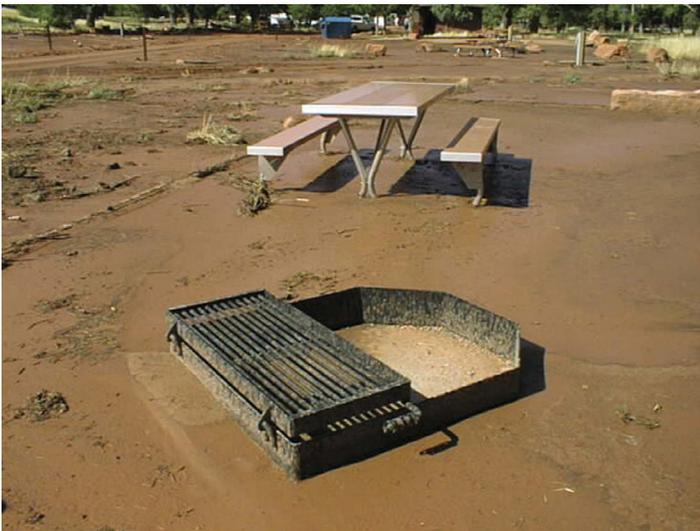
**Figure 2.5.** Sediment deposited by sheetflooding in the Watchman campground at the distal end of the 1998 Sammy's Canyon debris flow (photo courtesy of NPS).

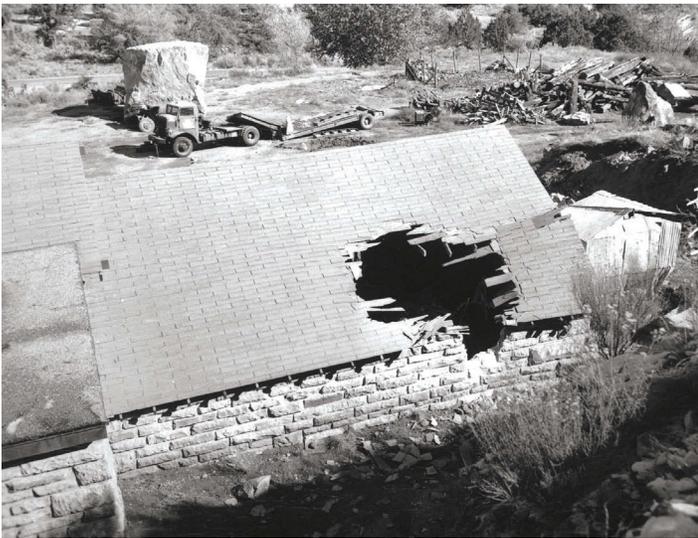
**Figure 3.1.** Damage to the roof of the Zion National Park maintenance facility in Oak Canyon caused by a rock-fall boulder in 1946 (photo courtesy of the National Park Service).

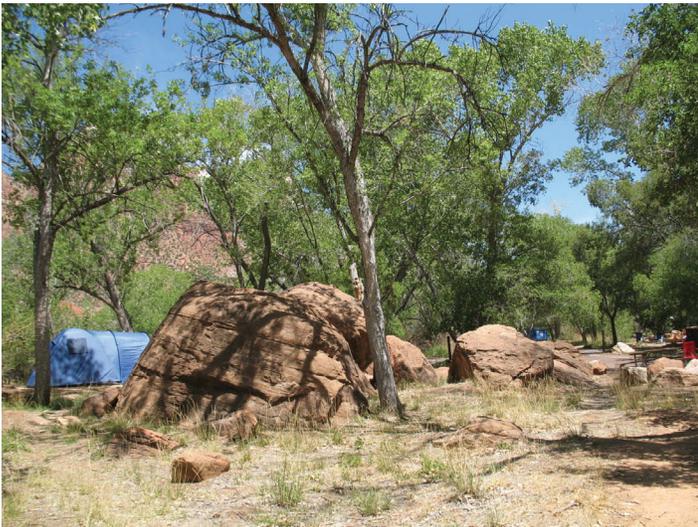
During our field reconnaissance, we observed several large boulders and boulder clusters in lower Zion Canyon well beyond the limits of normal rock-fall accumulation bordering canyon

**Figure 3.4.** Cluster of large rock-fall boulders in the Watchman campground far beyond the area of normal rock-fall accumulation at the base of canyon walls in lower Zion Canyon.

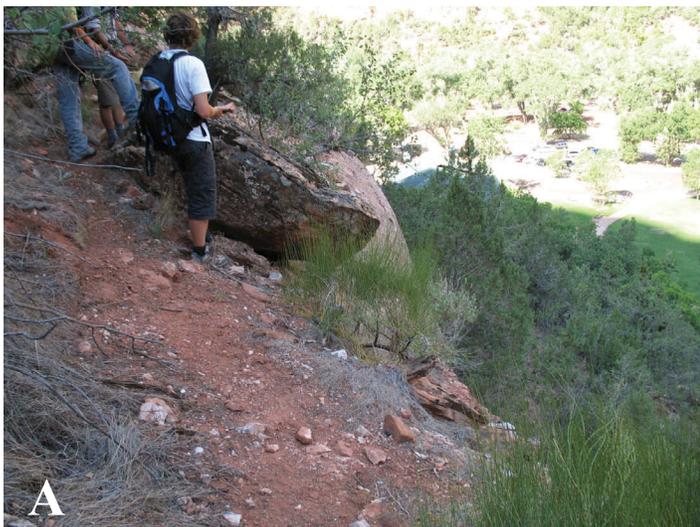
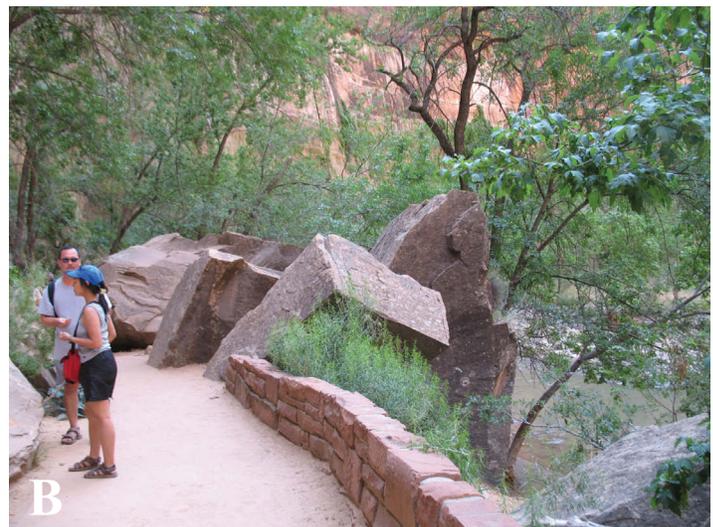
**Figure 3.6.** Permanent park facilities in rock-fall hazard zones. *A.* Precariously balanced boulder on a steep slope directly above Zion Lodge. *B.* Large rock-fall boulders along the heavily traveled River Walk Trail.

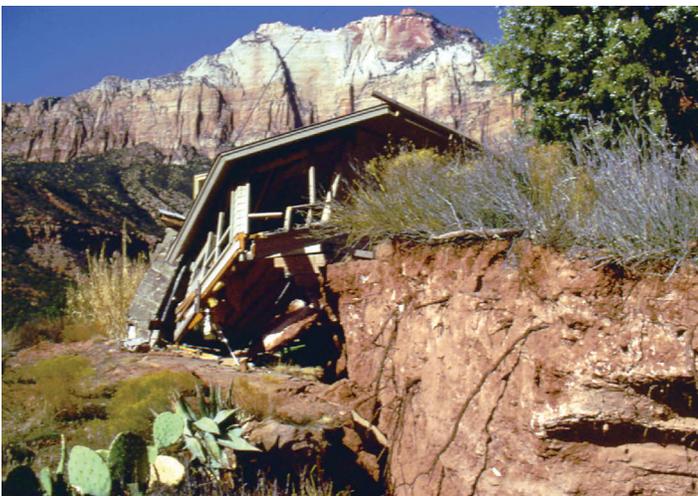
**Figure 4.1.** Home destroyed by the 1992 Springdale landslide in Springdale, Utah.

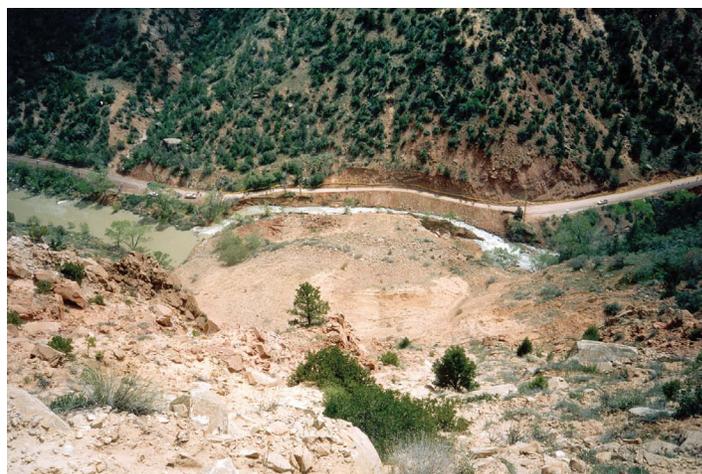
In April 1995, part of the Sentinel landslide reactivated and blocked the North Fork of the Virgin River for about an hour. The river subsequently breached the landslide dam and inundated Zion Canyon Scenic Drive. The ensuing erosion destroyed about 600 feet of roadway and underground utility lines. A temporary, one-lane road was constructed in the rubble slope to the east of the highway to evacuate people from the upper canyon (figure 4.5). Similar landslides occurred at or near this location in 1924 and again in 1941 (Grater, 1945; Solomon, 1996a). Ground water appears to be a contributing factor to the landslide reactivation. An outcrop of the Springdale Sandstone Member of the Kayenta Formation at the south end of the landslide produces several seeps and small springs. During excavation to place a rock buttress at the toe of the landslide in 2000, springs were observed discharging near river level from both the upstream and downstream margins of the slide mass. Both the winters of 1941 and 1995 were exceptionally wet, with January through April precipitation being 182 percent and 235 percent of the 70-year average, respectively.

**Figure 4.5.** Temporary road graded around the Sentinel landslide, April 1995 (photo credit G.F. Wieczorek, U.S. Geological Survey).

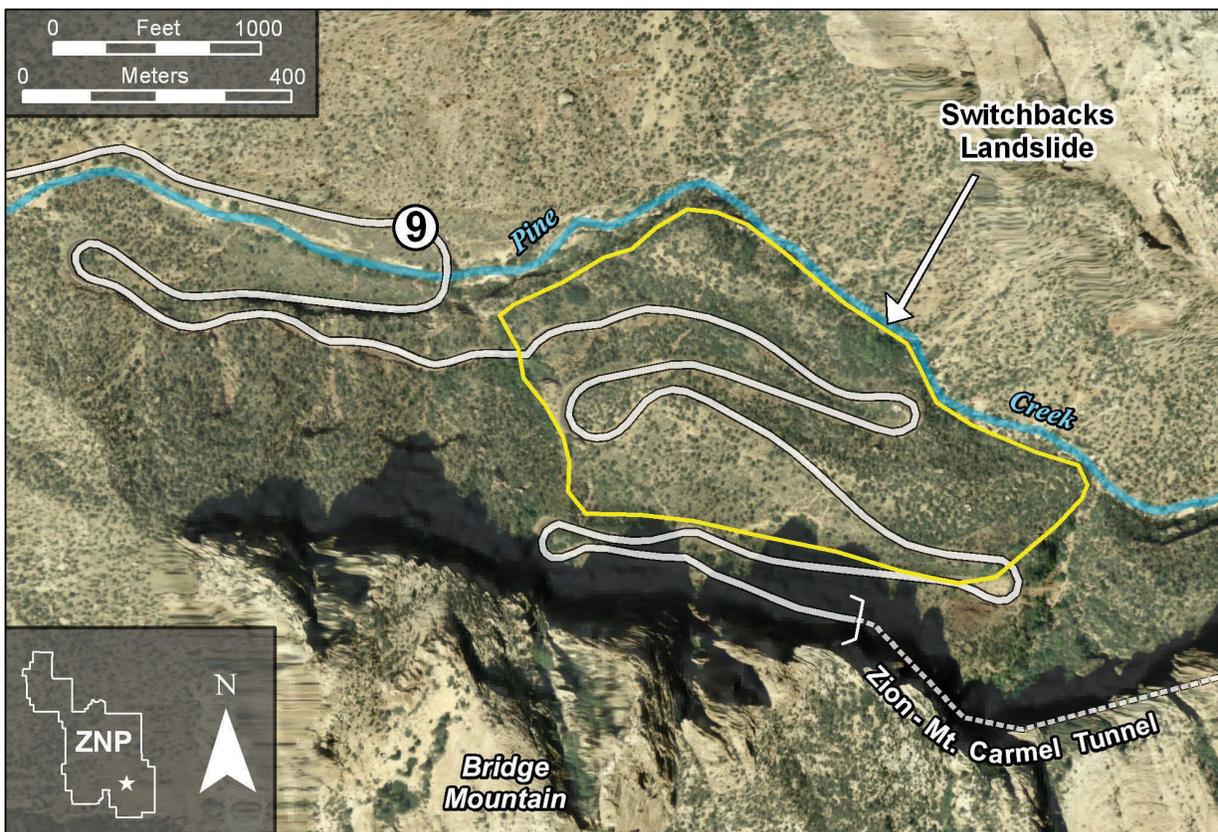
As part of the Yeh and Associates (2008) study, several boreholes were drilled in settlement areas along the roadway, subsurface materials were sampled and tested, and inclinometers and piezometers installed to monitor future landslide movement and changes in ground-water levels. Laboratory testing indicated that fill materials in the roadway are less than 95% of maximum dry density (ASTM D 698, T 99 method A; 2002) and susceptible to compaction upon wetting. A preliminary global slope-stability analysis showed that slope stability is highly dependent on ground-water conditions. The factor of

Figure 4.6. Zion–Mount Carmel Highway Switchbacks landslide (image source 2006 National Agricultural Imagery Program).

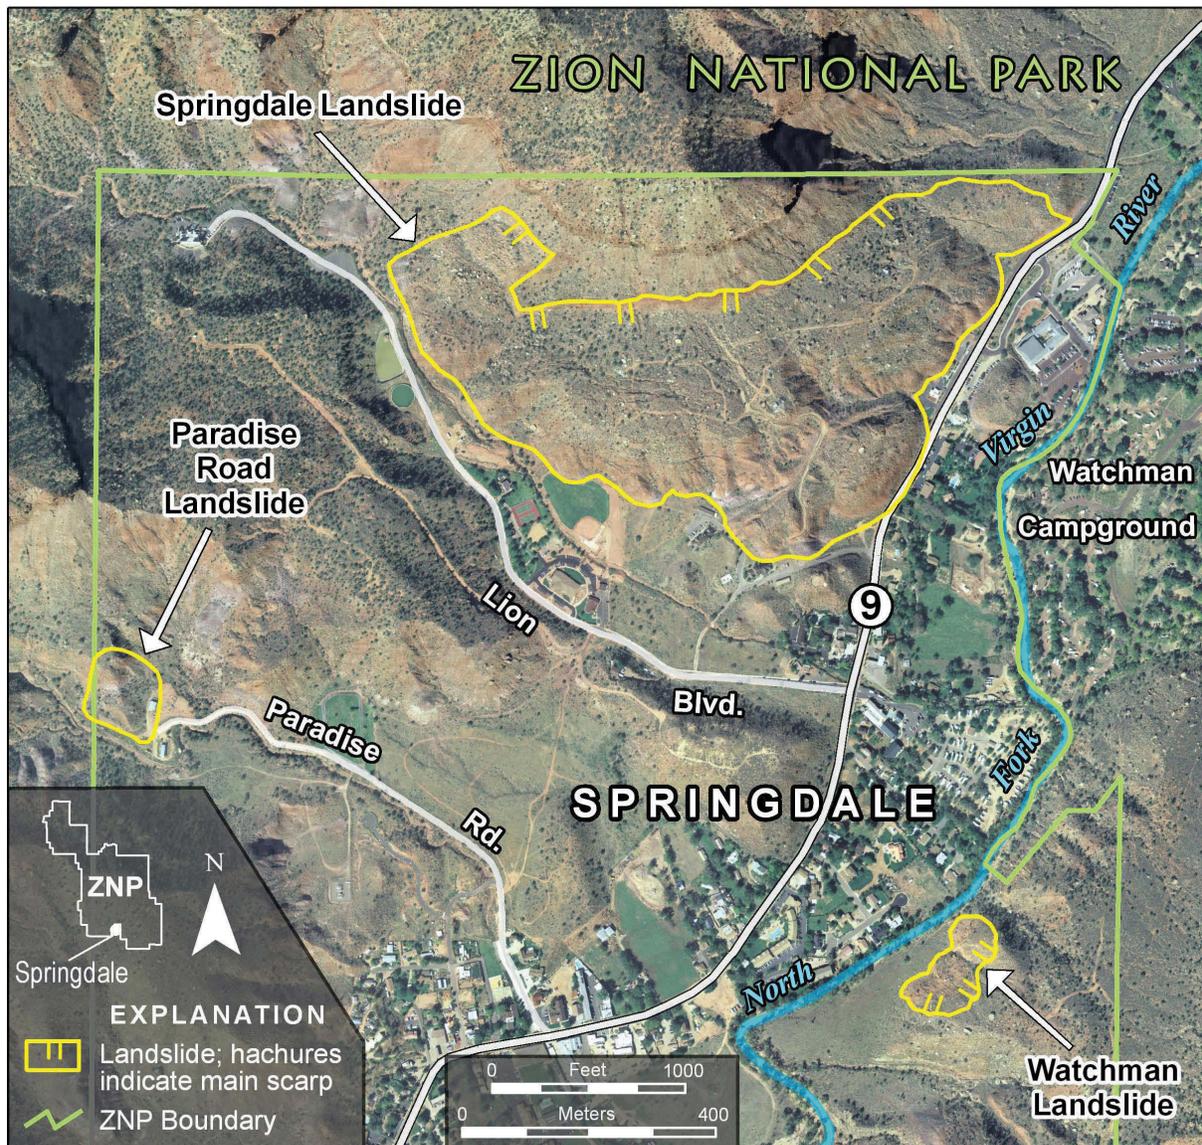
The landslide lies a few hundred feet southwest of the Zion National Park boundary and formed in unconsolidated deposits that have accumulated at the base of the steep east wall of Zion Canyon. The area of the landslide is approximately 3.1 acres, and the landslide toe abuts flat-lying alluvial terrace deposits

**Figure 4.7.** Springdale, Paradise Road, and Watchman landslides in Springdale, Utah (image source 2006 National Agricultural Imagery Program).

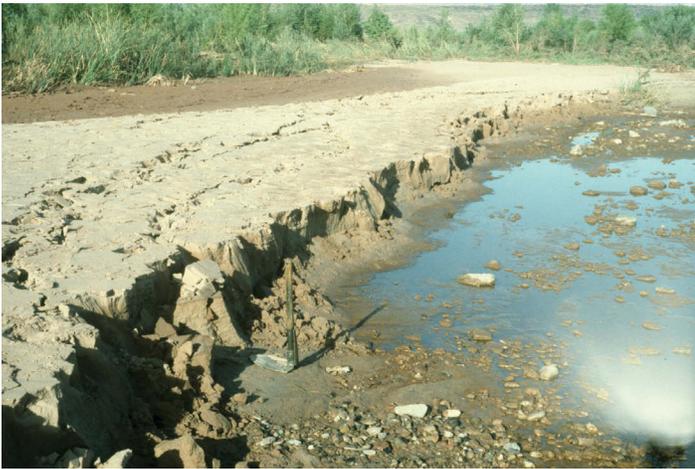
**Figure 5.8.** Lateral-spread cracking from liquefaction along the Virgin River resulting from the September 2, 1992, M 5.8 St. George earthquake. Folding shovel for scale (photo credit W.E. Mulvey).

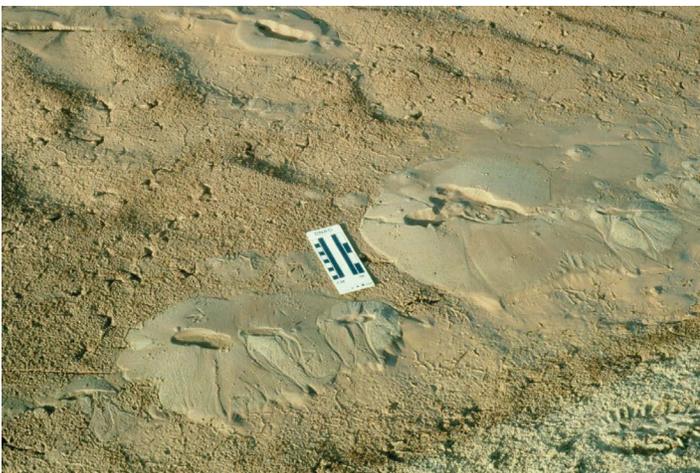
**Figure 5.9.** Sand blows from liquefaction along the Virgin River resulting from the September 2, 1992, M 5.8 St. George earthquake. Scale card shows centimeters (left) and inches (right) (photo credit W.E. Mulvey).

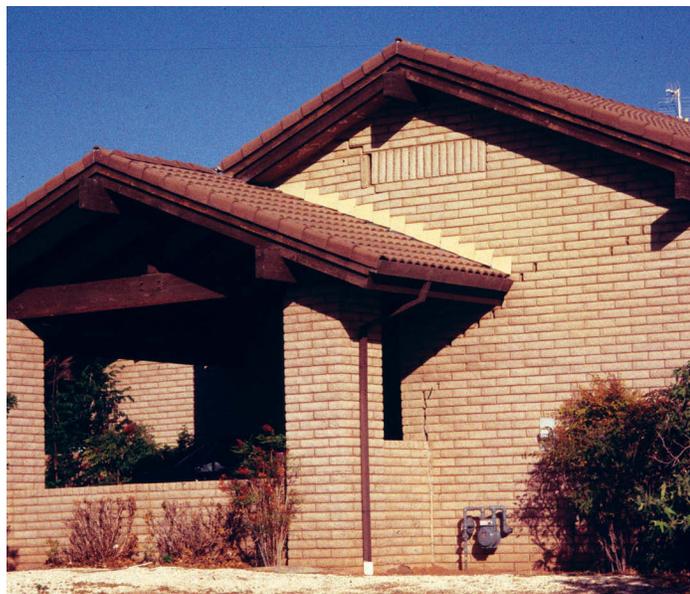
**Figure 6.2.** Home in southwestern Utah damaged by expansive soil/rock.

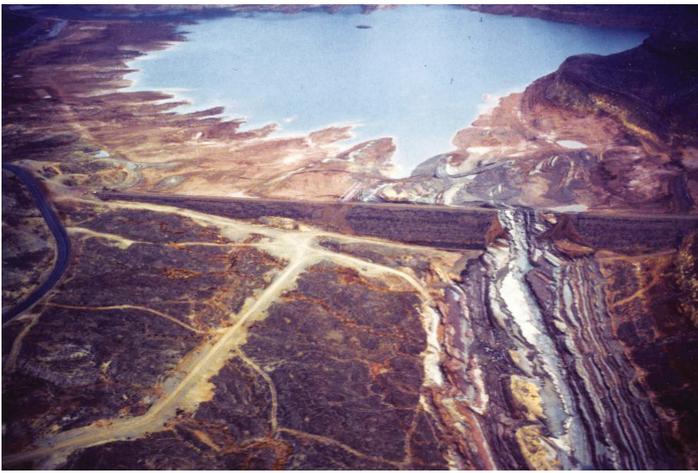
**Figure 6.5.** Quail Creek dike failure, January 1, 1989, in southwestern Utah was due in part to gypsum dissolution in the underlying Shnabkaib Member of the Moenkopi Formation (photo credit Ben Everitt).

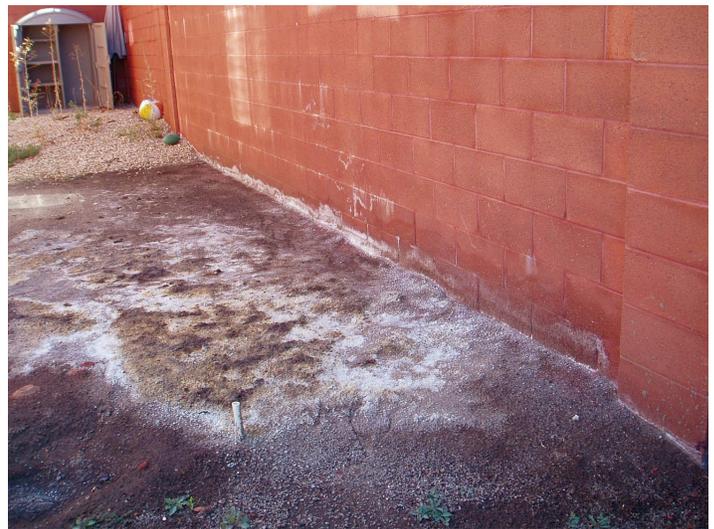
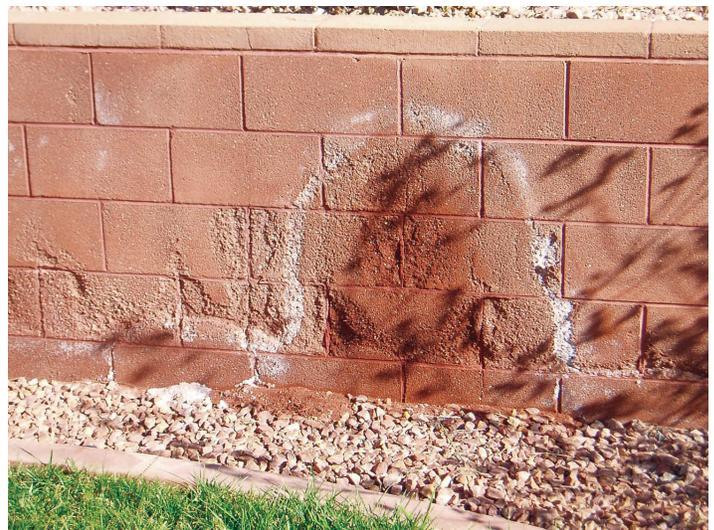
**Figure 6.6.** Corrosion of masonry block walls in southwestern Utah due to the reaction of the non-Type V cement used in the masonry blocks with high-sulfate soils (photo credit David Black, Rosenberg Associates).

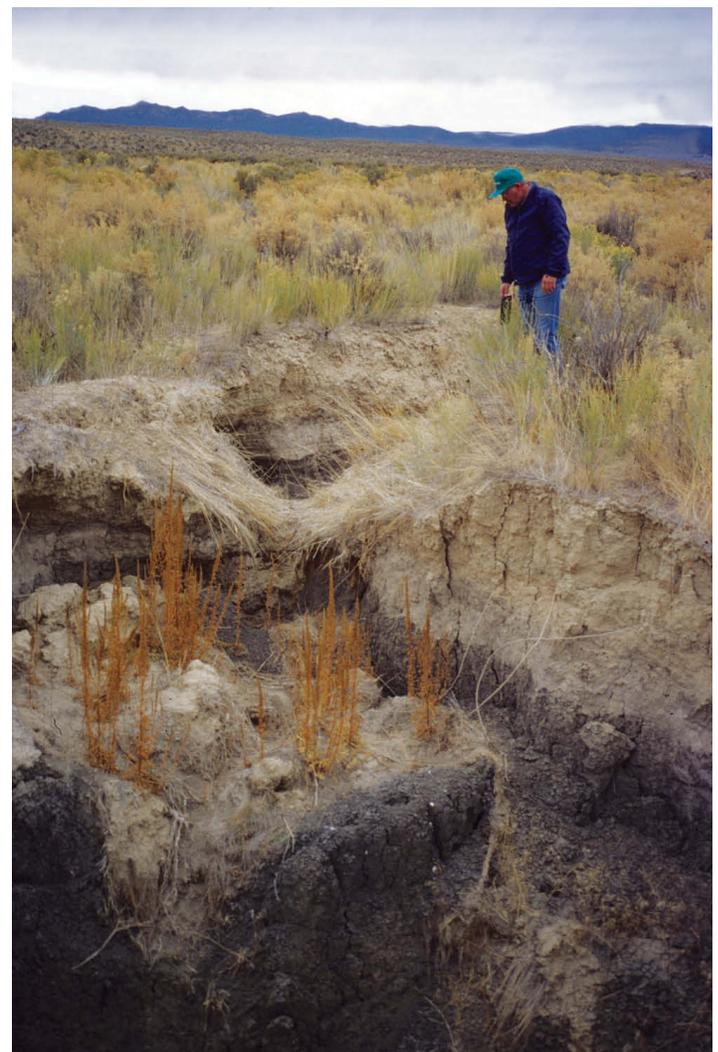
**Figure 6.8.** Collapsed pipe in fine-grained floodplain alluvium in southwestern Utah.
