# ESTIMATION OF POTENTIAL DEBRIS-FLOW VOLUMES FOR CENTERVILLE CANYON, DAVIS COUNTY, UTAH

by Richard E. Giraud and Jessica J. Castleton

**REPORT OF INVESTIGATION 267**  
**UTAH GEOLOGICAL SURVEY**  
*a division of*  
**UTAH DEPARTMENT OF NATURAL RESOURCES**  
**2009**

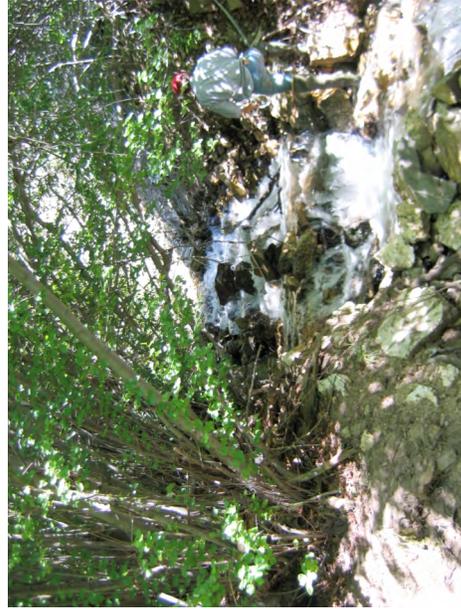
Channel Reach 2  
Bulked Volume 3161 yd<sup>3</sup>

View upchannel

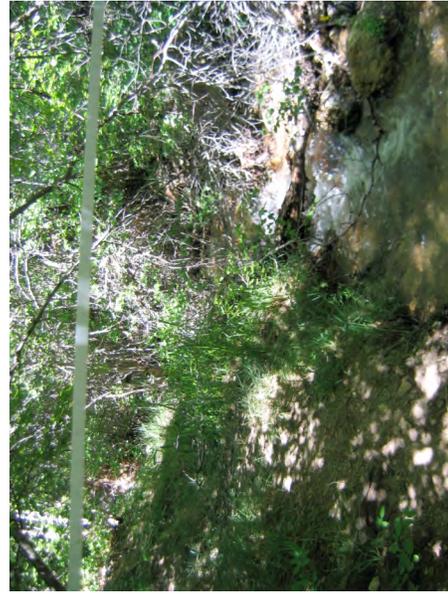
Channel Reach 4  
Bulked Volume 29,496 yd<sup>3</sup>

View upchannel

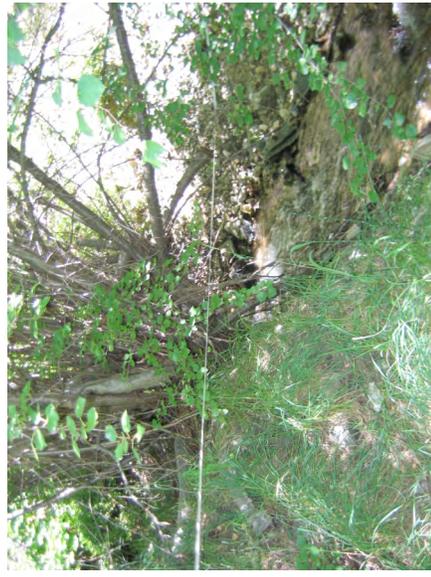
Channel Reach 4  
Bulked Volume 29,496 yd<sup>3</sup>

View upchannel

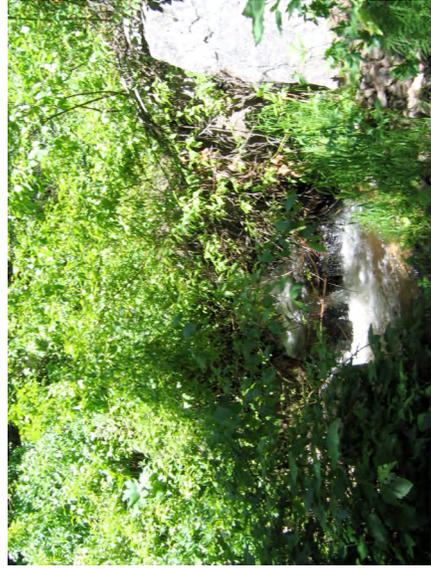
Channel Reach 8  
Bulked Volume 5023 yd<sup>3</sup>

View upchannel

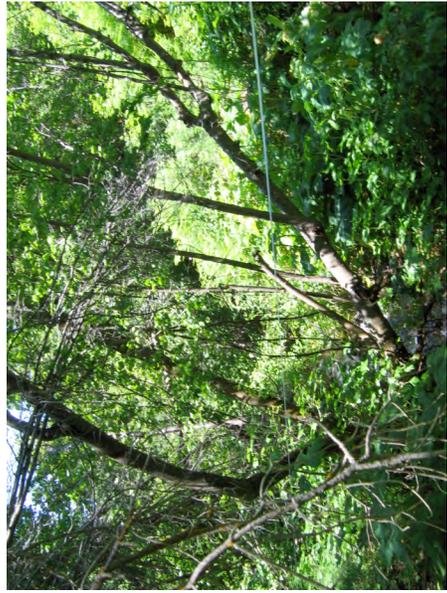
Channel Reach 11  
Bulked Volume 16,716 yd<sup>3</sup>

View upchannel

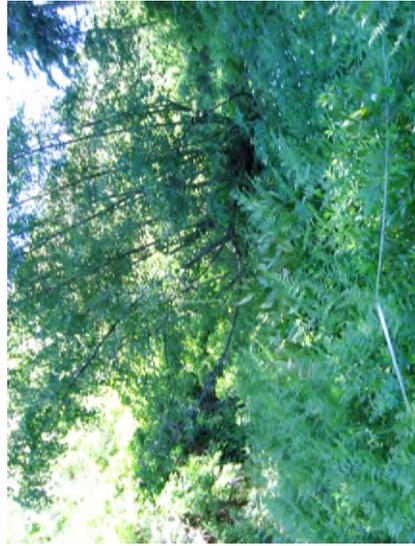
Channel Reach 13  
Bulked Volume 32,208 yd<sup>3</sup>

View upchannel

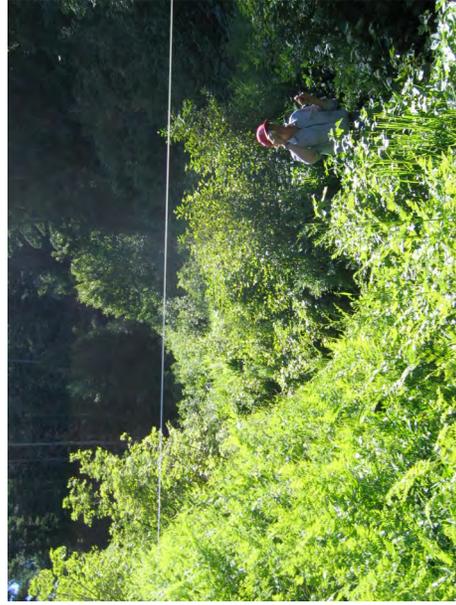
Channel Reach 13  
Bulked Volume 32,208 yd<sup>3</sup>

View upchannel

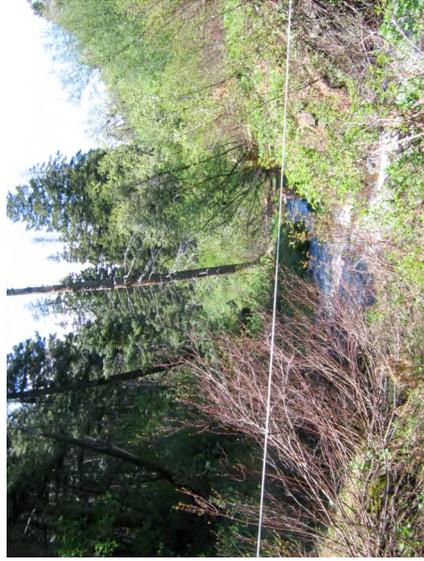
Channel Reach 13  
Bulked Volume 32,208 yd<sup>3</sup>

View upchannel

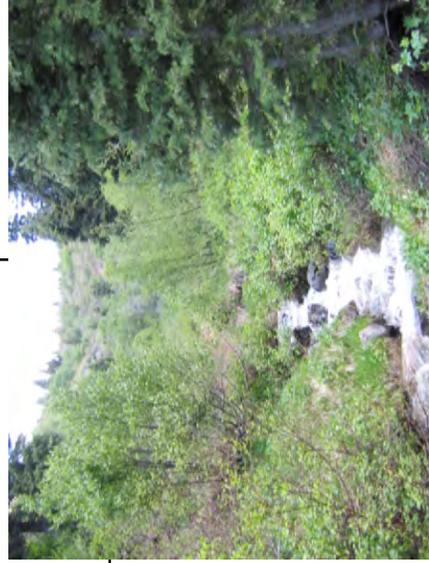
View upchannel

Channel Reach 14  
Bulked Volume 12,037 yd<sup>3</sup>

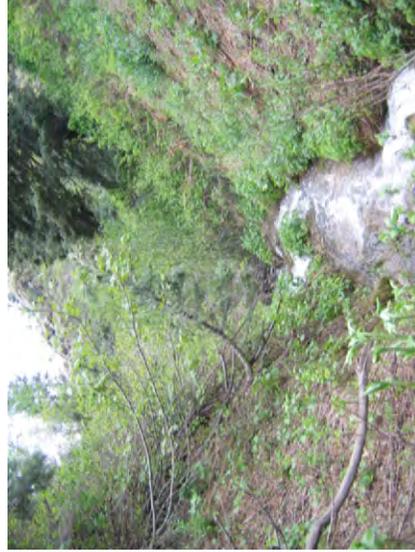
Channel Reach 15  
Bulked Volume 2678 yd<sup>3</sup>

View upchannel
