TECHNICAL REPORTS FOR 2002–2009 GEOLOGIC HAZARDS PROGRAM

COMPILED BY ASHLEY H. ELLIOTT

Report of Investigation 269
Utah Geological Survey
a division of
Utah Department of Natural Resources
2010

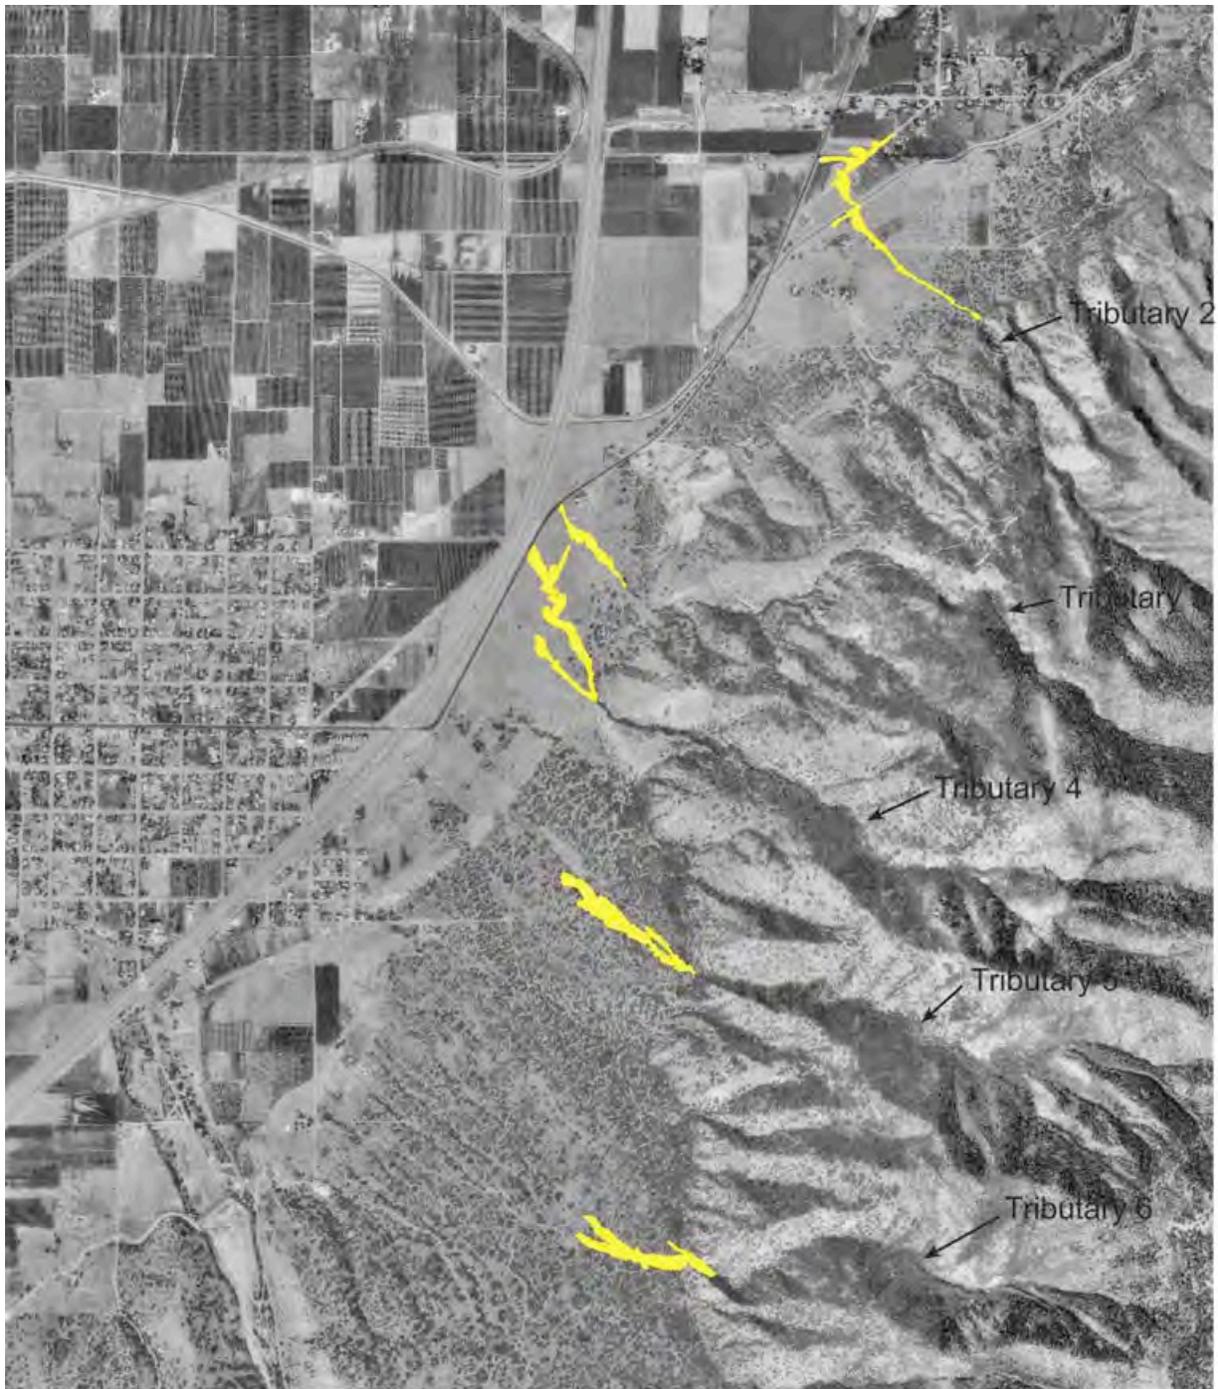
Figure 2. Orthophoto map showing debris-flow deposits (yellow).

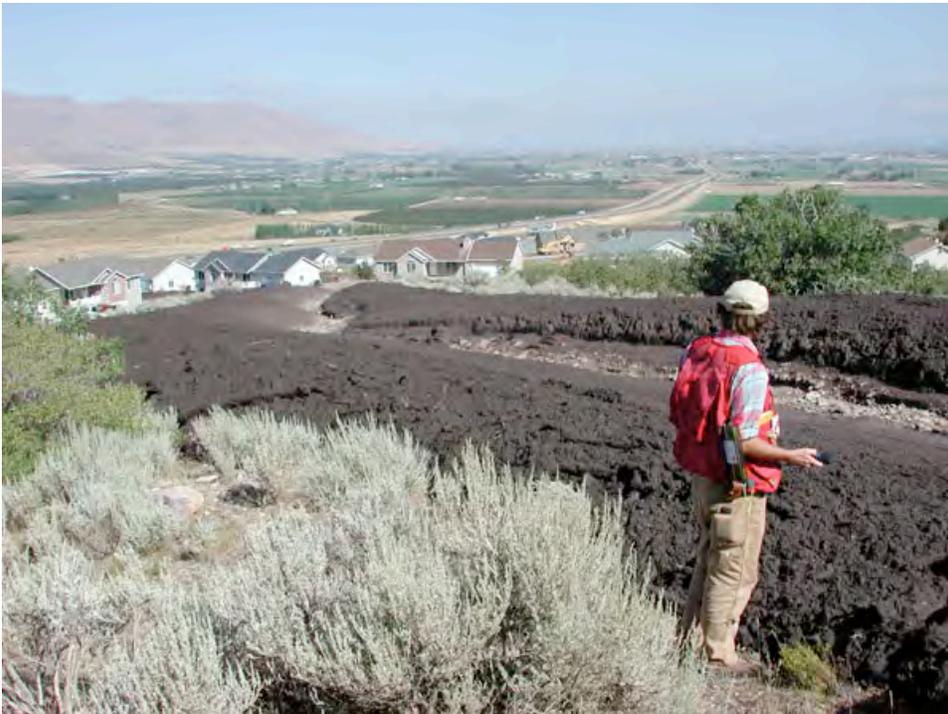
*(b) Levee deposits of tributary 4 north lobe on the fan apex.
Figure 4. Debris-flow deposits.*

The debris flow from tributary 4 was the most damaging of the five. When the flow reached the mouth of tributary 4, it split into two lobes. The larger, north lobe flowed through the Santaquin subdivision causing substantial property damage (figure 4a, figure 5). Most of the north lobe did not follow city streets but established a direct path down the alluvial fan. Subsequent floodwater traveled down roadways. The south lobe flowed down an undeveloped portion of the fan and deposited debris on a newly excavated subdivision road south of the existing development.

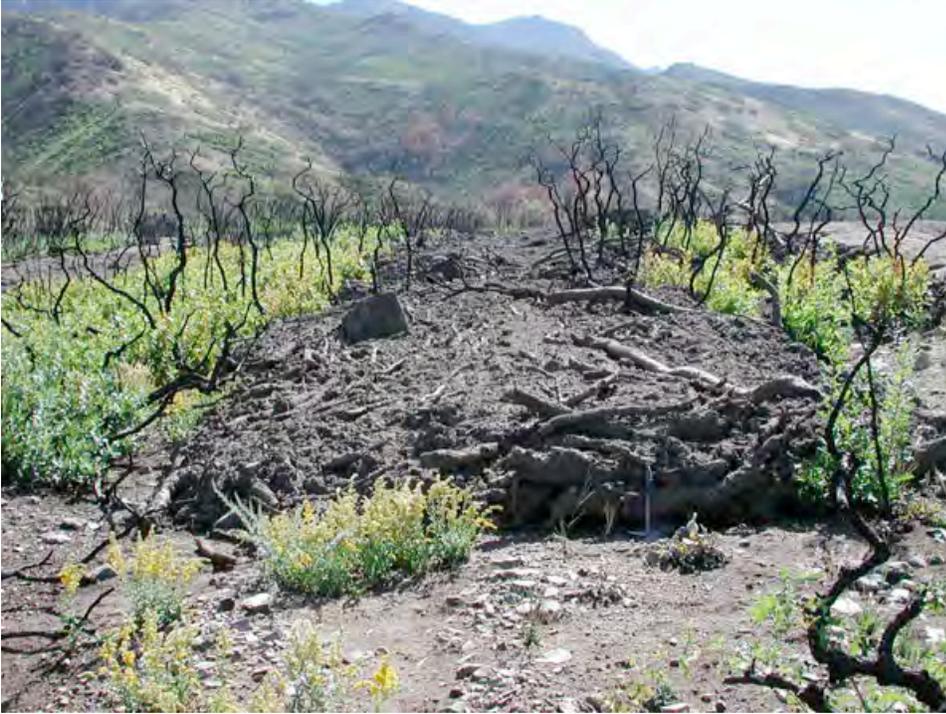
(c) Toe of tributary 5 overbank deposit north of main lobe.

The debris flow from tributary 5 deposited sediment at the mouth of the drainage east of developed areas. Post debris-flow floodwater reached a subdivision, including a newly excavated road; however, no major property damage was reported. The debris-flow deposit on the upper portion of the fan contained considerable woody debris and trees up to several inches in diameter (figure 4c). Near the top of the deposit a moderate-sized lobe is present north of the main flow that contains much less woody debris and large clasts, and likely represents a later surge.

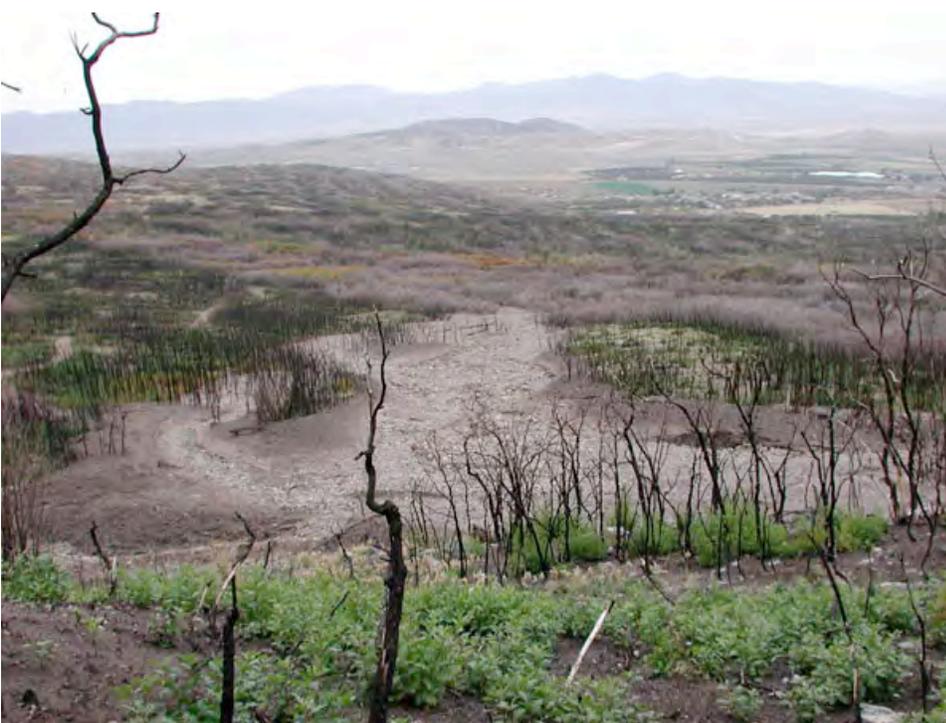
(d) View of tributary 6 deposit looking downfan (eastward).

The tributary 6 deposit was similar in character to the tributary 5 deposit. Neither the debris flow nor associated floodwater affected any developed areas (figure 4d).

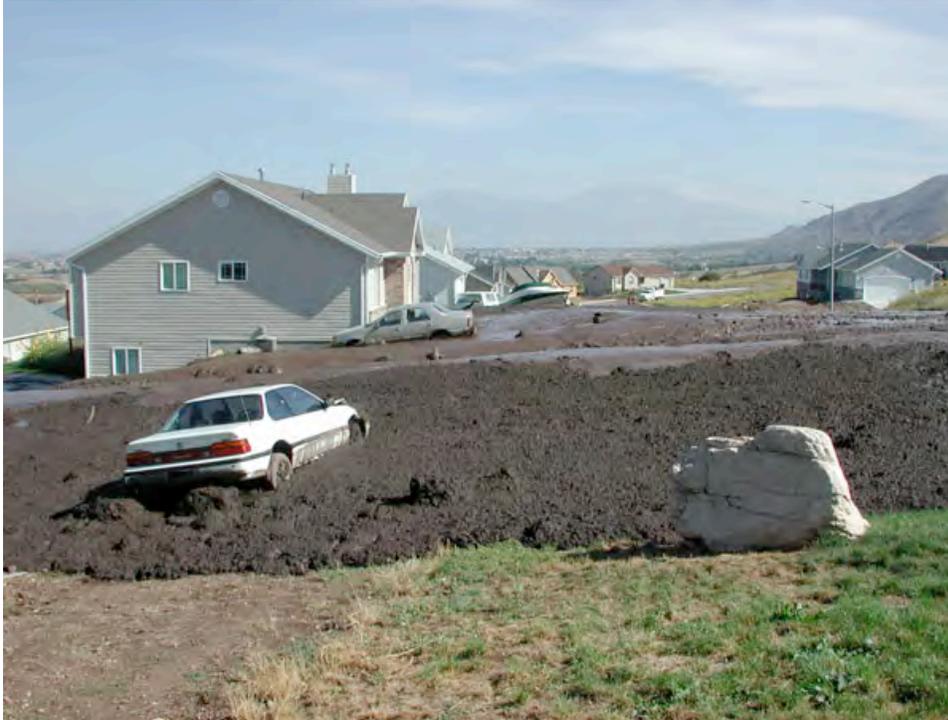
(a) Debris-flow sediment deposited at the intersection of Lambert Avenue and Apple View Street. The debris flow rafted vehicles and filled basements with sediment.

Three of the five debris flows and associated flooding caused damage to infrastructure, property, and houses in the communities of Santaquin and Spring Lake. Most of the damage occurred at the Santaquin subdivision from the north lobe of the tributary 4 debris flow. Vehicles were moved (figure 5a), some were pushed into houses; basements were flooded and filled with debris as ground-level windows were broken (figure 5b); house and garage doors were buckled inward (figure 5c); and the back wall of one house was broken by impact forces (figure 5d). A preliminary report prepared by Ryan Pietramali of the Utah Division of Emergency Services indicates five homes and two businesses received major damage and 27 homes received minor damage at a total cost of about \$500,000 (U.S. Small Business Administration Damage Assessment Report dated September 19, 2002).

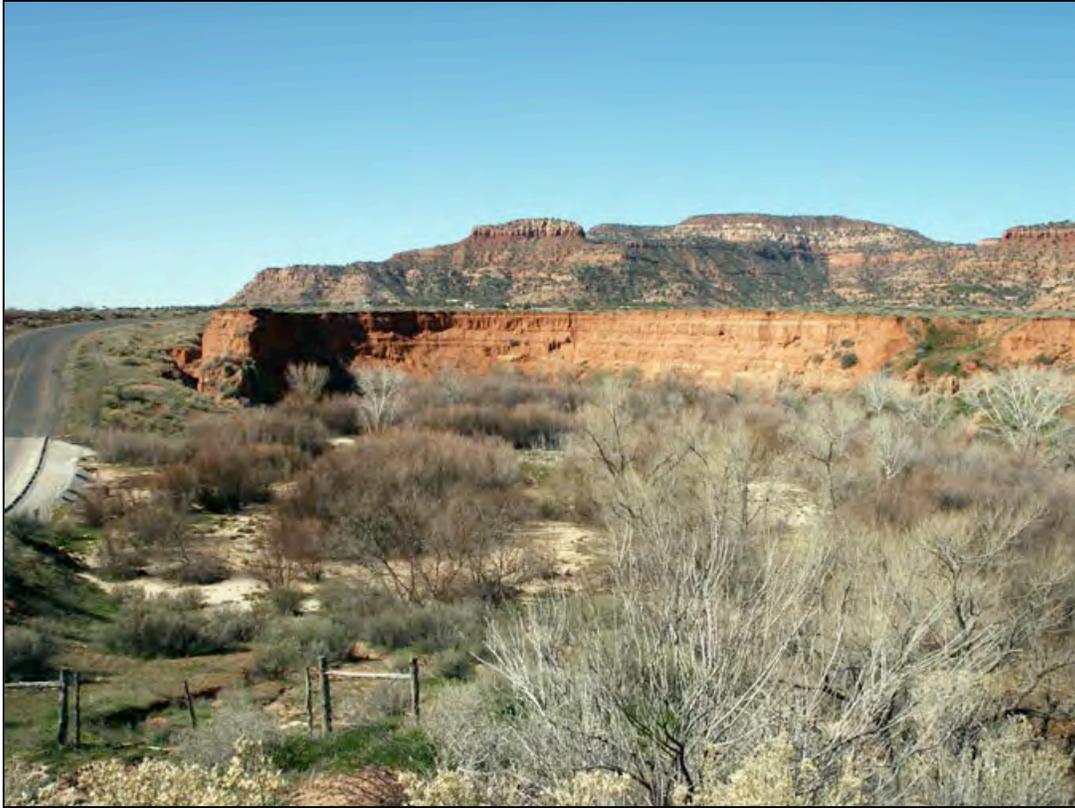
Figure 3. View to the southwest of Kanab Creek, showing the steep-walled arroyo that formed due to floods in the 1880s.

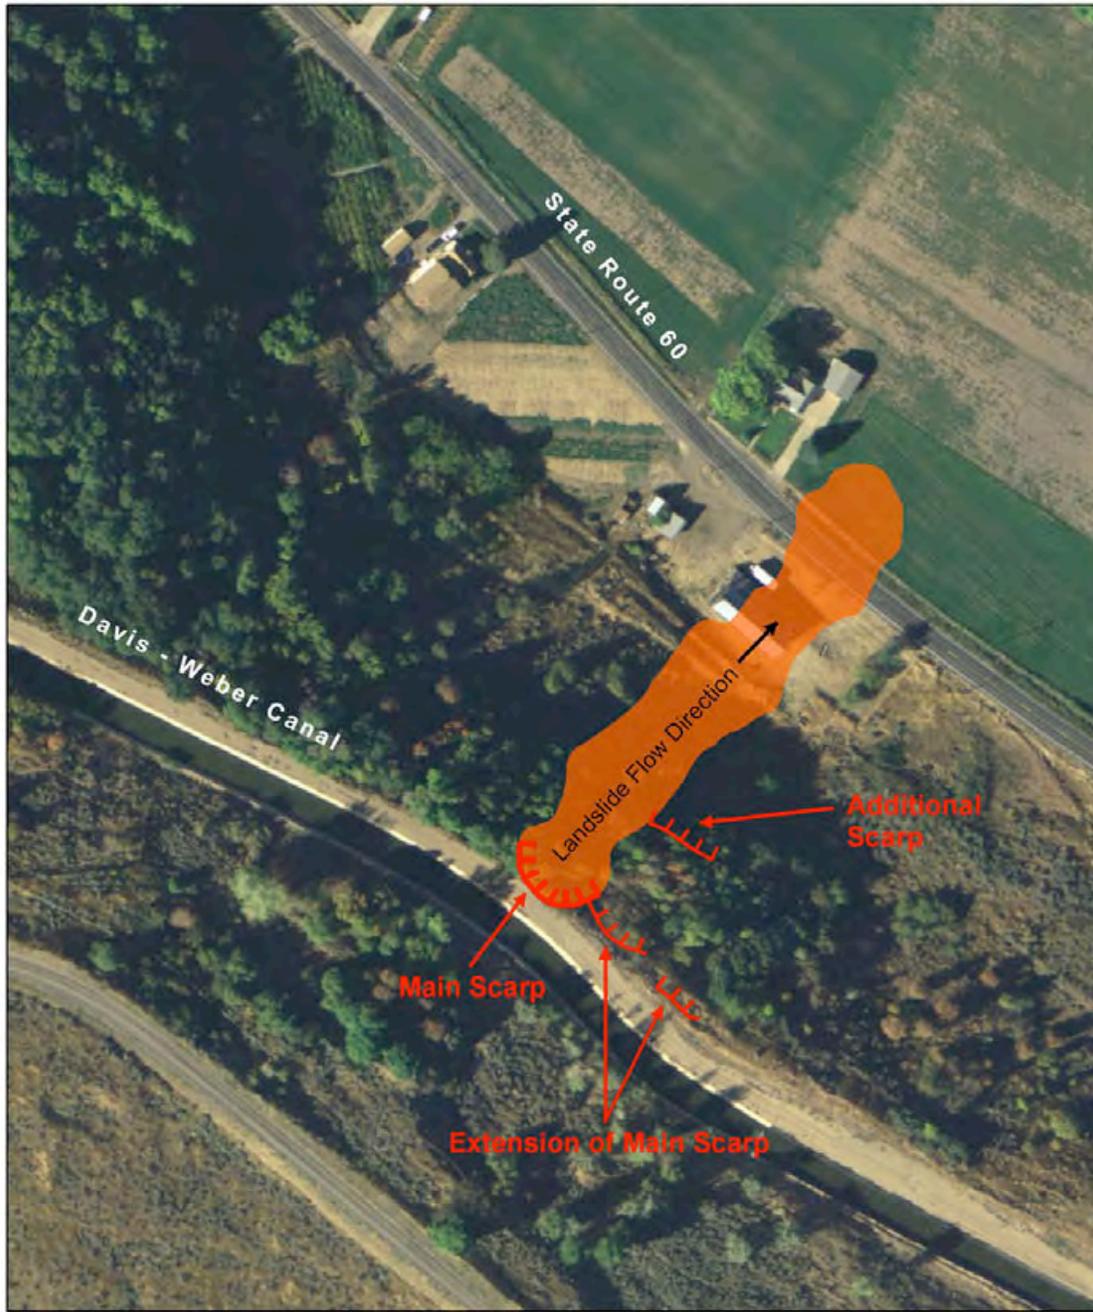
The landslide occurred shortly after 6 p.m., and demolished a barn, took out telephone poles, and blocked State Route 60 (South Weber Drive) (figures 2, 3, 4). The landslide is approximately 480 feet long and 80 feet wide at its widest point (figure 3) and between stations 305 and 310 on the Davis-Weber Canal. According to Nolan Birt (verbal communication, March 4, 2005), the barn owner who witnessed the event, the total landslide travel time was about a

Figure 3. Image showing landslide flow direction, the Davis-Weber Canal, main scarp, other scarp, and runout beyond State Route 60 (South Weber Drive).

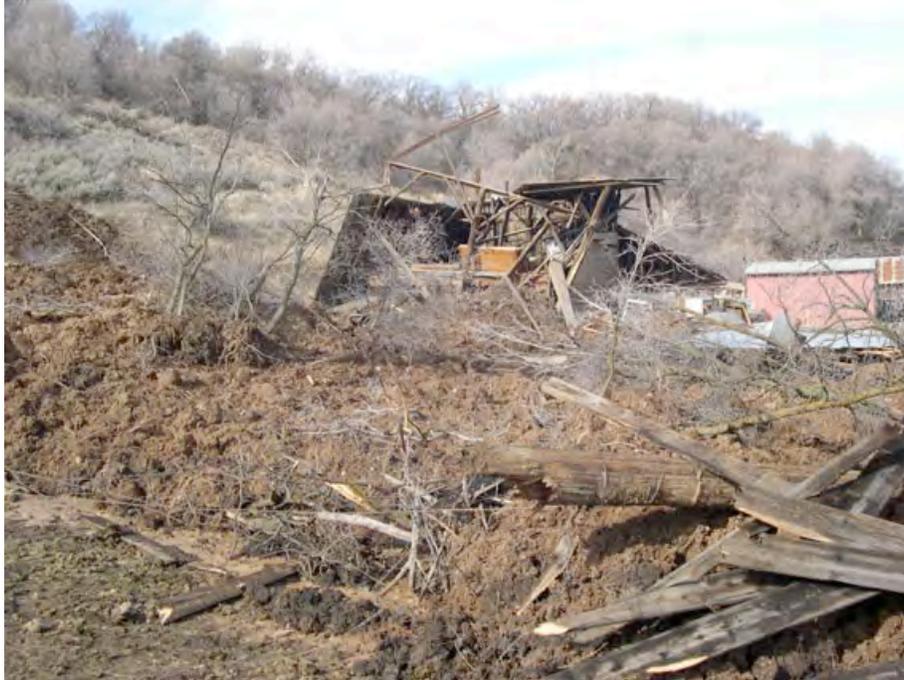
Figure 4. Looking across the lower part of the landslide at the demolished barn. The clump of trees in the foreground was rafted downslope on top of the landslide debris.

minute and the barn provided no resistance to landslide movement. Based on this approximate travel time, the estimated landslide velocity is about 8 feet per second, which classifies as very rapid landslide movement (Cruden and Varnes, 1996). The landslide is just below the Davis-Weber Canal and likely started moving as a rotational slide, but likely transformed into a rapid earth flow about midway downslope and ran out 150 feet beyond the toe of the slope across State Route 60 and onto a flat field. Grass, shrubs, and trees cover this northeast-facing slope. Some trees were rafted on top of the landslide debris (figure 4).

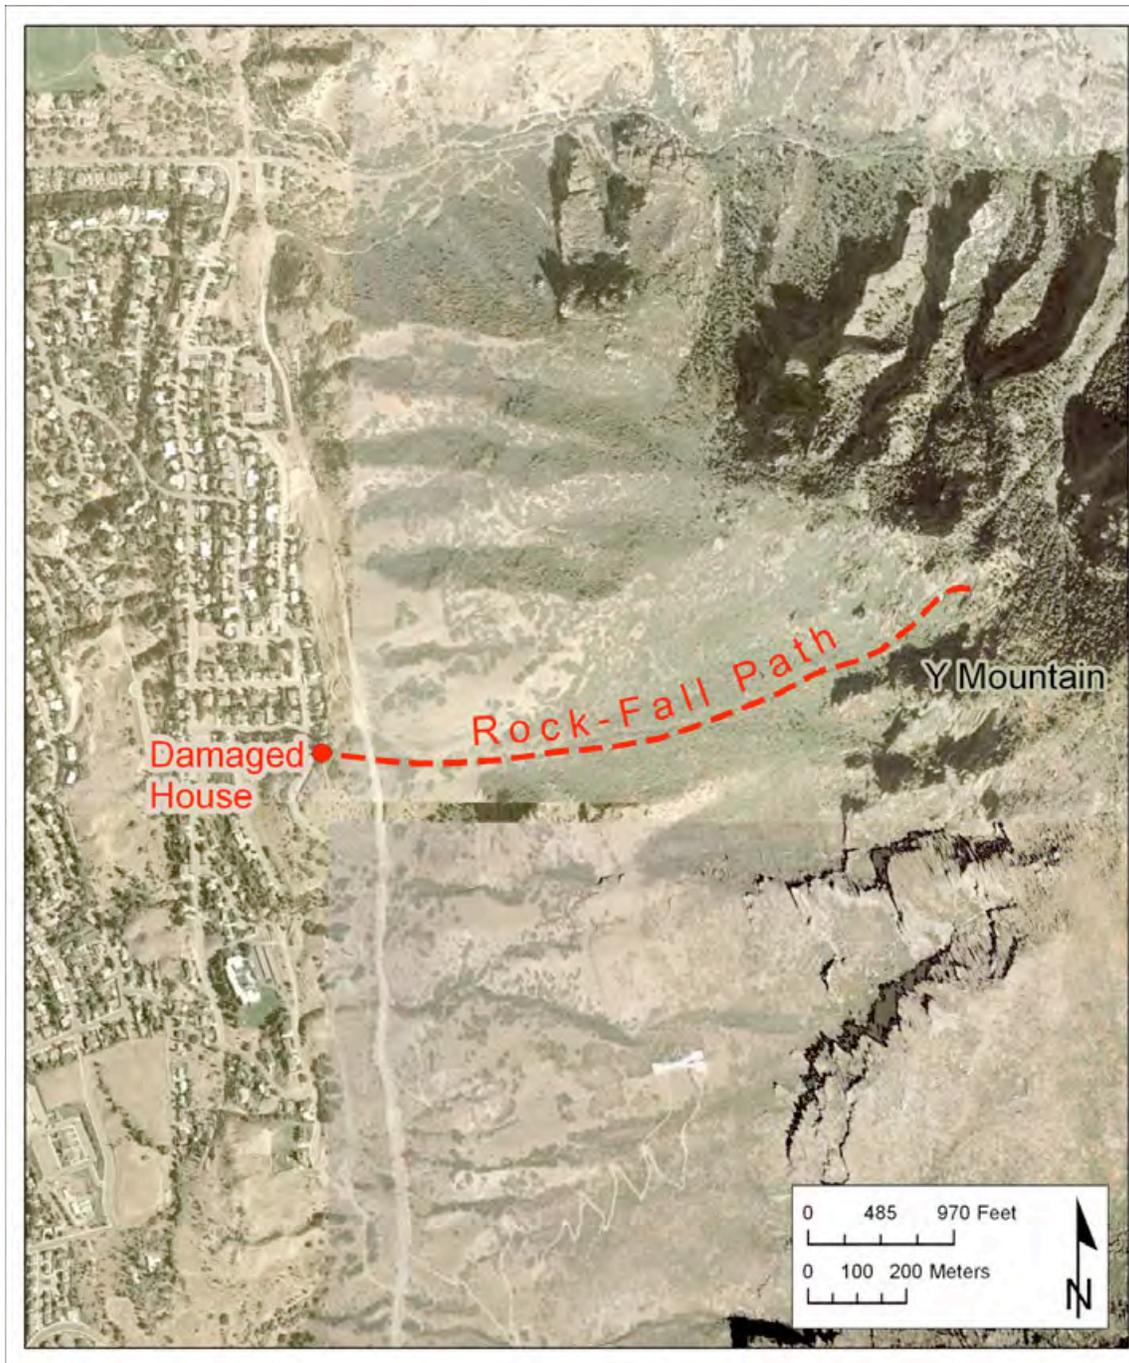
Figure 2. "Y" Mountain source area, the rock-fall path, and damaged house.

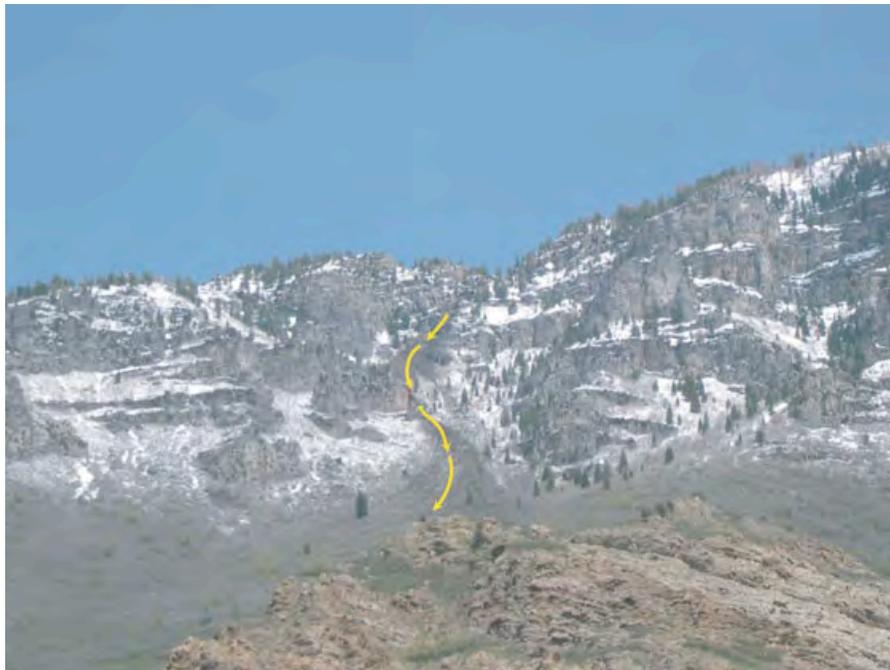
Figure 4. View east to the rock-fall source area in the Mississippian Desert Limestone on the north end of “Y” Mountain showing path of the rock fall (arrows) as indicated by dark soil and rock fragments on the snow surface.

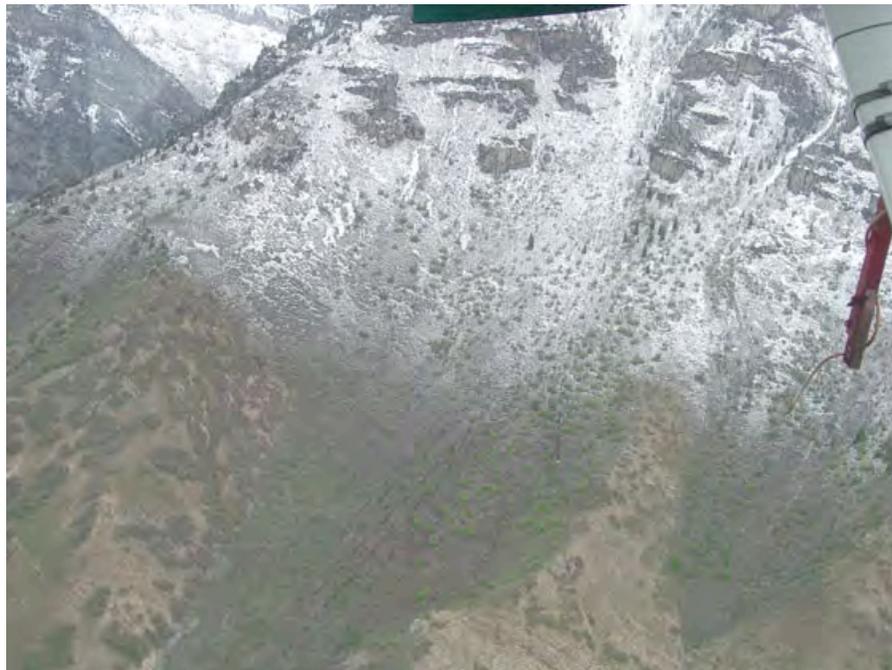
Figure 6. View of the rock fall runout track on May 17, 2005. Dark brown soil streaks show the path of rocks that traveled downslope. Recent snowfall obscures the runout track in the upper part of the photo (photo by Dave Bennett).

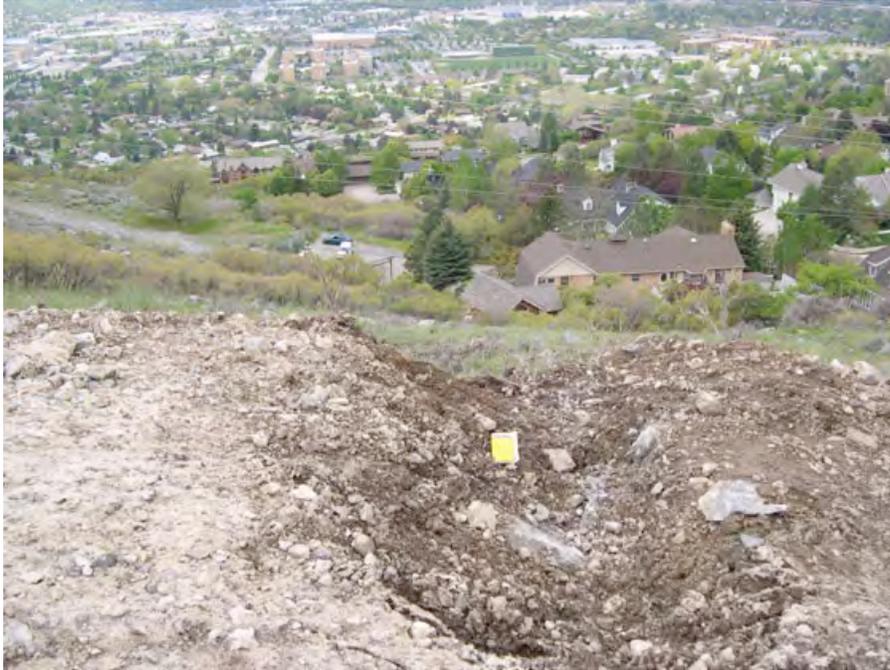
Figure 7. *Impact crater (bounce mark) on the slope just above the guest house (yellow object is notebook for scale).*

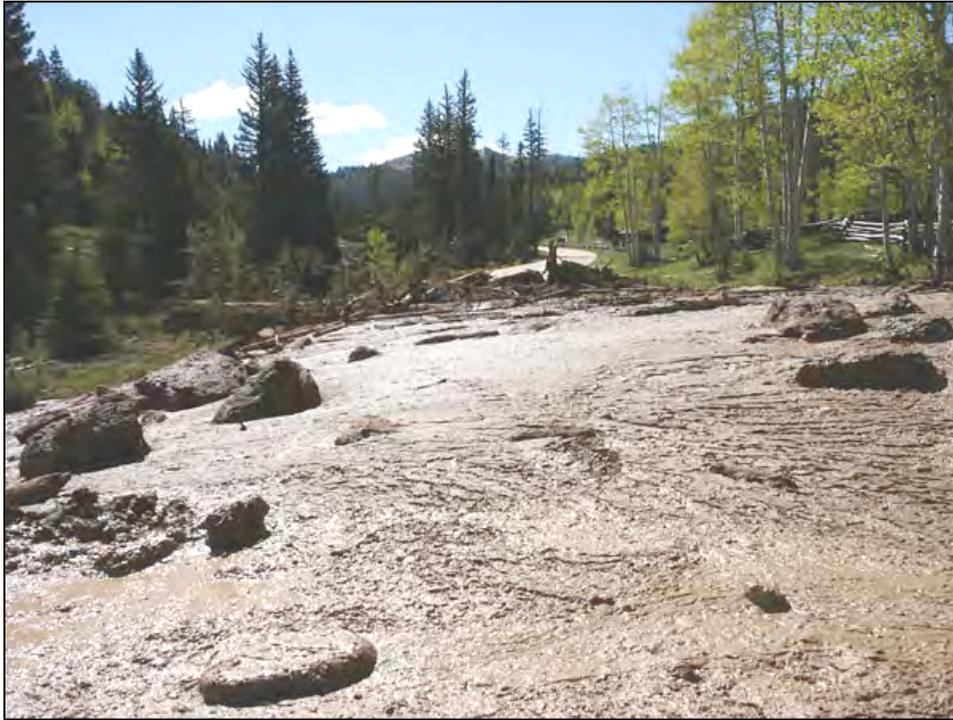
Figure 2. Location where the Black Mountain debris flow crossed SR-14 on June 3, 2005; photo was taken on June 4 about 30 hours after the debris flow occurred during UDOT cleanup operations.

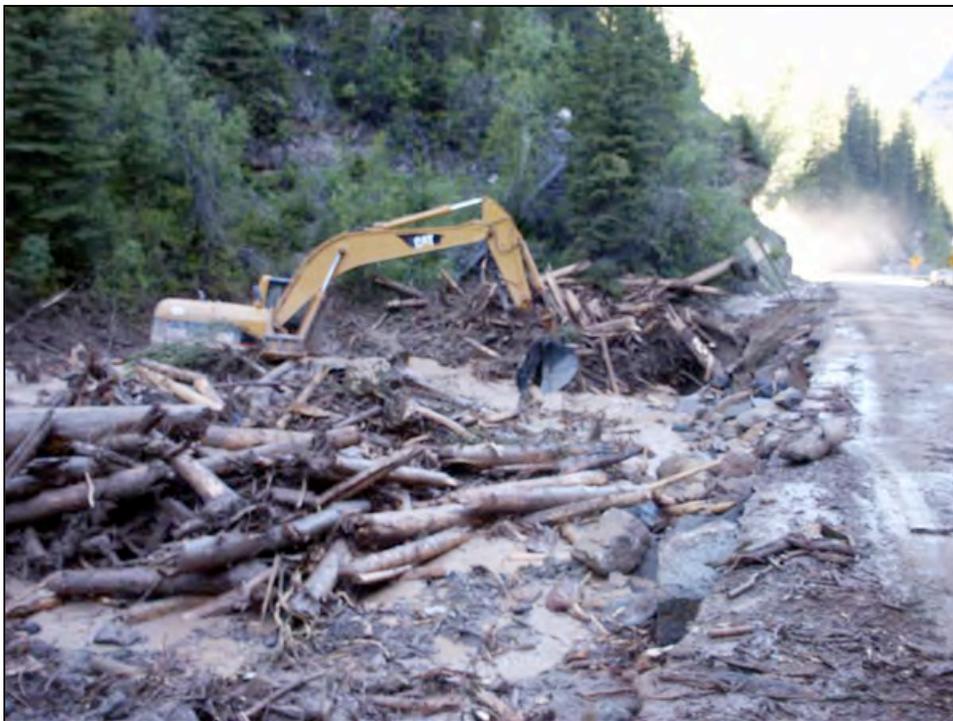
Figure 3. Log jam created by the Black Mountain debris flow at a box culvert beneath SR-14.

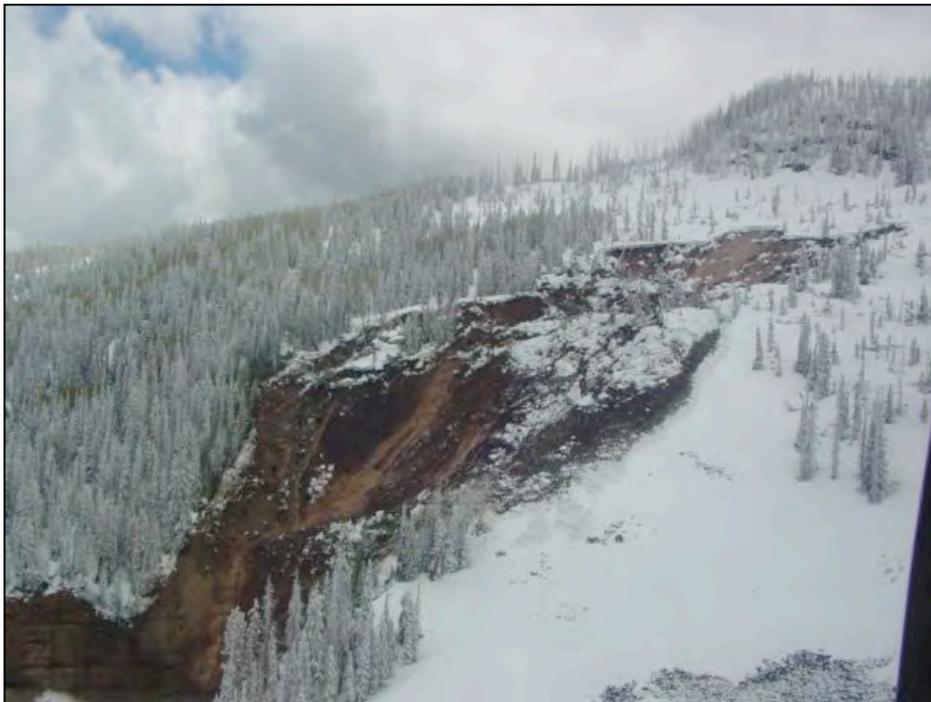
Figure 5. *Detached slide mass on Black Mountain from which the Black Mountain debris flow originated (UHP photograph).*

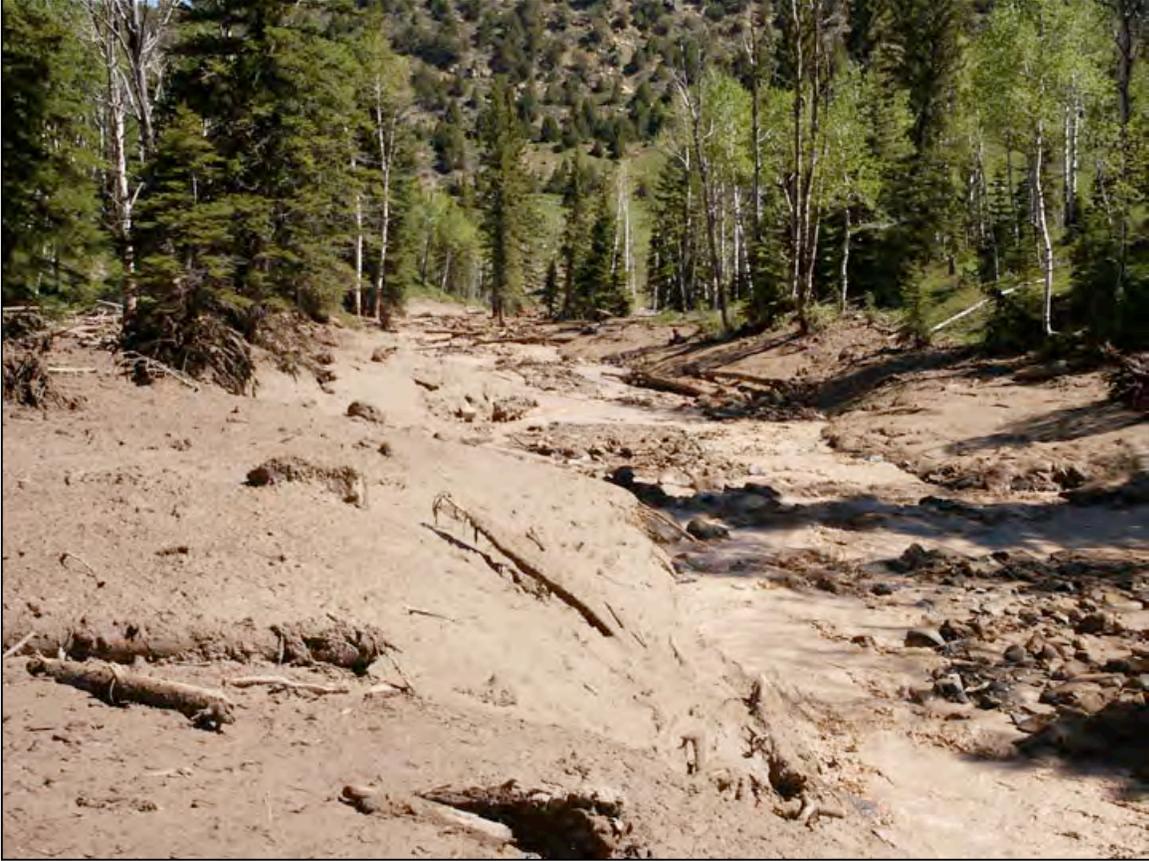
Figure 8. Scoured channel of the un-named tributary of Crow Creek about 0.6 miles above the juncture of the two streams.

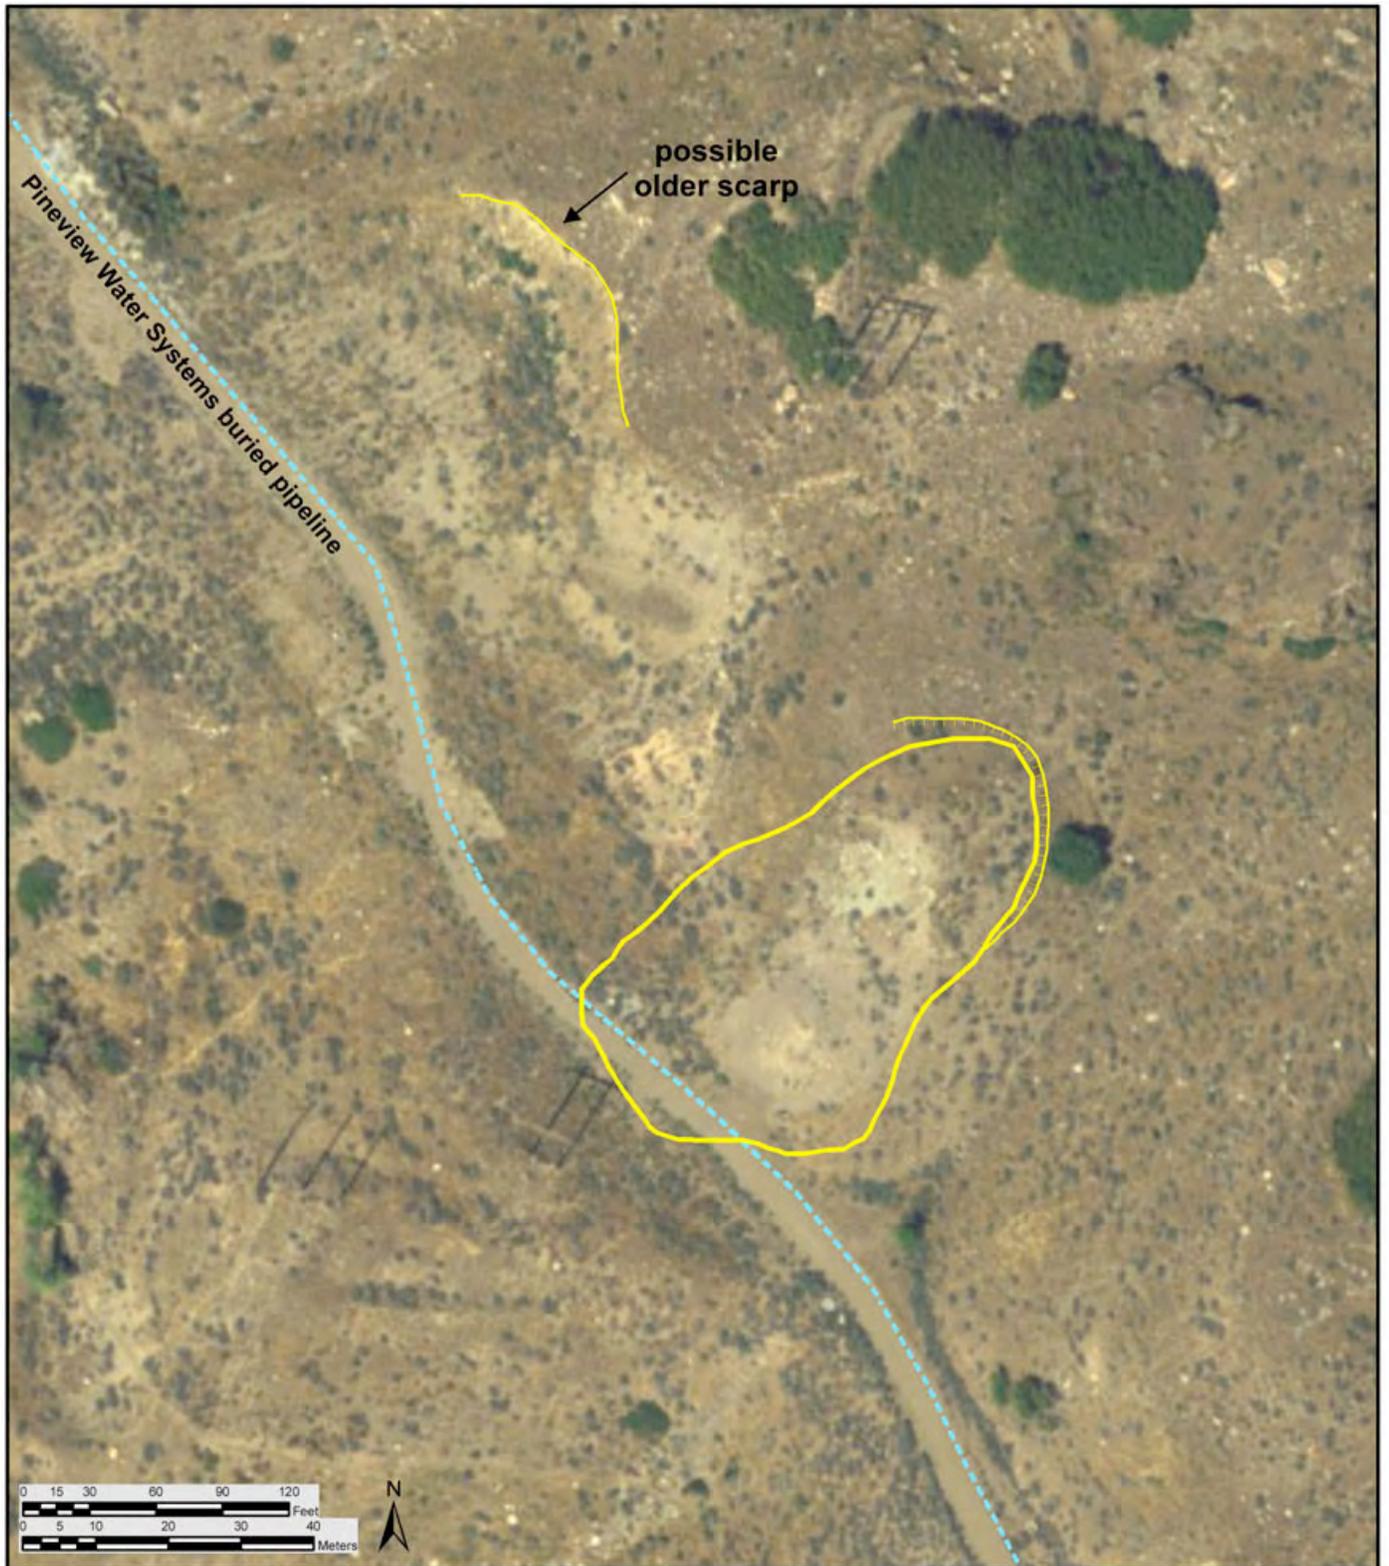
Figure 2. April 15, 2005, landslide deposit and main scarp.

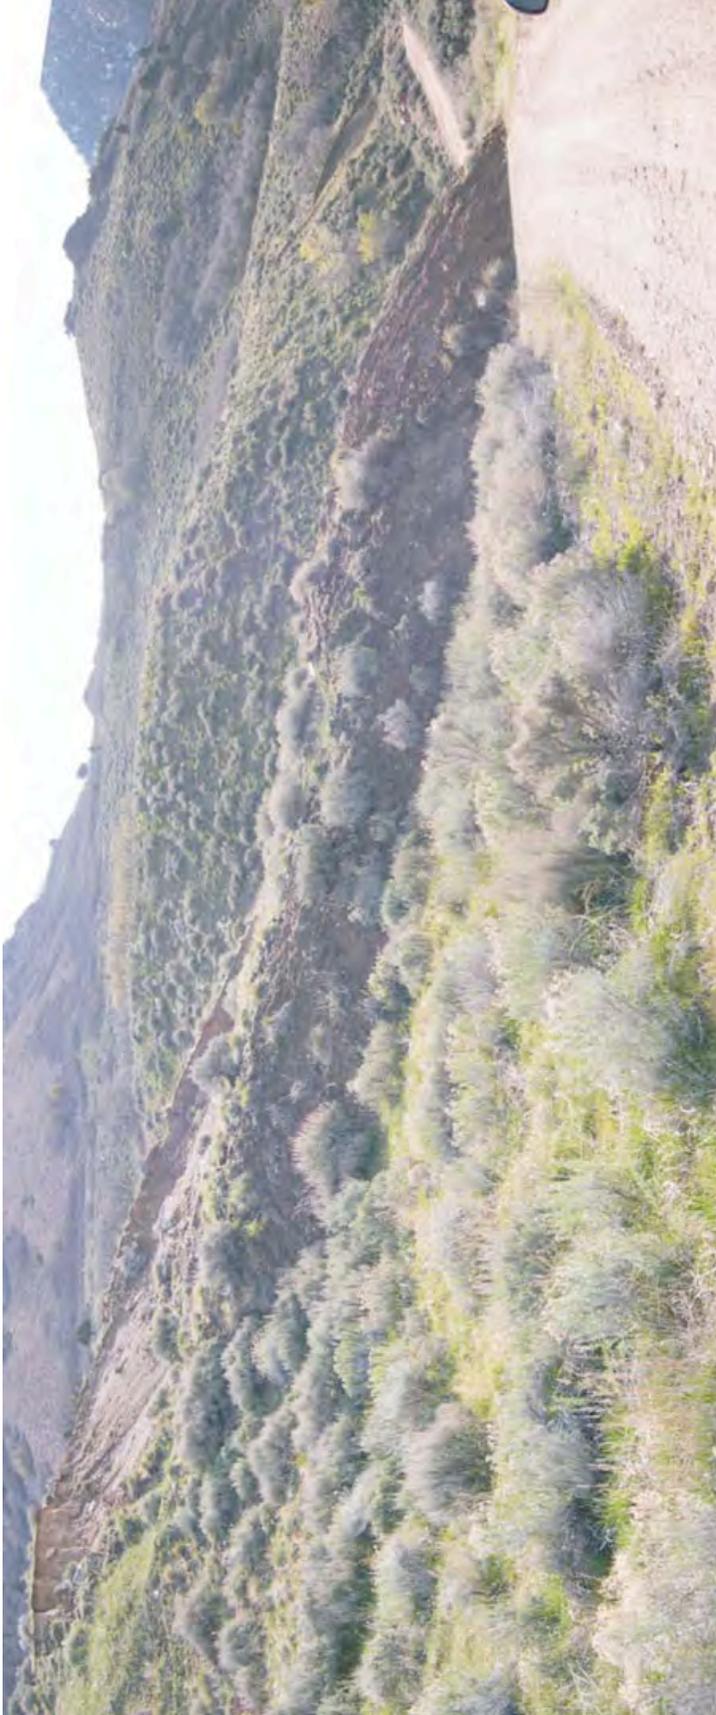
Figure 3. Side view of landslide looking southeast.

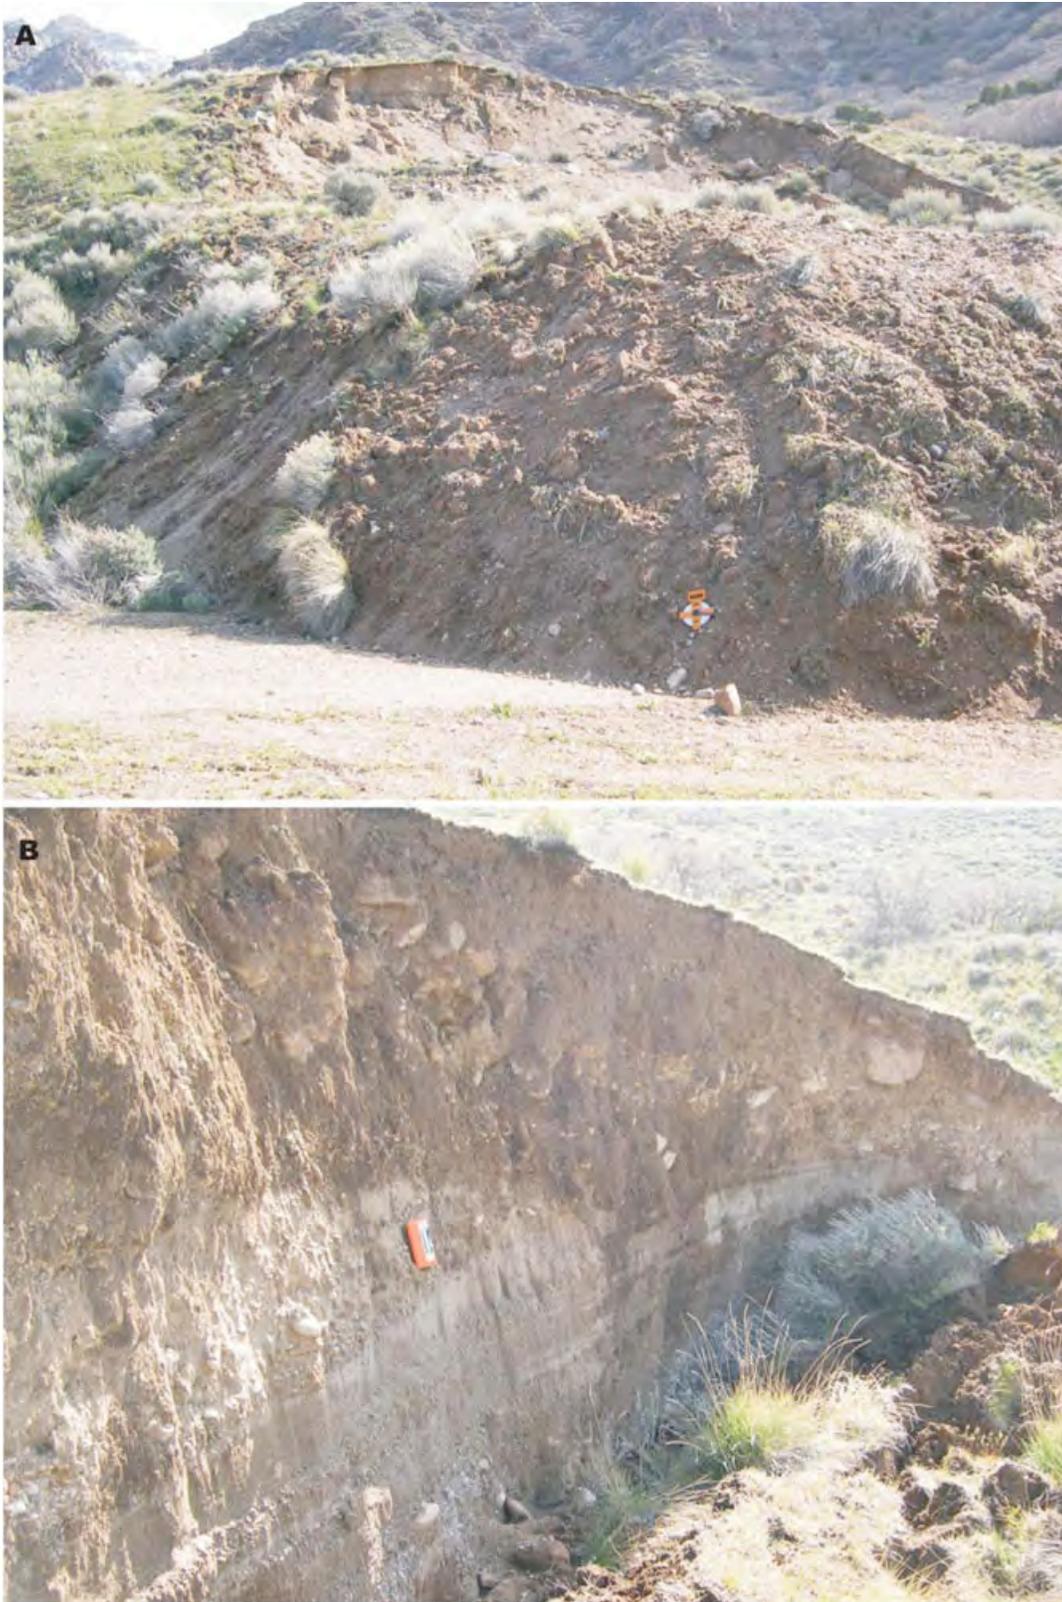
Figure 4. a) Landslide main scarp and toe of deposit covering road.
b) Main scarp exposure showing post-Bonneville alluvium and colluvium overlying lacustrine sand and gravel.

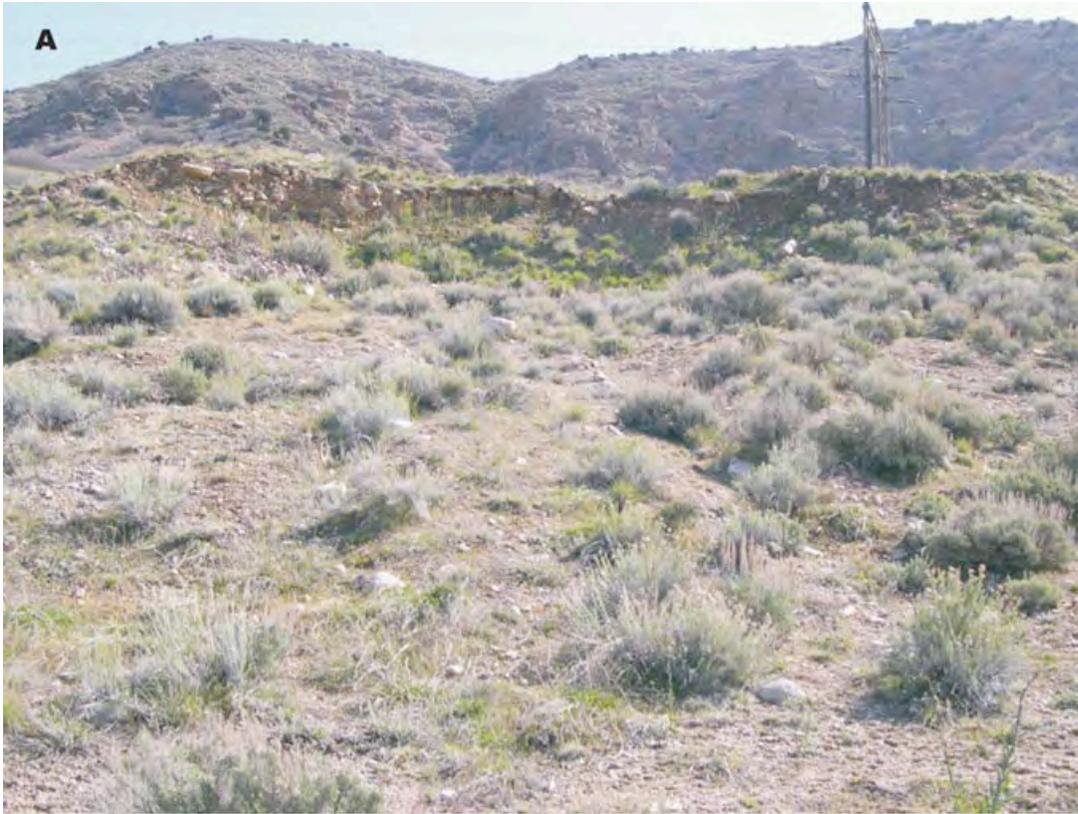
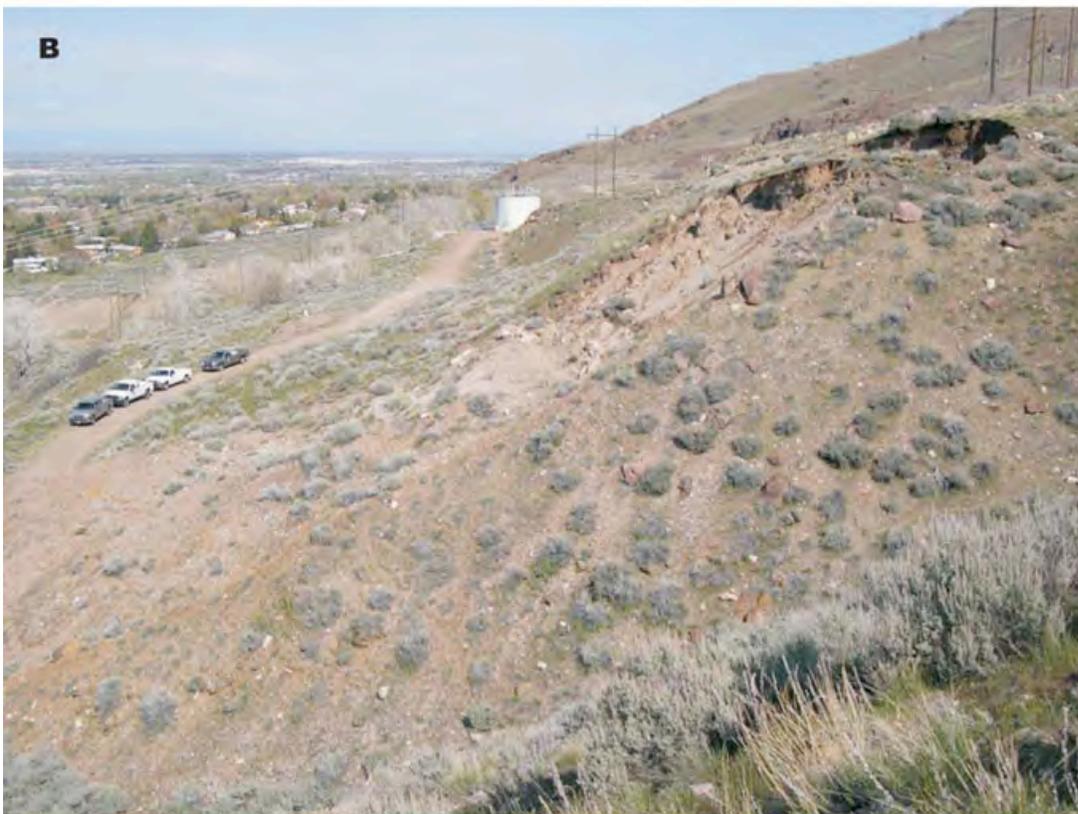
Figure 5. a) Possible older landslide scarp northwest of 2005 landslide.
b) Side view of 2005 landslide showing down-dropped blocks of soil at head.
