TECHNICAL REPORTS FOR 2002–2009 GEOLOGIC HAZARDS PROGRAM

COMPILED BY ASHLEY H. ELLIOTT

Report of Investigation 269
Utah Geological Survey
a division of
Utah Department of Natural Resources
2010

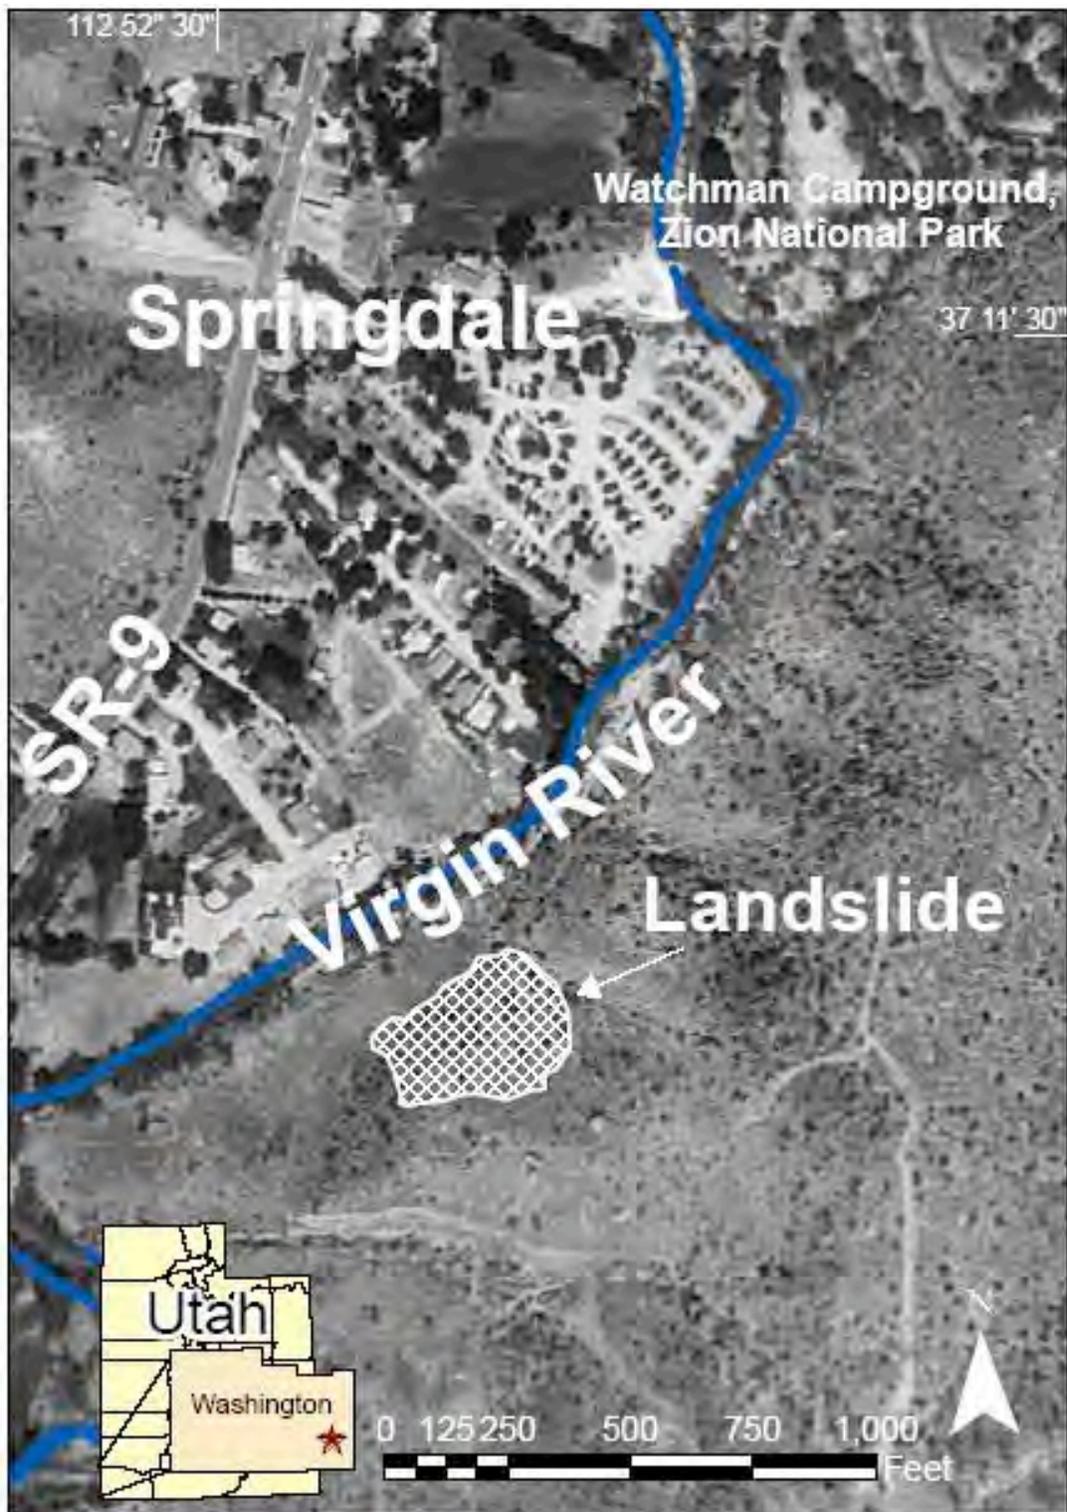
Figure 2. Rotational slump landslide formed during May 2005 on the east side of the Virgin River in Springdale, Utah (base map U.S. Geological Survey Springdale East 7.5' orthophoto quadrangle).

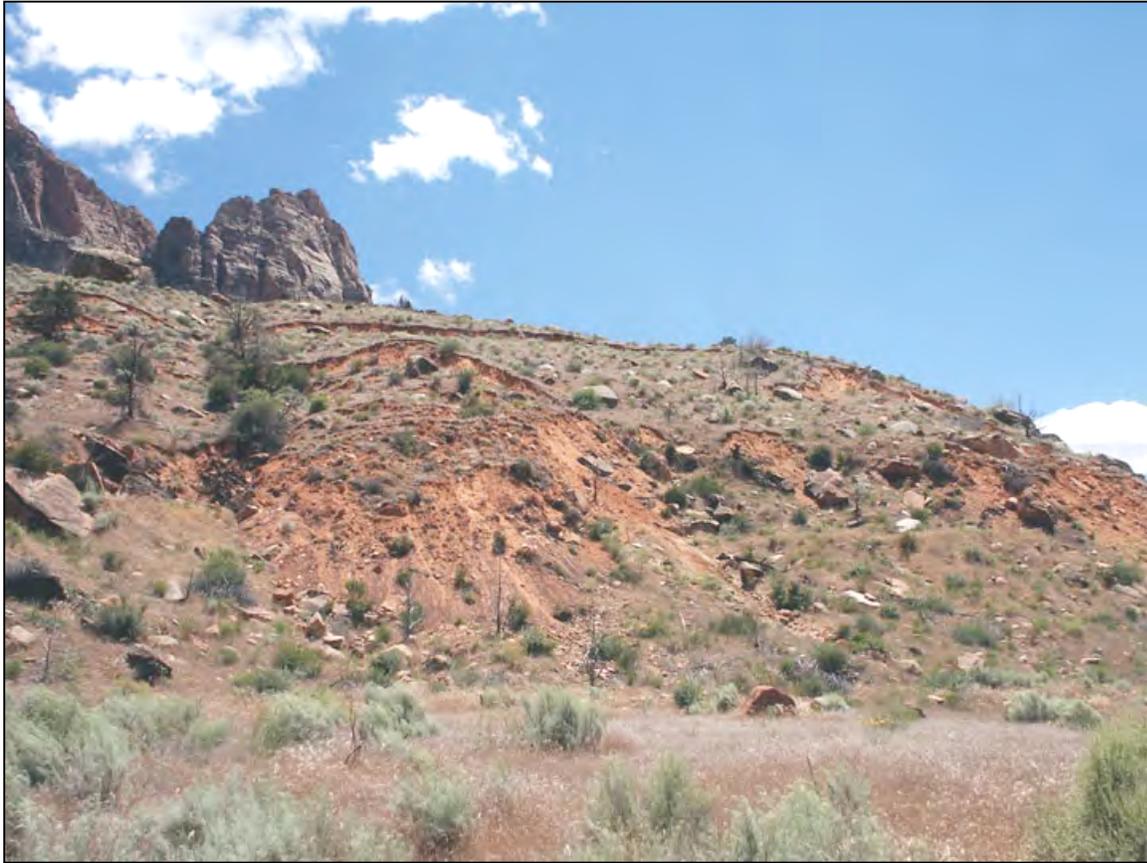
Figure 3. *View to the east of the landslide in Springdale on the east side of the Virgin River; landslide formed progressively during May 2005.*

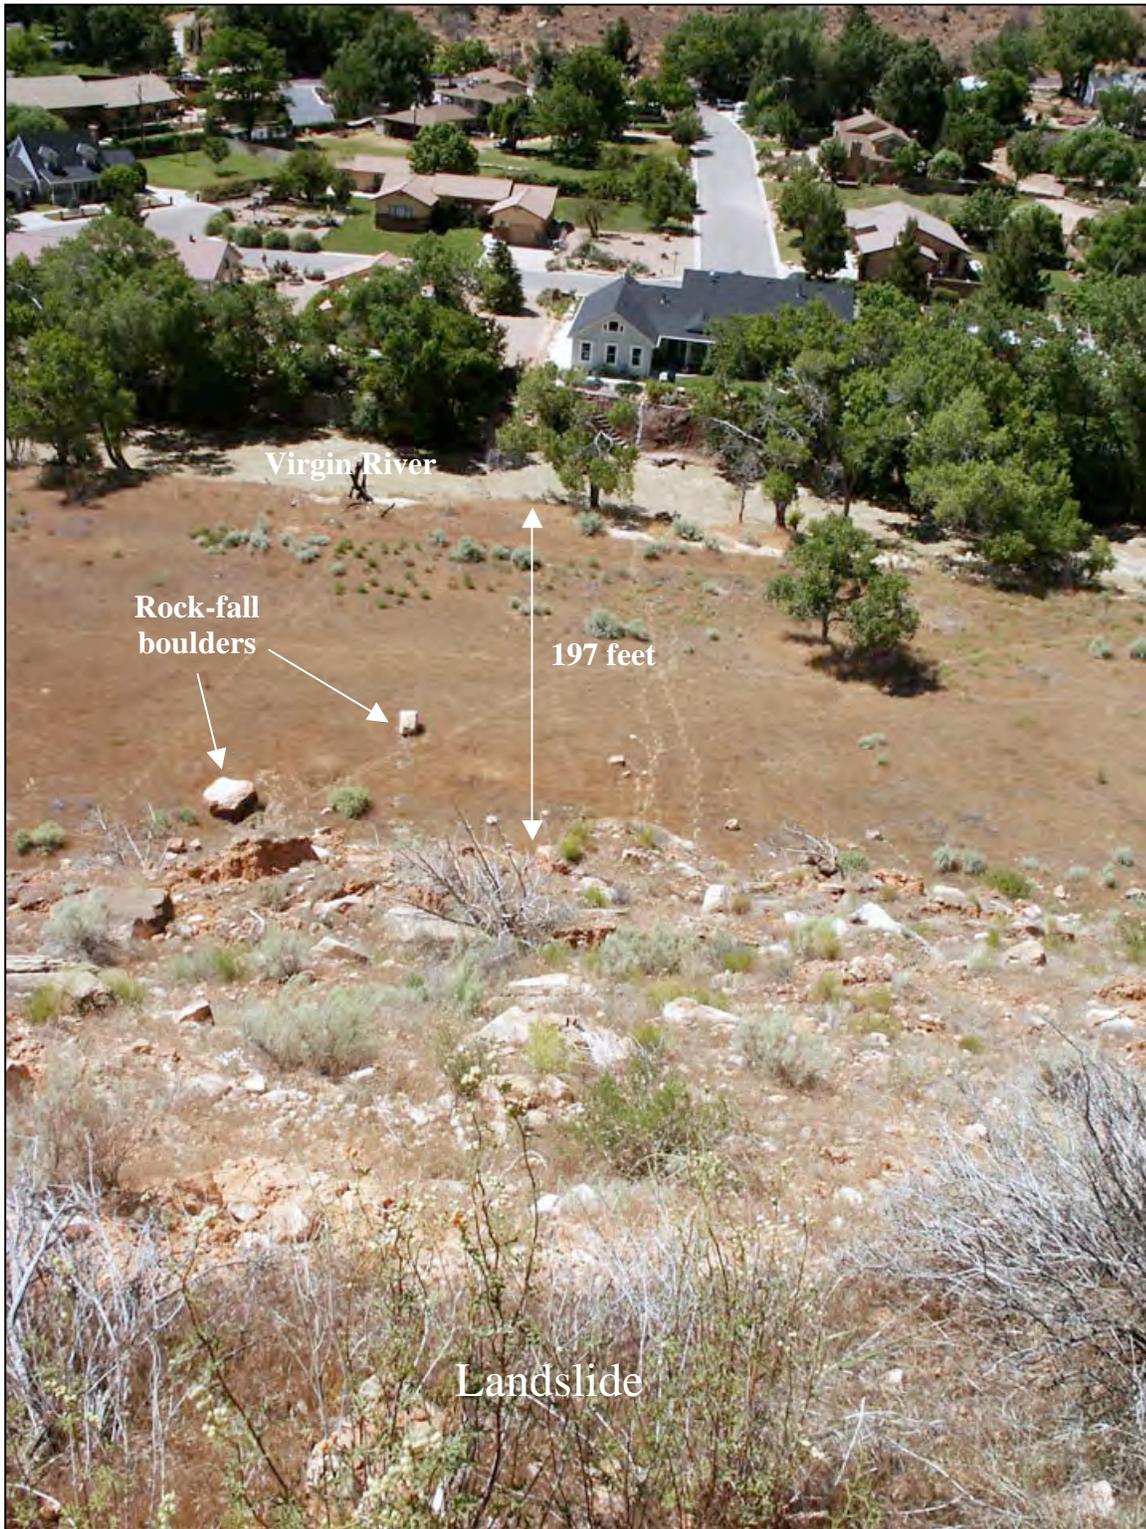
Figure 4. View from the landslide toward the Virgin River, showing the 197 feet of separation between the landslide toe and the river; note the rock-fall boulders that have rolled from the landslide surface onto the alluvial terrace deposits along the river.

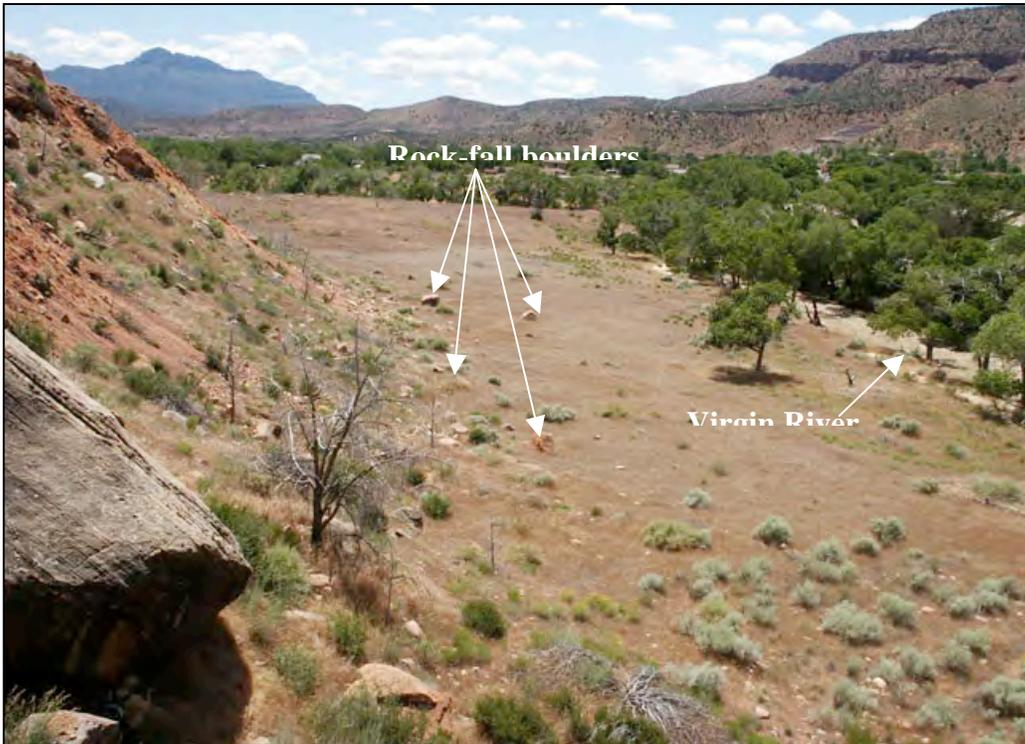
Figure 5. Rock-fall boulders at the base of the landslide; most have accumulated within a few feet of the landslide toe, but a few have rolled farther out on the alluvial terrace bordering the Virgin River.

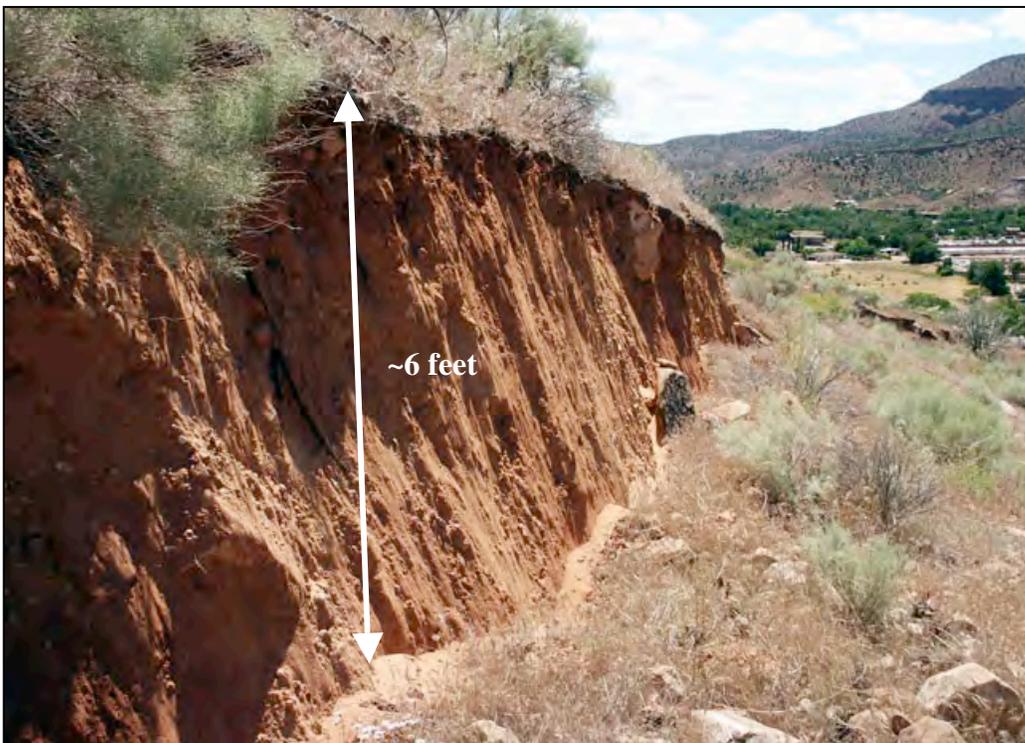
Figure 6. Landslide main scarp.

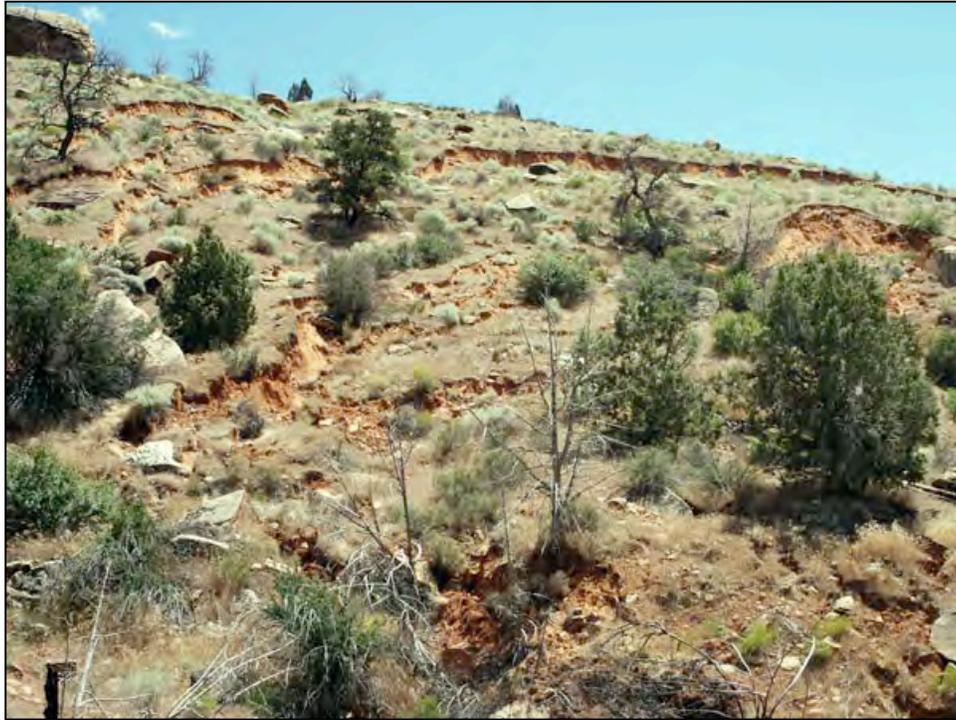
Figure 7. *Transverse scarps within the landslide mass.*

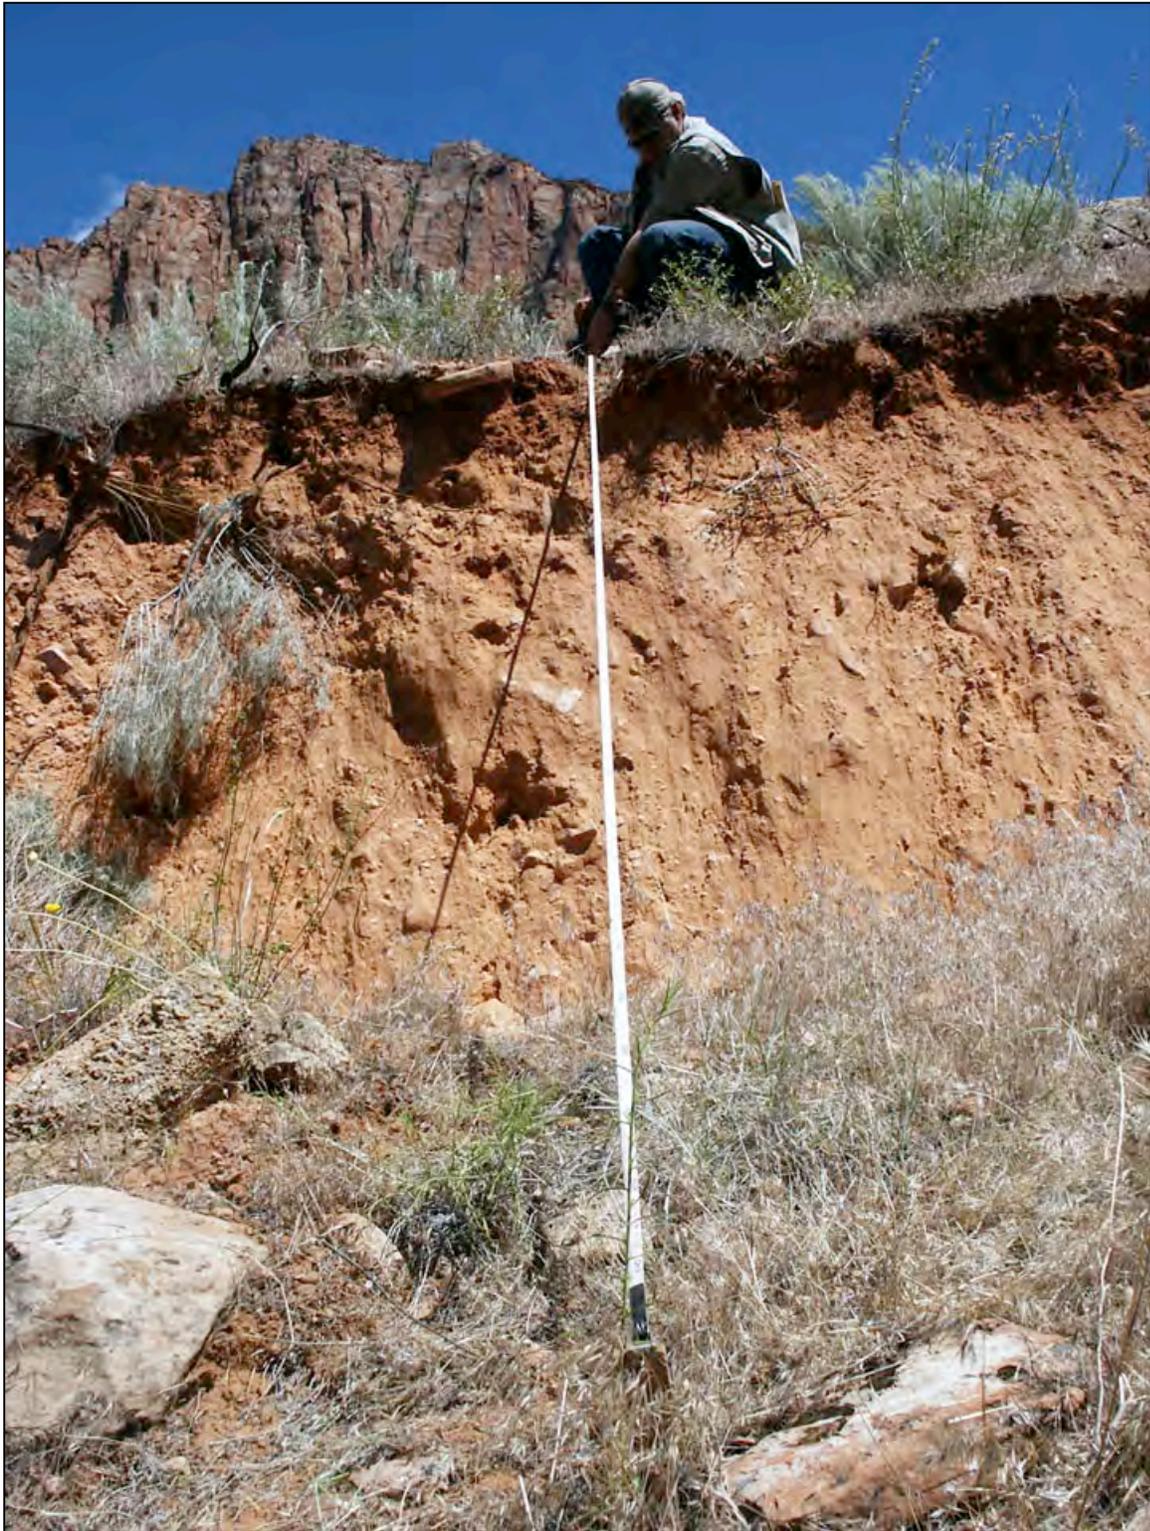
Figure 9. North monitoring station; distance between wooden stakes is 13.25 feet.

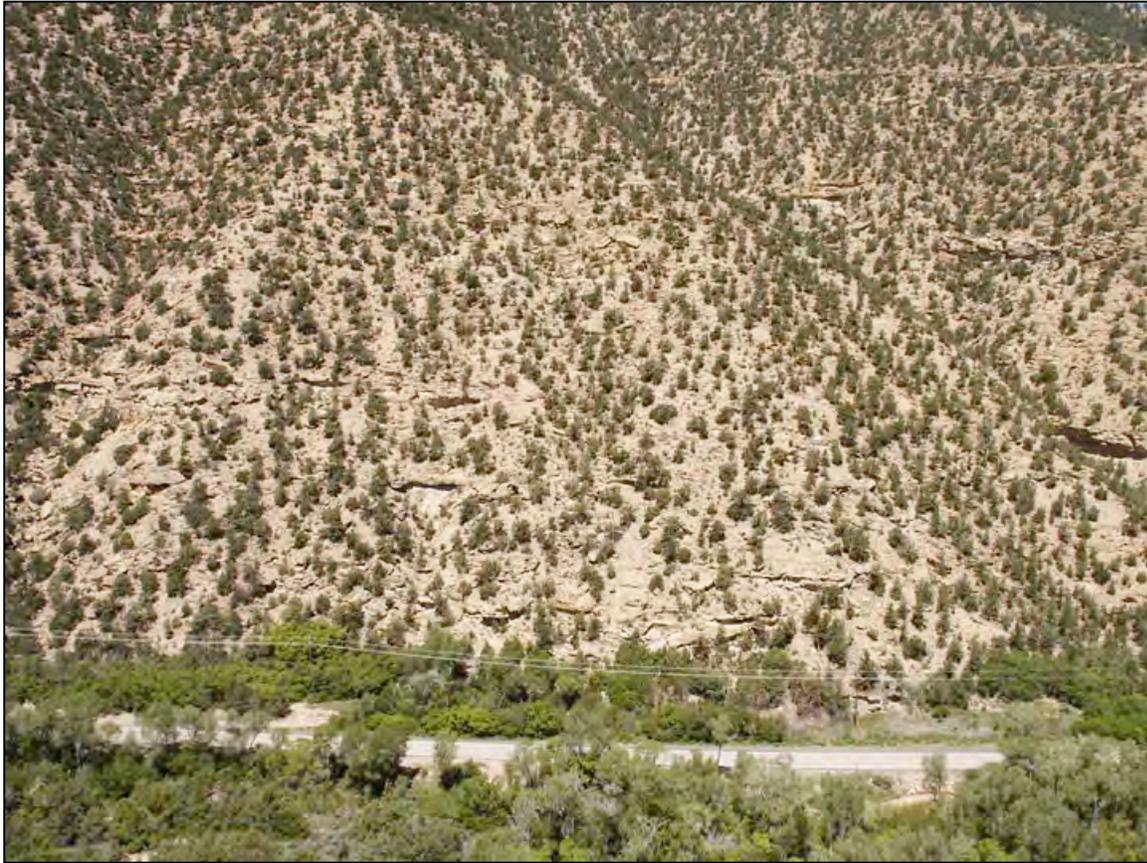
Figure 2. West wall of Parowan Canyon as it appears directly across from the June 3, 2005, rock fall that damaged the Parowan City penstock. The nearly continuous exposures of the Cretaceous Iron Springs Formation with sparse vegetative cover of pinyon pine and juniper shown here are similar to the conditions on the east canyon wall where the rock fall occurred. SR-143 and the dense riparian vegetation along Parowan Creek are visible at the bottom of the photo.

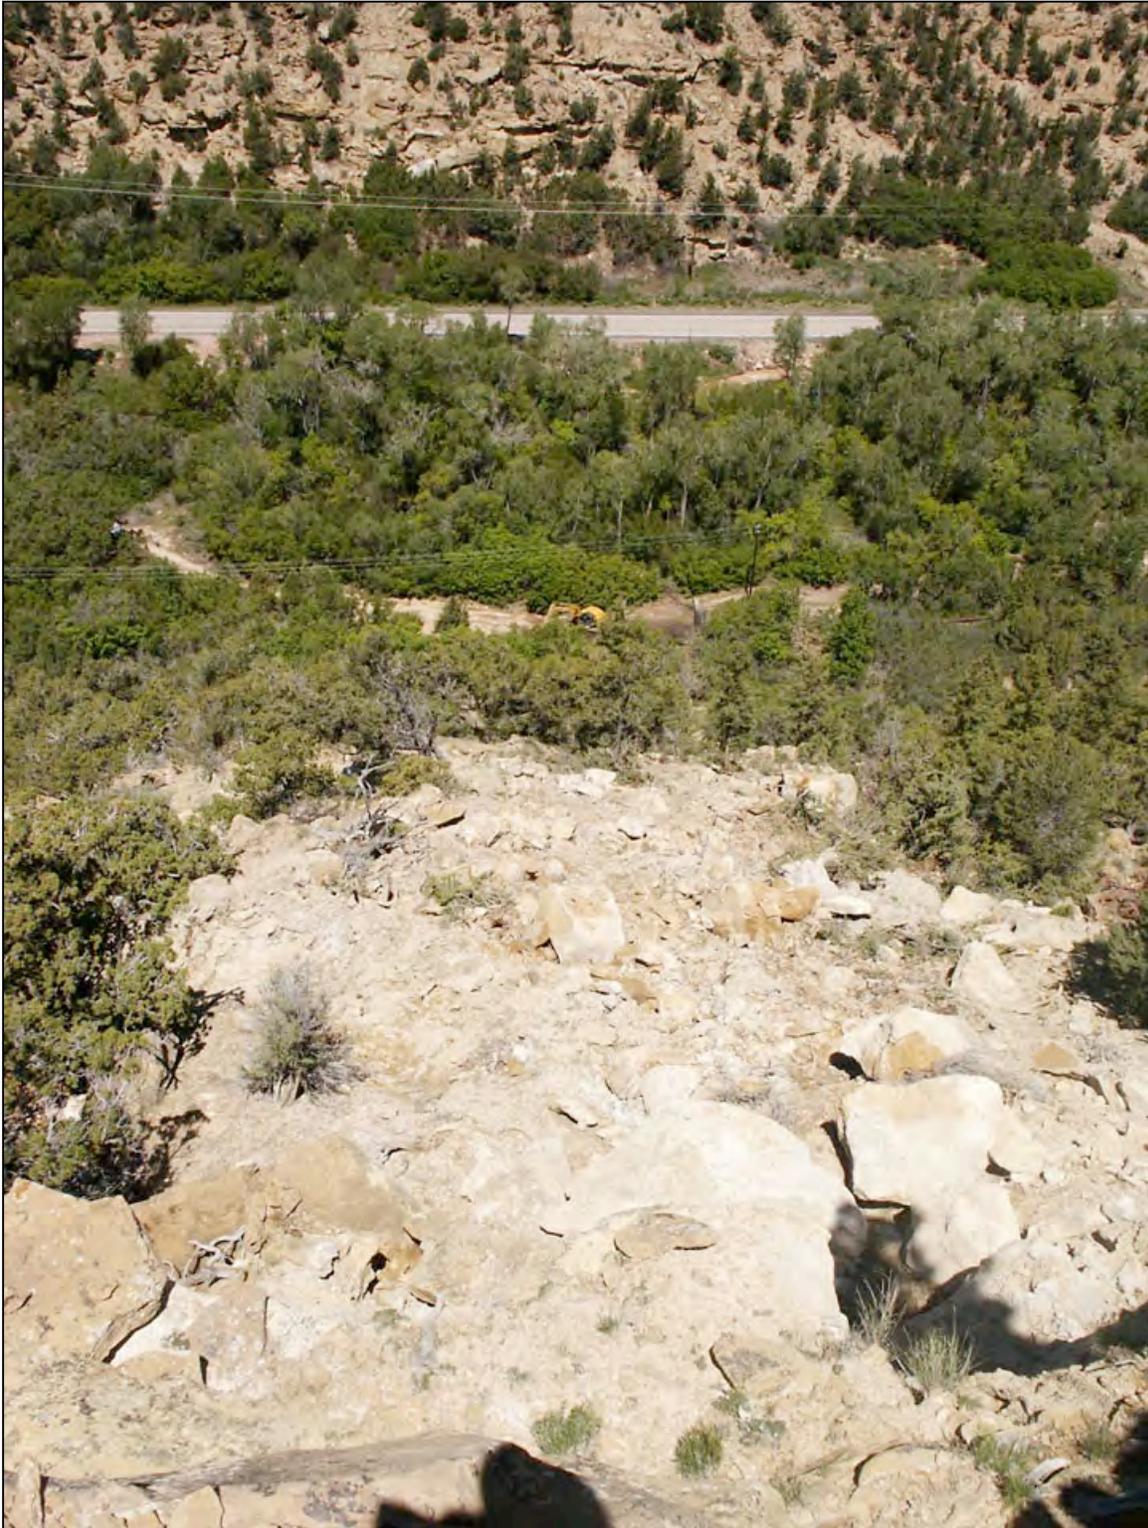
Figure 4. Rock-fall path stripped of vegetation down the east side of Parowan Canyon. Note the narrow canyon bottom, which accommodates SR-143, Parowan Creek, and the penstock and service road.

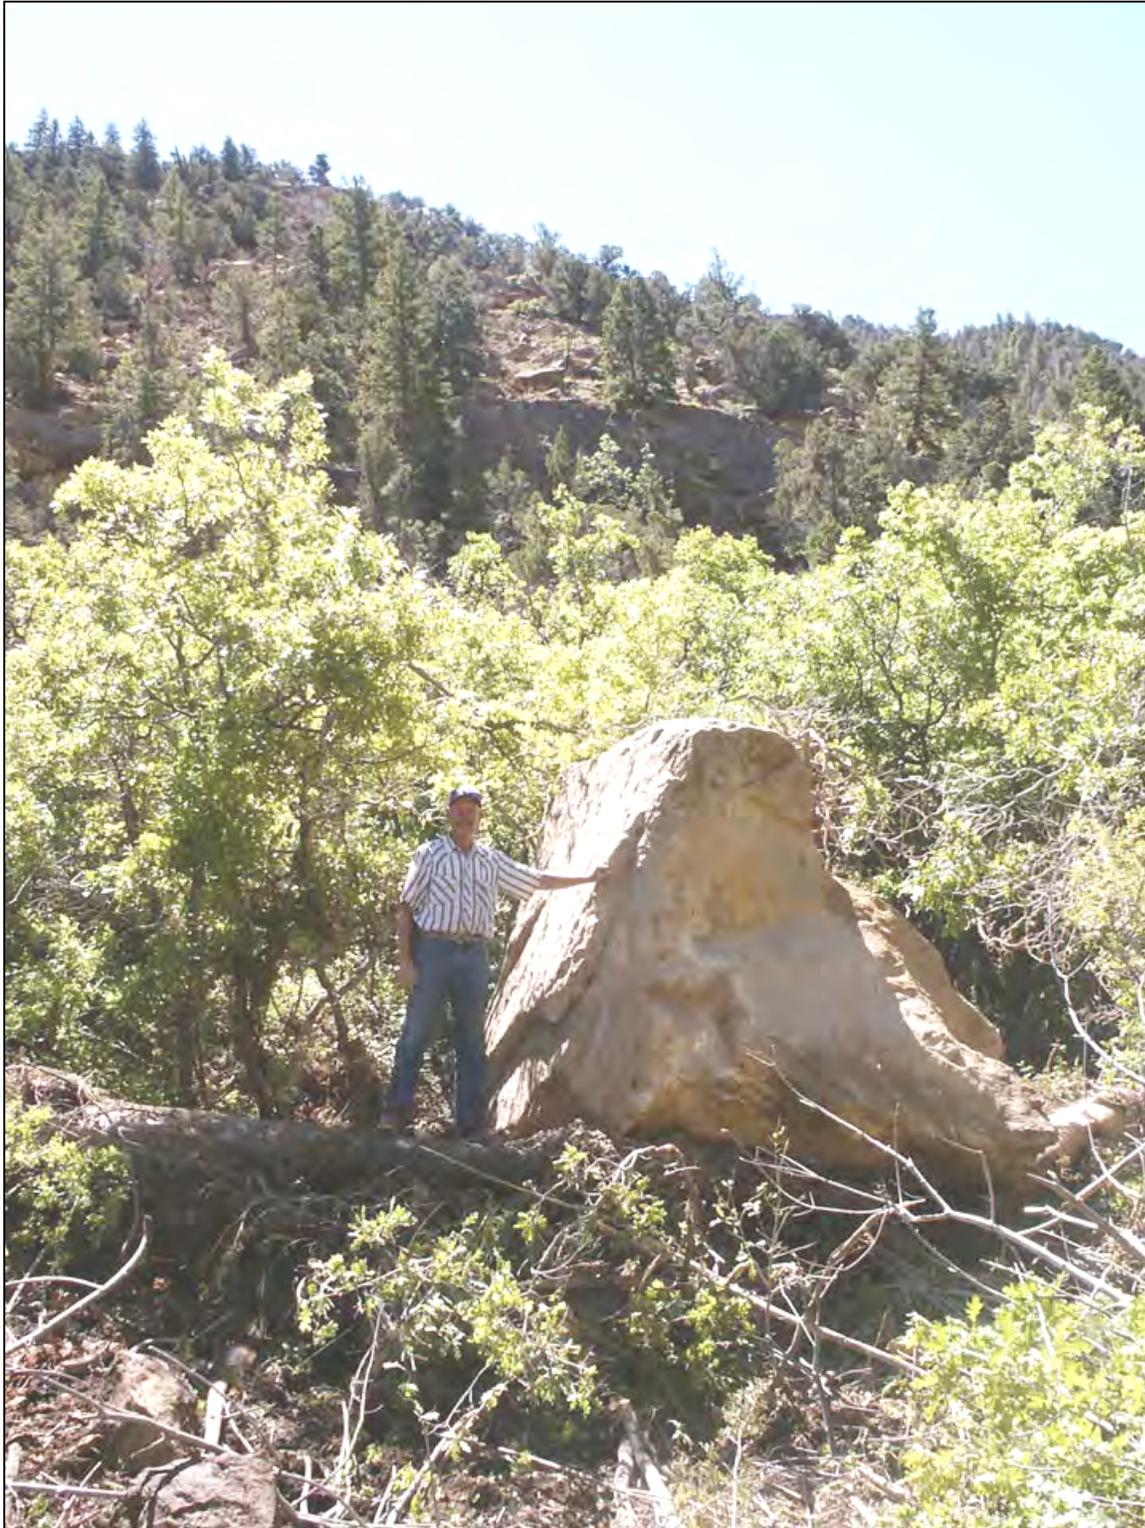
The largest boulder, measuring 14x9x8.5 feet and weighing an estimated 80 tons, came to rest directly on top of the penstock (figures 5 and 6). The second boulder that struck the penstock measured 8.5x4x4 feet and weighed an estimated 10 tons. After hitting the penstock (figure 7), that boulder rolled an additional approximately 50 feet before coming to rest in dense vegetation adjacent to Parowan Creek (figure 8). The third boulder, measuring 8x5.5x4 feet and weighing an estimated 13 tons, narrowly missed the penstock and caused no damage (figure 9).

Figure 5. Sandstone boulder weighing an estimated 80 tons resting directly on top of a section of the Parowan City penstock. The rock-fall path down the east wall of Parowan Canyon is visible through the trees below the skyline.

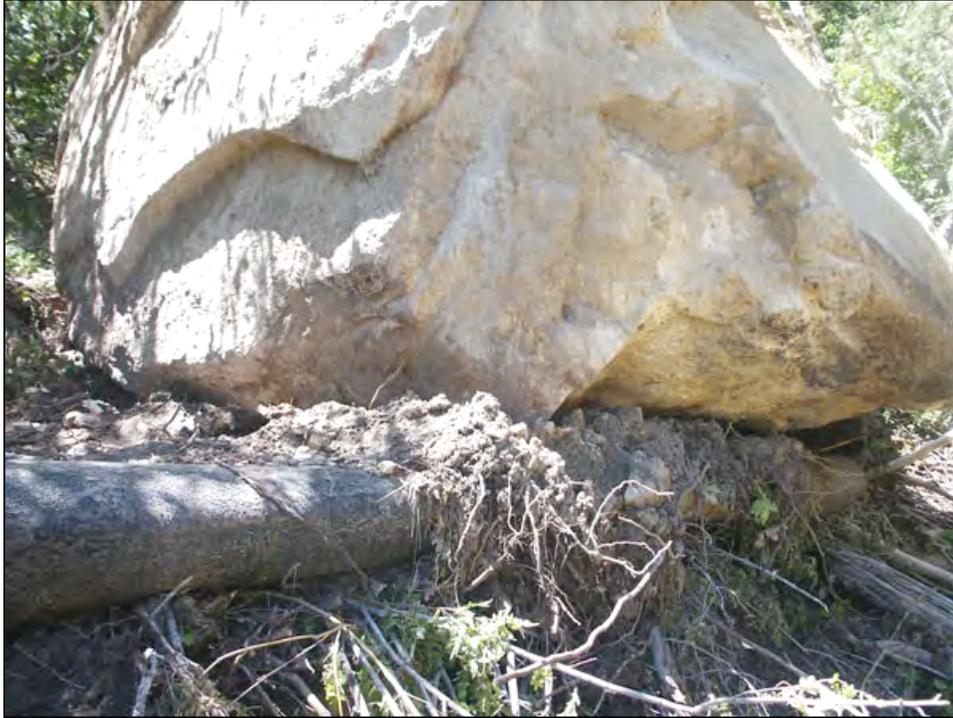
Figure 6. *Approximately 80-ton boulder resting on top of the 26-inch diameter Parowan City penstock pipe.*

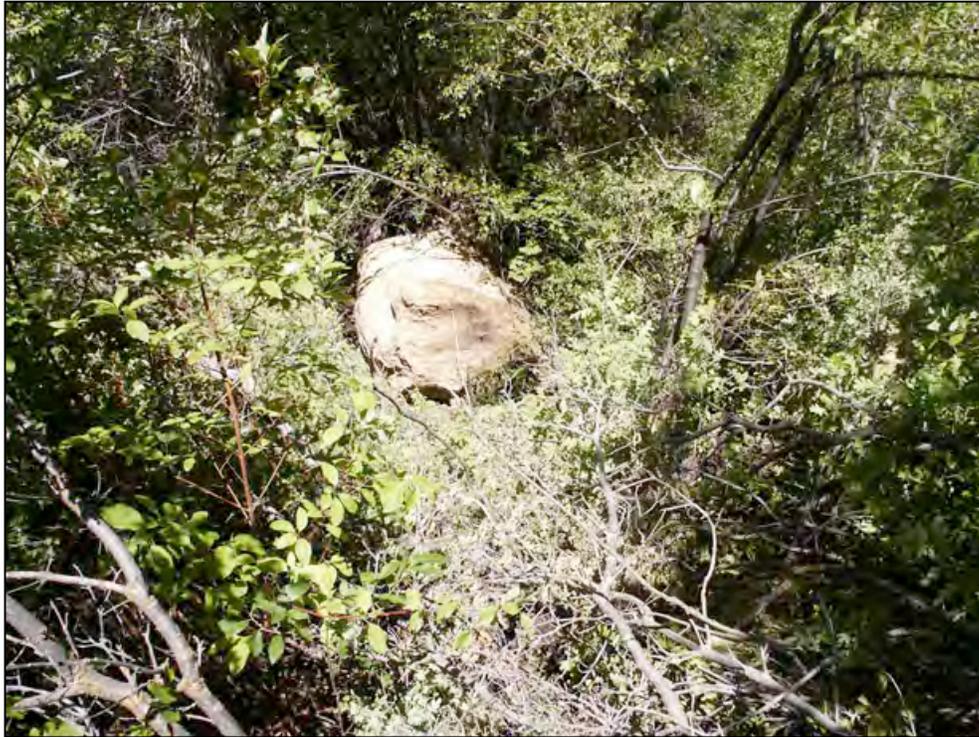
Figure 8. After striking the Parowan City penstock, this approximately 10-ton rock-fall boulder came to rest in dense riparian vegetation along Parowan Creek.

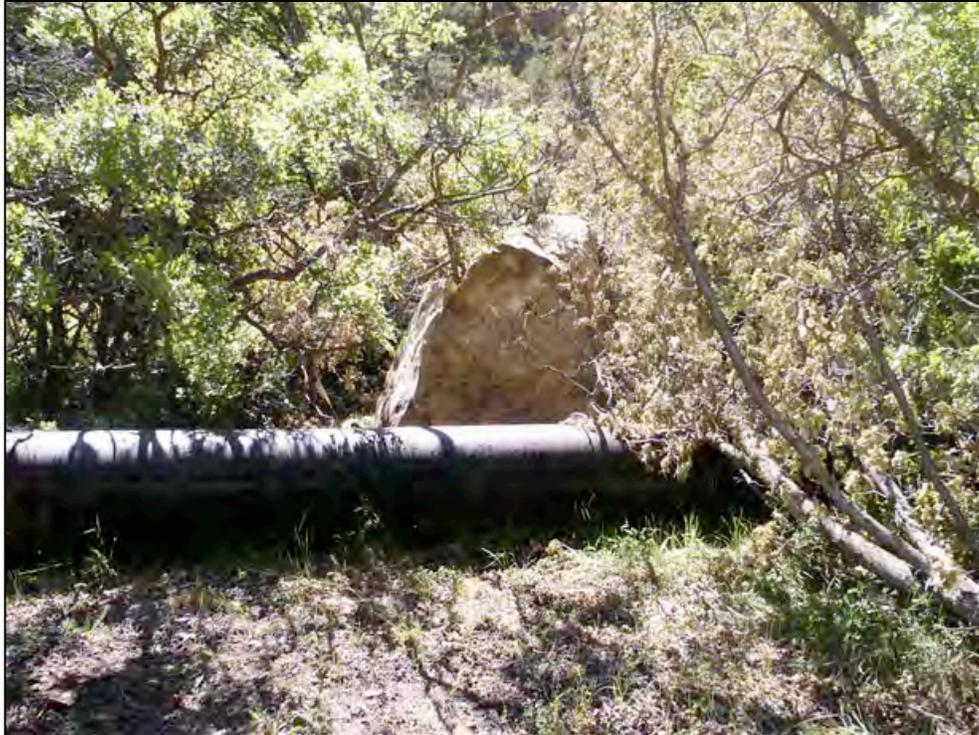
Figure 9. Approximately 13-ton rock-fall boulder, which stopped just before striking the Parowan City penstock.

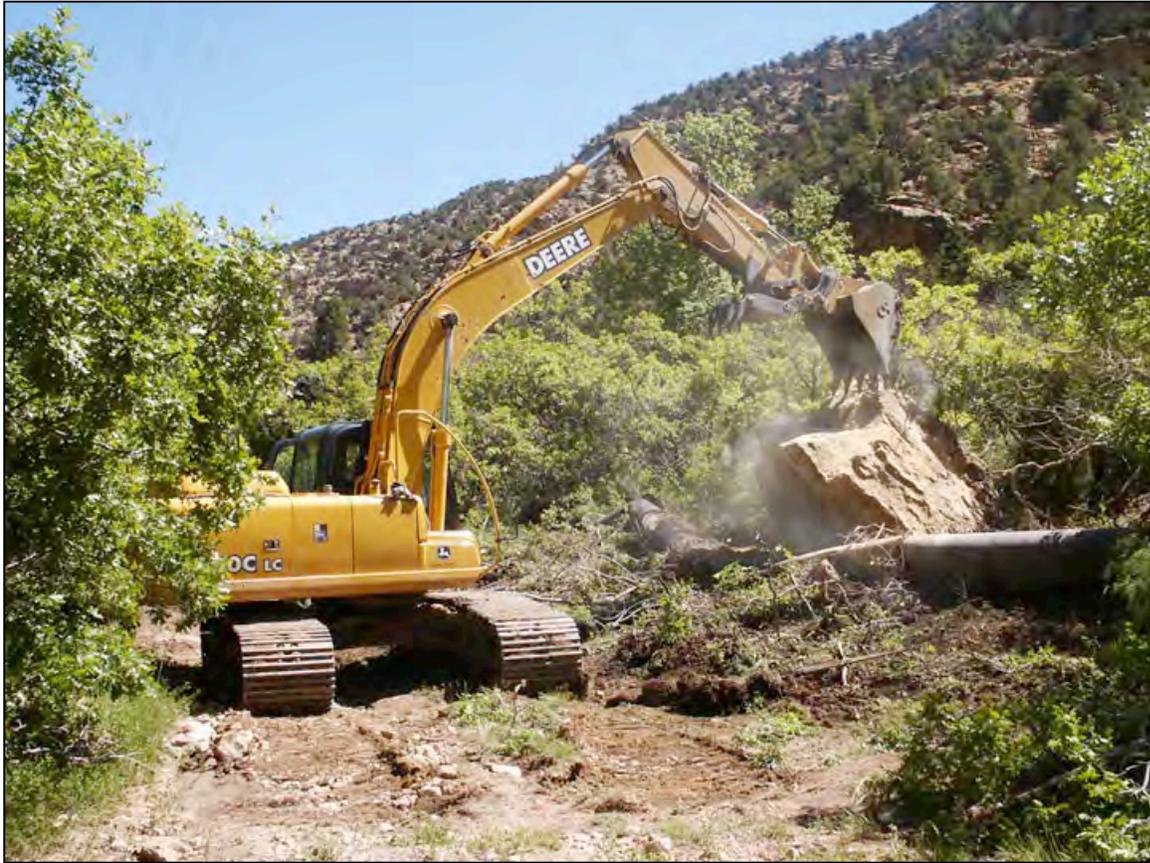
Figure 10. Trackhoe removing the 80-ton boulder from on top of the Parowan City penstock.

At the time of my field visit, workers were using a large trackhoe to remove the boulder from on top of the penstock (figure 10). The workers estimated that two to three 40-foot sections of pipe would be required to repair the ruptured portions of the penstock, but were unsure how much of the vacuum-deformed pipe would require replacement.

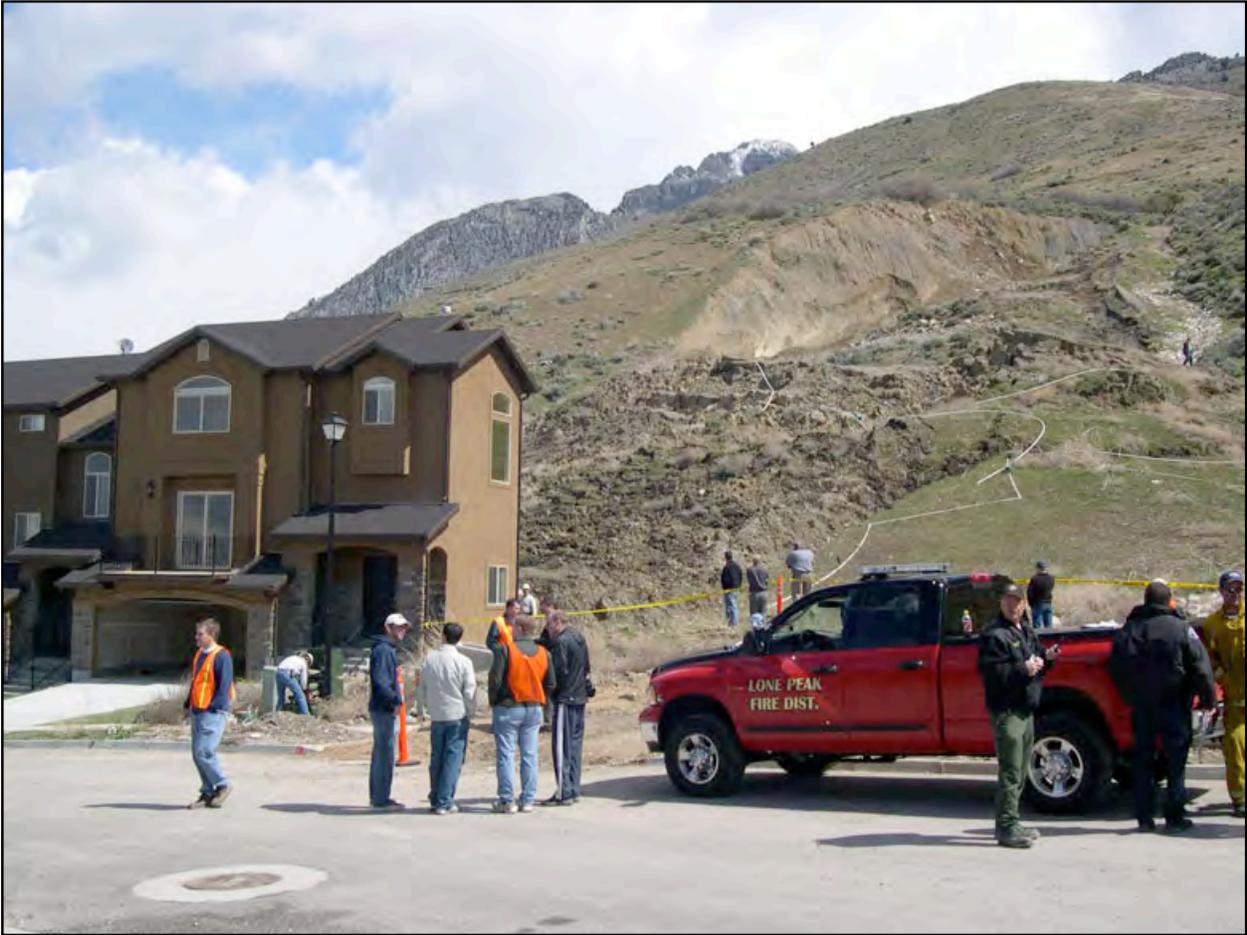
Figure 2. View to the northeast of the landslide on April 29, 2005, from Sage Vista Lane.

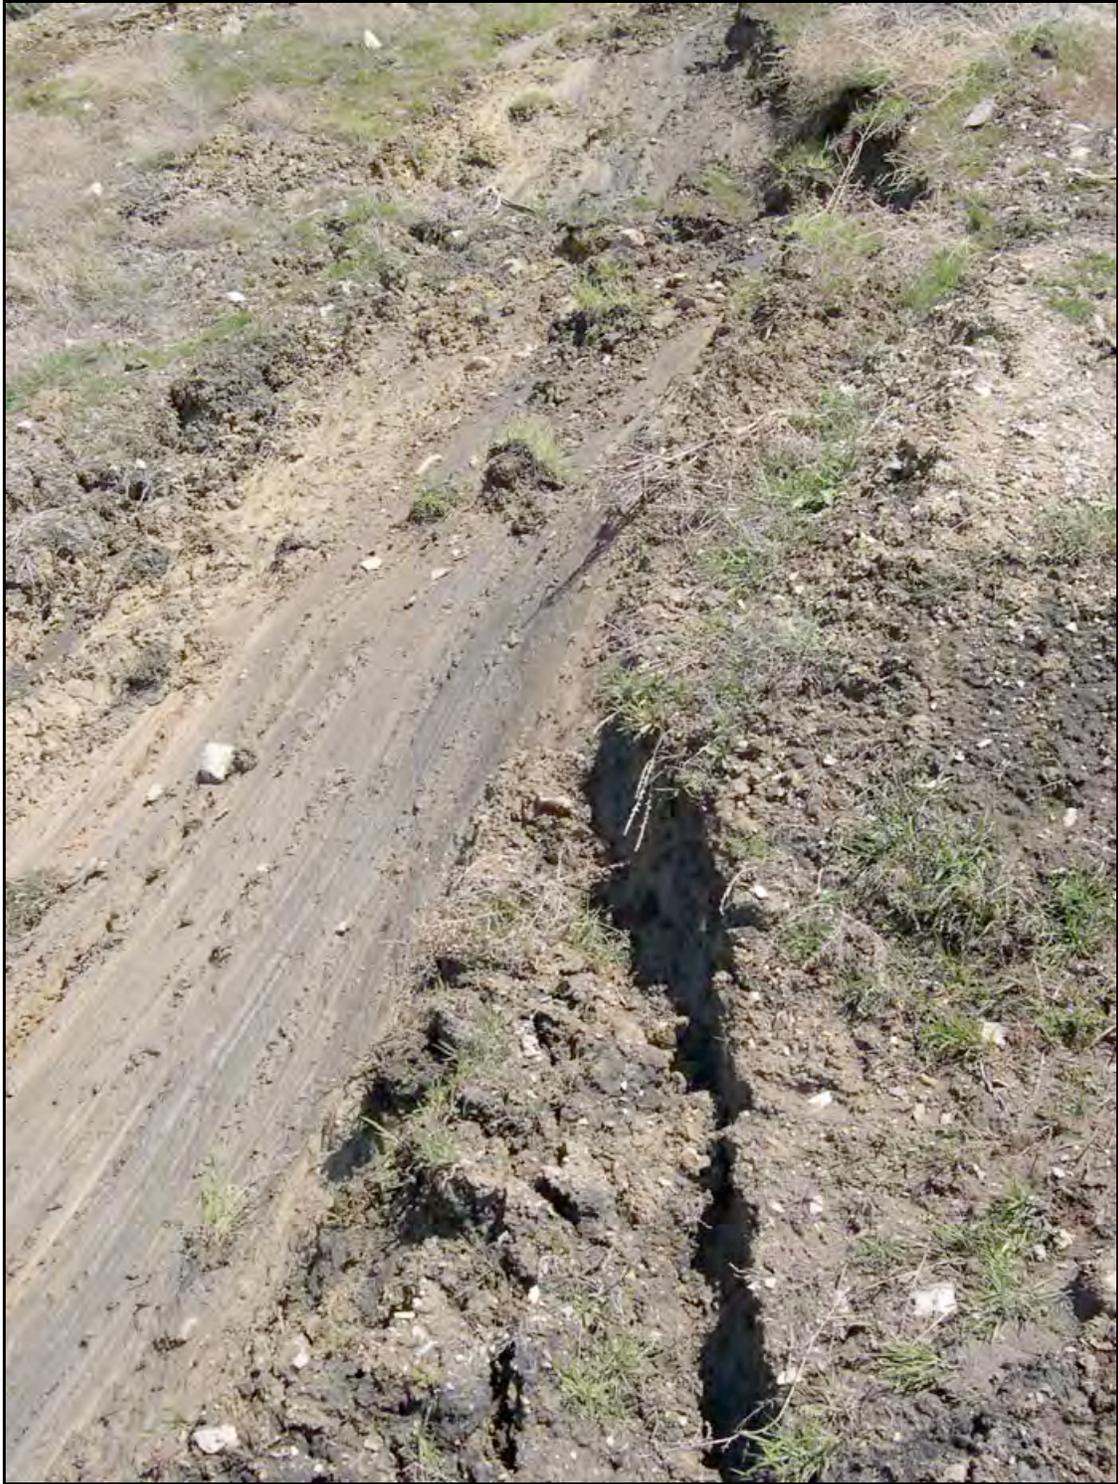
The middle part of the landslide was relatively intact and consisted of fractured soil, whereas the upper part of the landslide was somewhat more deformed and disrupted. A cobble-lined drainage ditch in this area remained mostly linear suggesting that it was mostly translated in intact and undeformed blocks (figure 6). Dark gray, highly polished slickensides were locally exposed on top of exposed black clay in the upper part of the landslide, suggesting the upper part of the slide is locally shallow (possibly less than 10 feet deep; figure 7).

Figure 7. View of slickensides in the upper, shallow part of the landslide.

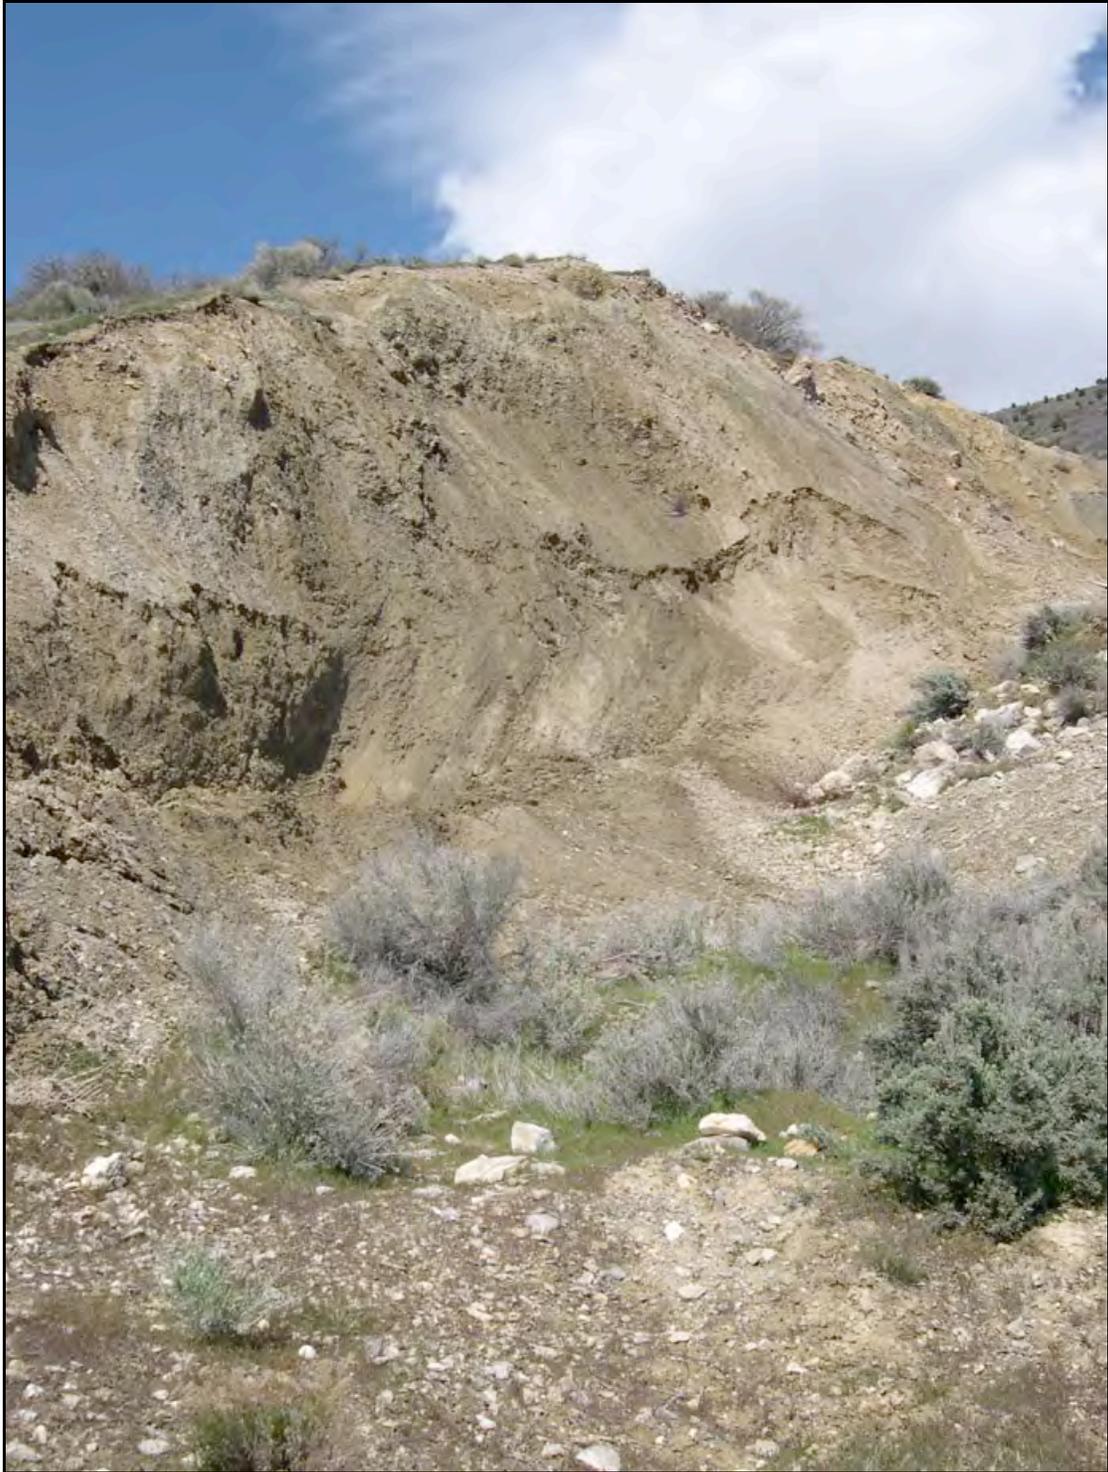
Figure 8. View of south-facing scarp along north edge of landslide on April 29, 2005. The upper part of the scarp is from movement of the slide in 1983. The lower nearly vertical part is from movement of the Sage Vista Lane landslide in 2005.

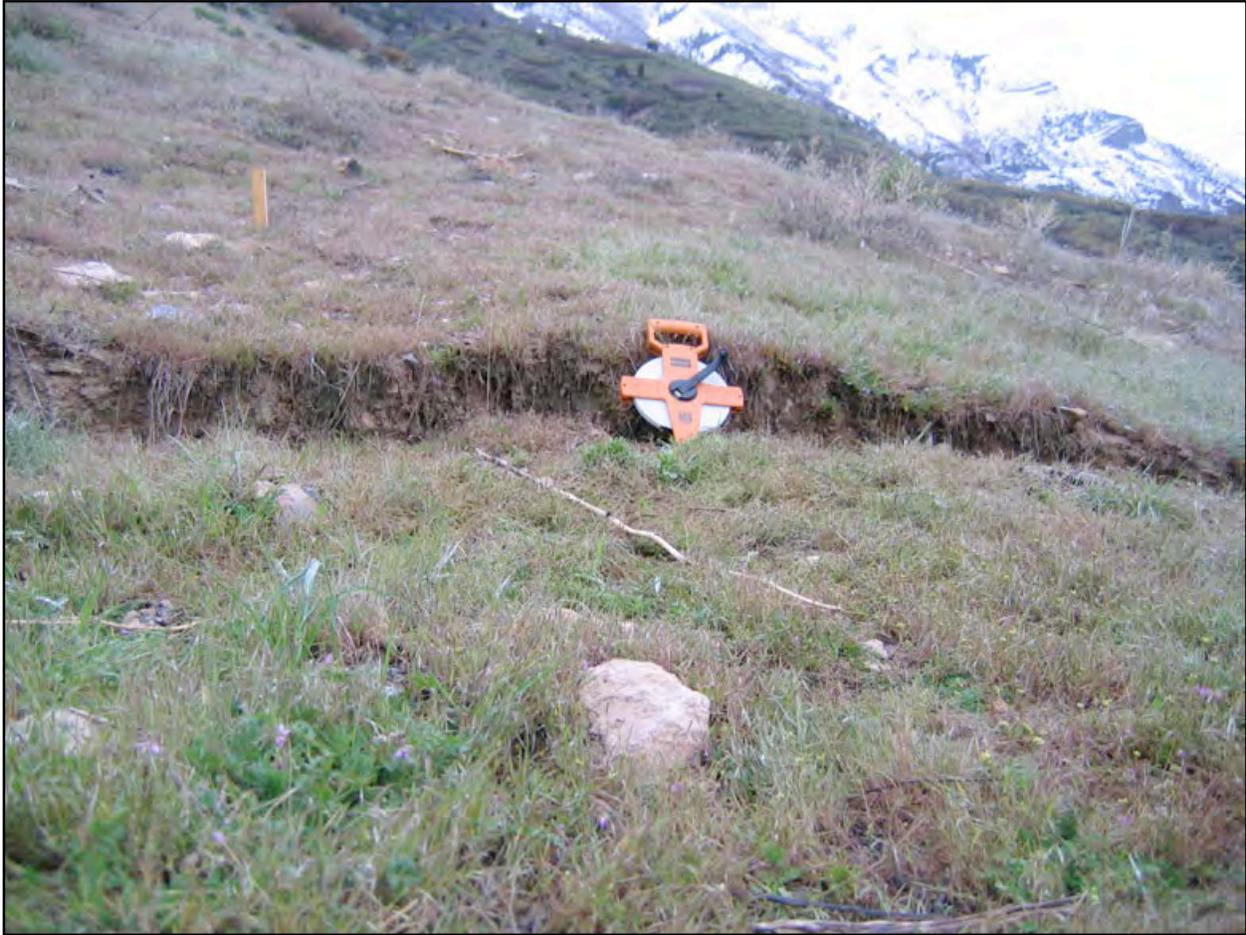
Figure 13. View of main scarp of small landslide upslope of main slide on May 12, 2005. By May 5, 2005 another scarp connected this small slide to one farther upslope joining the two slides into a single shallow landslide.
