TECHNICAL REPORTS FOR 2002–2009 GEOLOGIC HAZARDS PROGRAM

COMPILED BY ASHLEY H. ELLIOTT

Report of Investigation 269
Utah Geological Survey
a division of
Utah Department of Natural Resources
2010

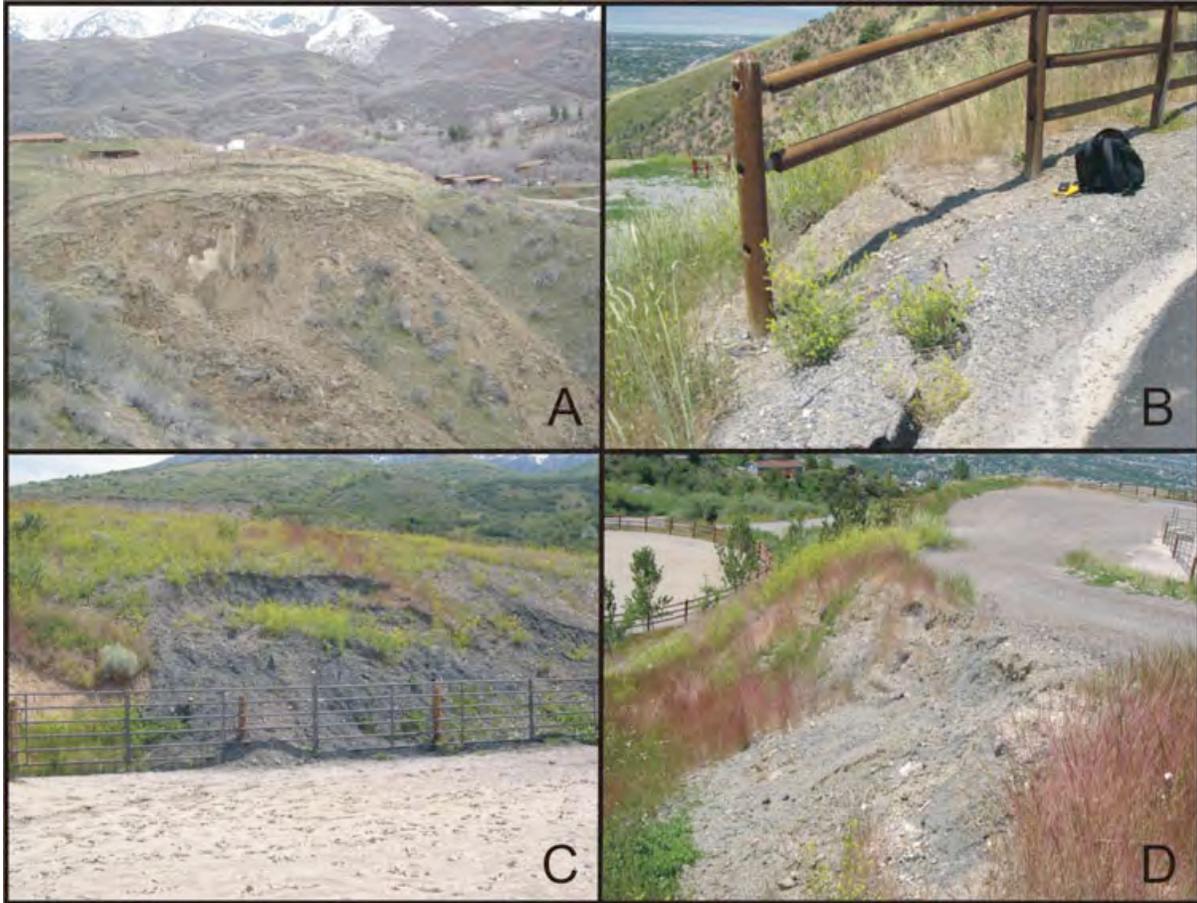
Figure 2. Landslides in 2005 on horse ranch east of East Lawn Memorial Hills Cemetery, Provo. (A) View to the east of north part of main landslide on March 17. (B) Minor offset on main scarp of small companion slide to main landslide southeast of tack shed that caused minor damage to fence. View is to the west. (C) View to the east of small landslide northeast of riding arena in highly weathered Manning Canyon Shale or debris derived from the shale. Movement direction is to the west-southwest. (D) View to the west-southwest of main scarp of small landslide east of barn. Movement direction is to the southeast. Photographs of small landslides (B, C, and D) taken on June 23.

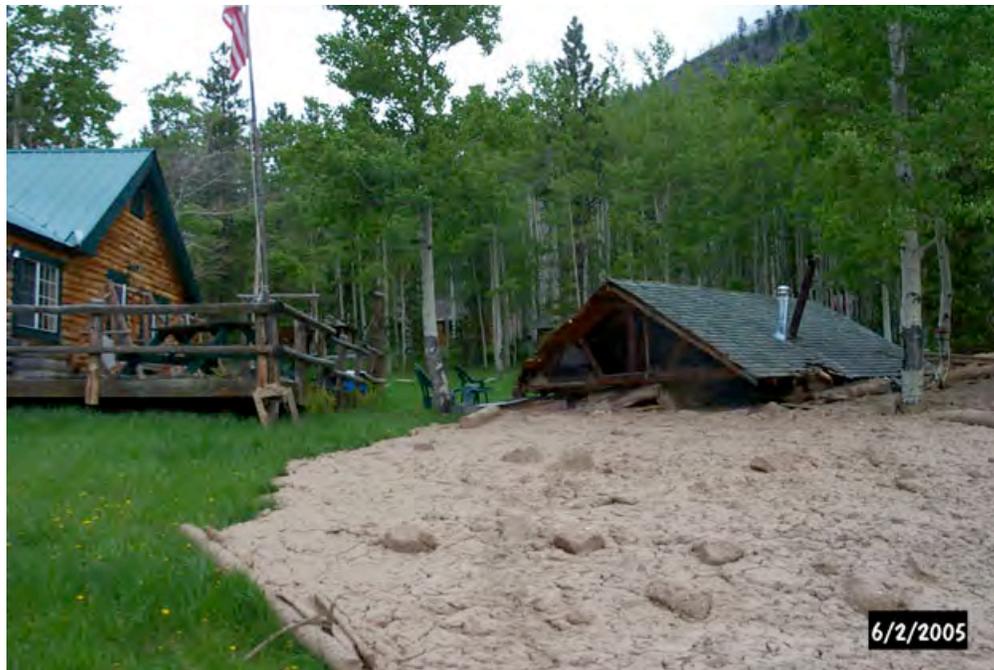
Figure 2. The roof of the Chepta cabin lies on the toe of the U-Bar Ranch debris-flow deposit. The cabin roof is approximately 180 feet downslope of the original cabin position. The U-Bar Ranch lodge (building with green metal roof) is left of the deposit. Photo by Dave Herron, U.S. Forest Service.

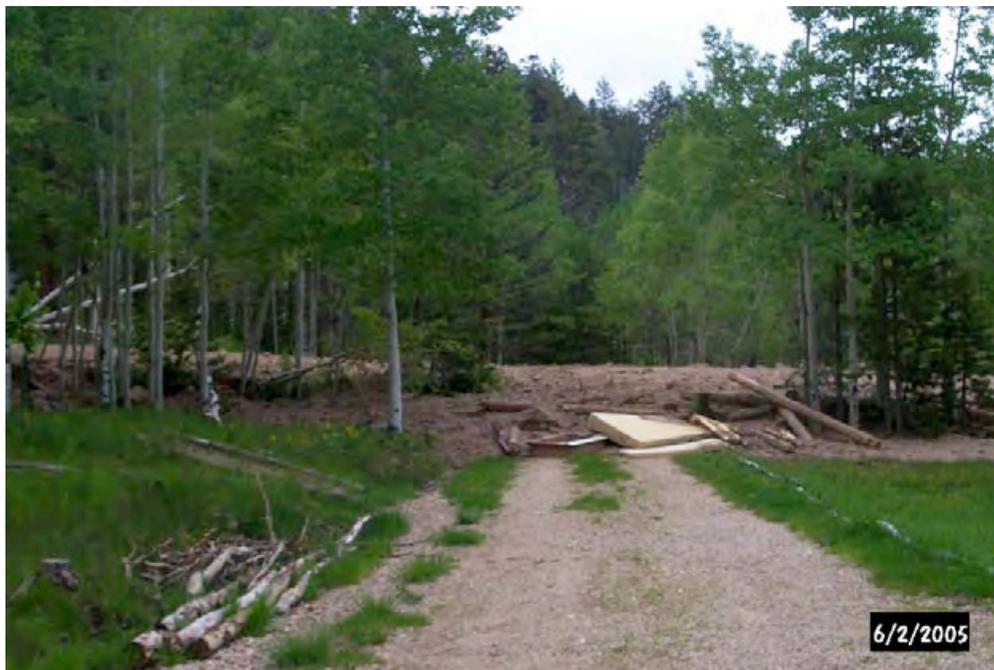
Figure 3. The U-Bar Ranch debris-flow deposit. The deposit is 4 to 5 feet thick and is blocking the access road into the ranch. The mattress and cut logs on the road are from the demolished Chepta log cabin. Photo by Dave Herron, U.S. Forest Service.

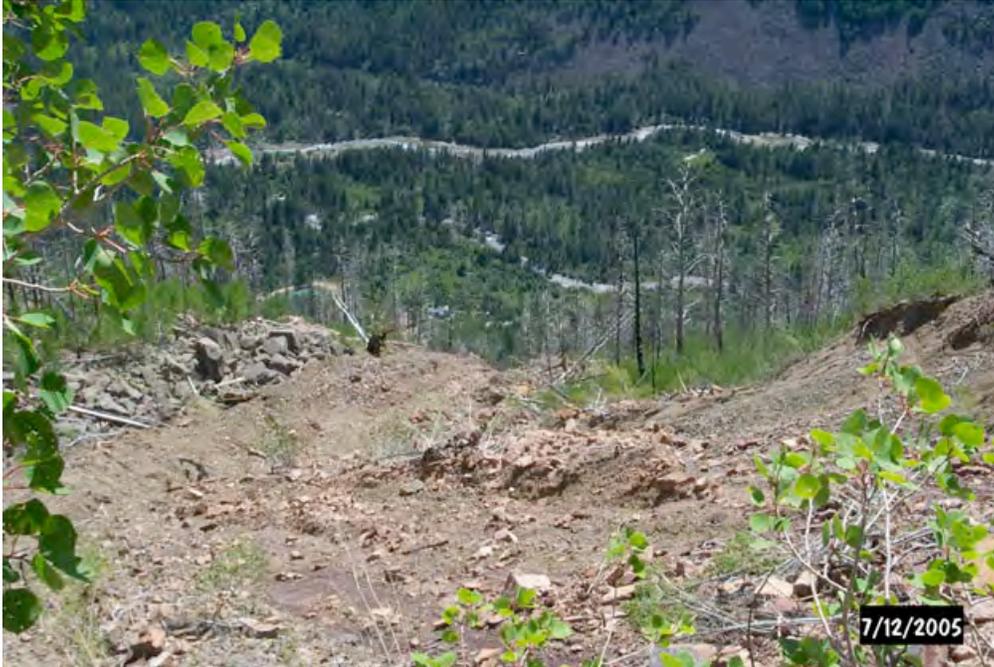
Figure 4. View looking west down the U-Bar Ranch debris slide toward the Uinta River, showing smaller slide blocks within the slide and weathered shale adjacent to the slide. The travel angle from the debris slide to ranch lodge (building with green roof in center of photo) is 27°. Photo by Dave Herron, U.S. Forest Service.

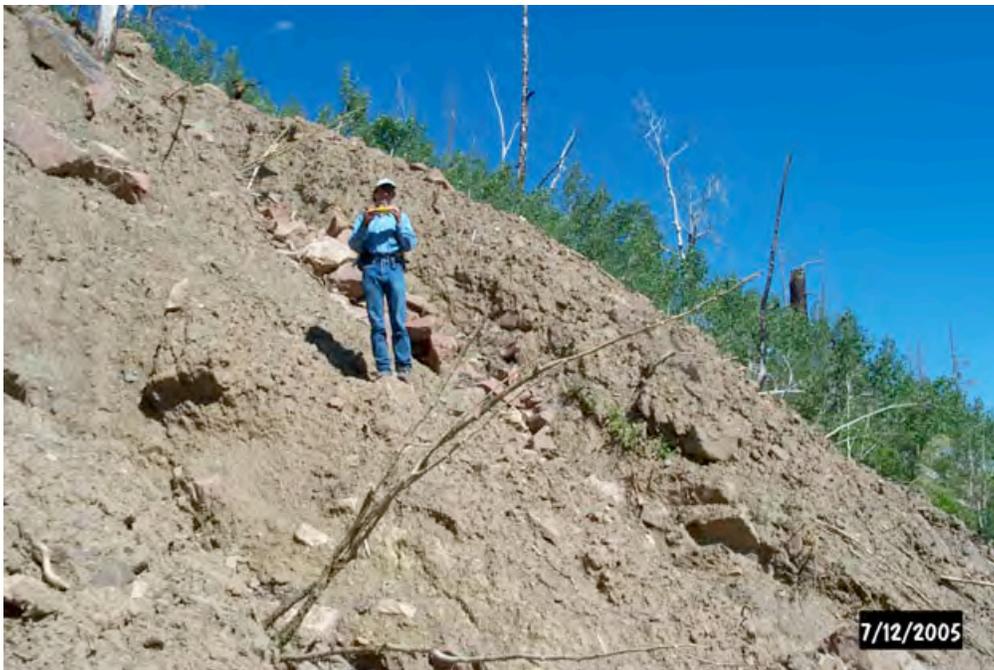
Figure 5. Left-bank channel levee of U-Bar Ranch debris flow at 8800 feet elevation. The levee is deposited on a 27-30° slope indicating a viscous phase of the debris flow. Photo by Dave Herron, U.S. Forest Service.

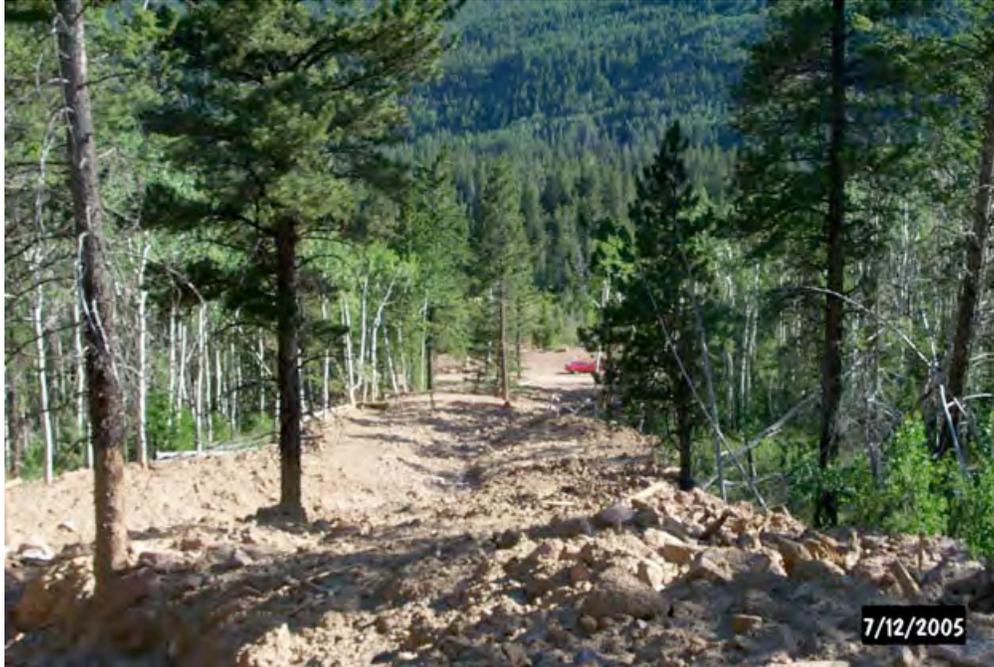
Figure 6. View looking west down the lower U-Bar Ranch flow path. Maximum flow depth shown by mud lines and boulder impact on tree trunks is 4 to 5 feet. The deposit toe is just beyond the red car. Photo by Dave Herron, U.S. Forest Service.

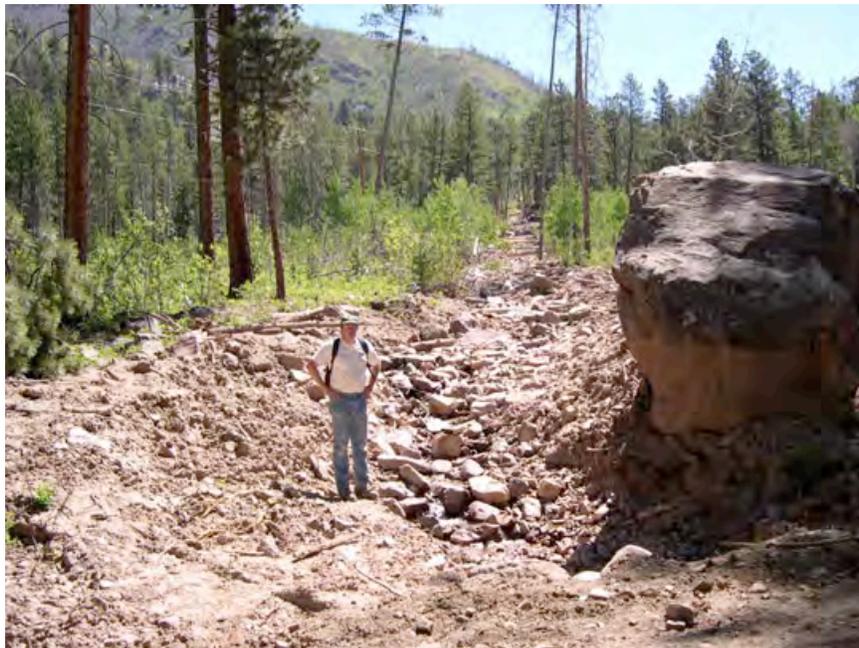
Figure 7. Looking up the alluvial-fan channel from Forest Service Road 118 and Wandin Campground. The Wandin Campground flow plugged the culvert at the bottom of the photo and flowed across the road into the campground. The mud line on the large boulder indicates a maximum flow depth of 3.8 feet. This large boulder indicates the size of boulders transported by previous debris flows.

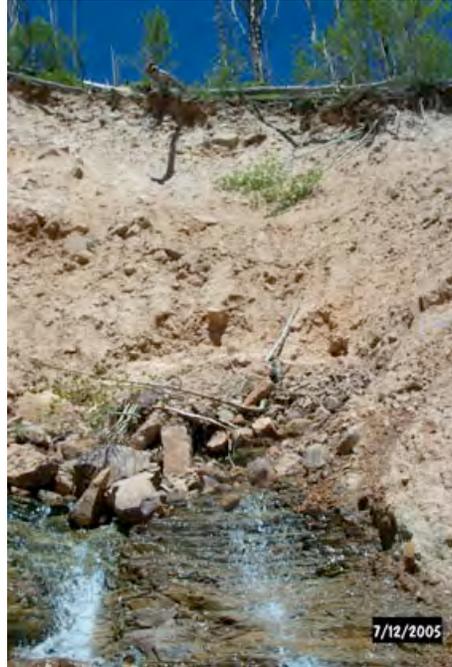
Figure 8. Wandin Campground debris-slide main scarp. The scarp is 20-25 feet high and exposes unconsolidated till and colluvium. A spring is flowing over shale bedrock in the lower part of the photo. Photo by Dave Herron, U.S. Forest Service.

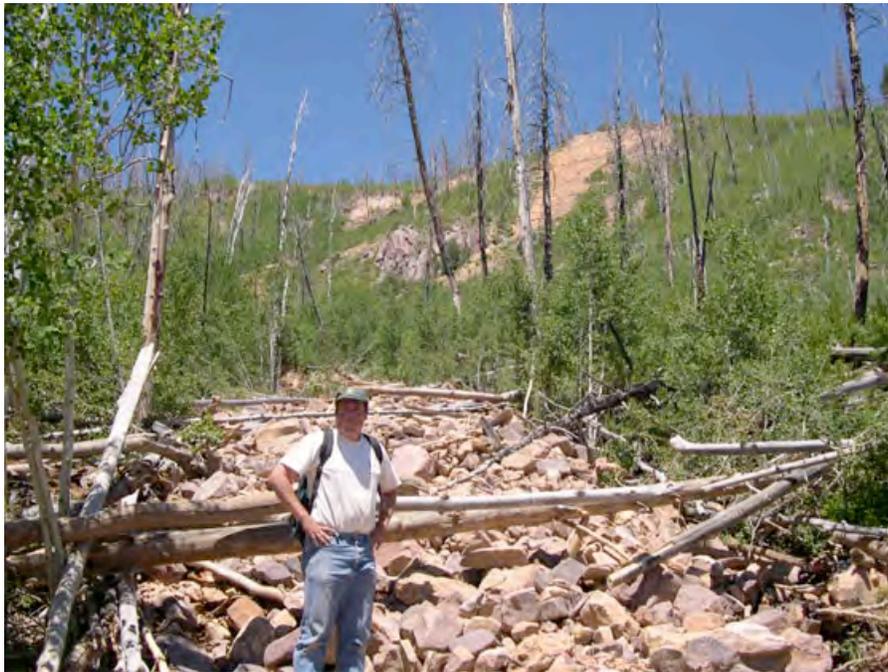
Figure 9. Wandin Campground debris-flow channel plug at 8880 feet elevation. The two light-colored areas without vegetation in the upper part of the photo are debris slides. The debris slide on the left is the source of the 2005 Wandin Campground debris flow. The debris slide on the right occurred between 1993 and 2004.

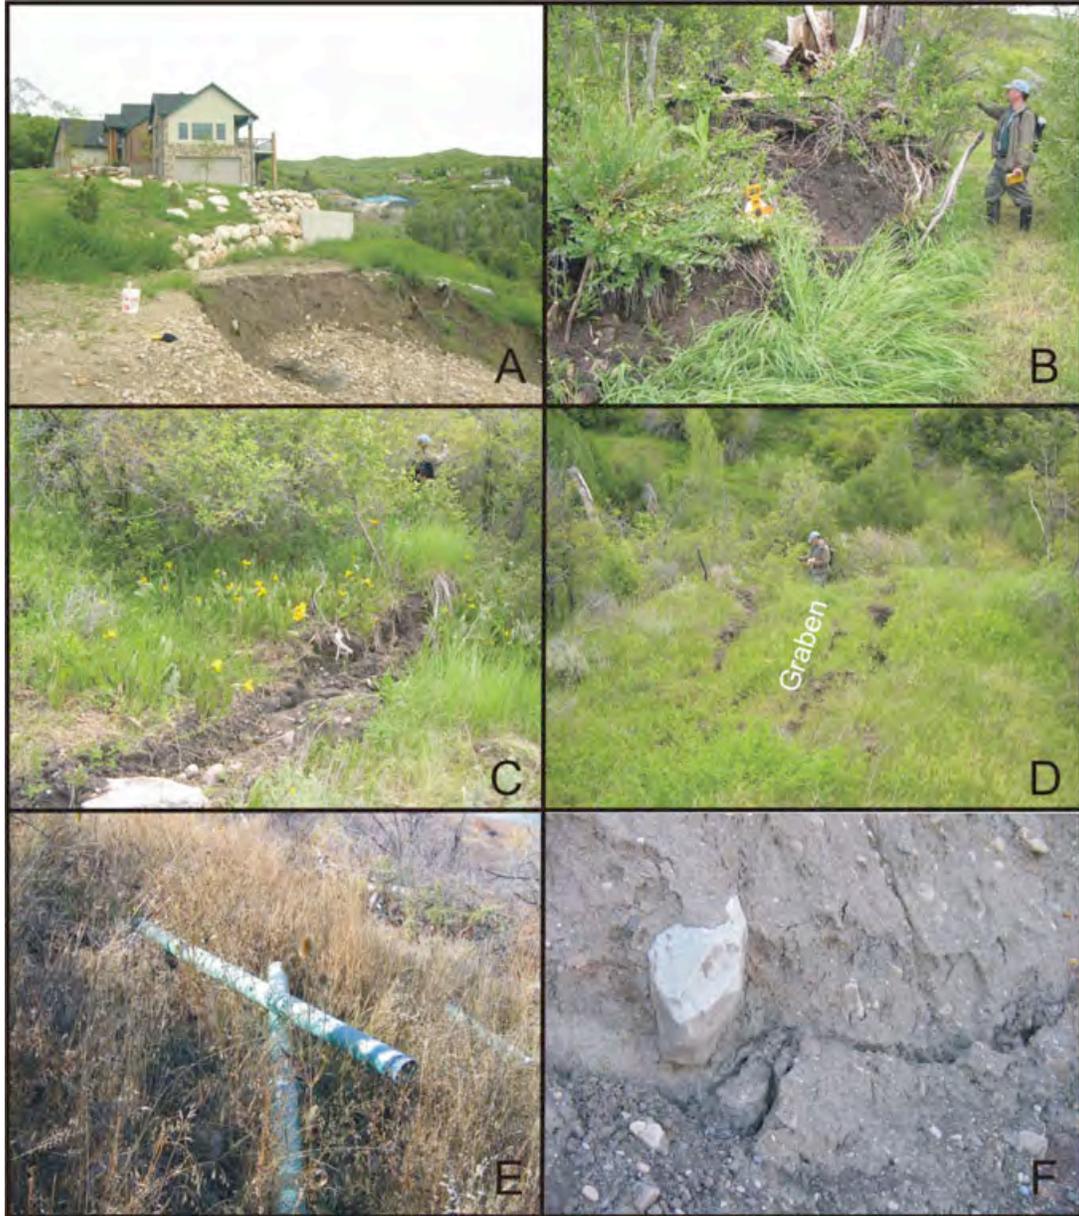
Figure 3. Southern Sewer-Line landslide. (A) View to the northwest of main scarp of the Southern Sewer Line landslide. Landsliding destroyed the eastern part of the sewer corridor embankment, but had not exposed the sewer pipe as of January 13, 2006. House at 6110 N. Creekside Drive visible in background. (B) View to the northwest of toe of the landslide. Lower toe thrust/fold is approximately 5 feet high. West edge of Gordon Creek (not visible just to the right of the edge of the photograph) was only 3.4 feet from toe on October 12, 2005. (C) View downslope of right-flank shear cutting across natural slope. (D) View downslope of east-trending graben in lower part of slide. (E) Broken drainpipe in lower part of slide. Upslope pipe displaced about 3.9 feet downslope. (F) Recent offset of main scarp on November 1, 2005, due to continued movement of slide in latter part of 2005.

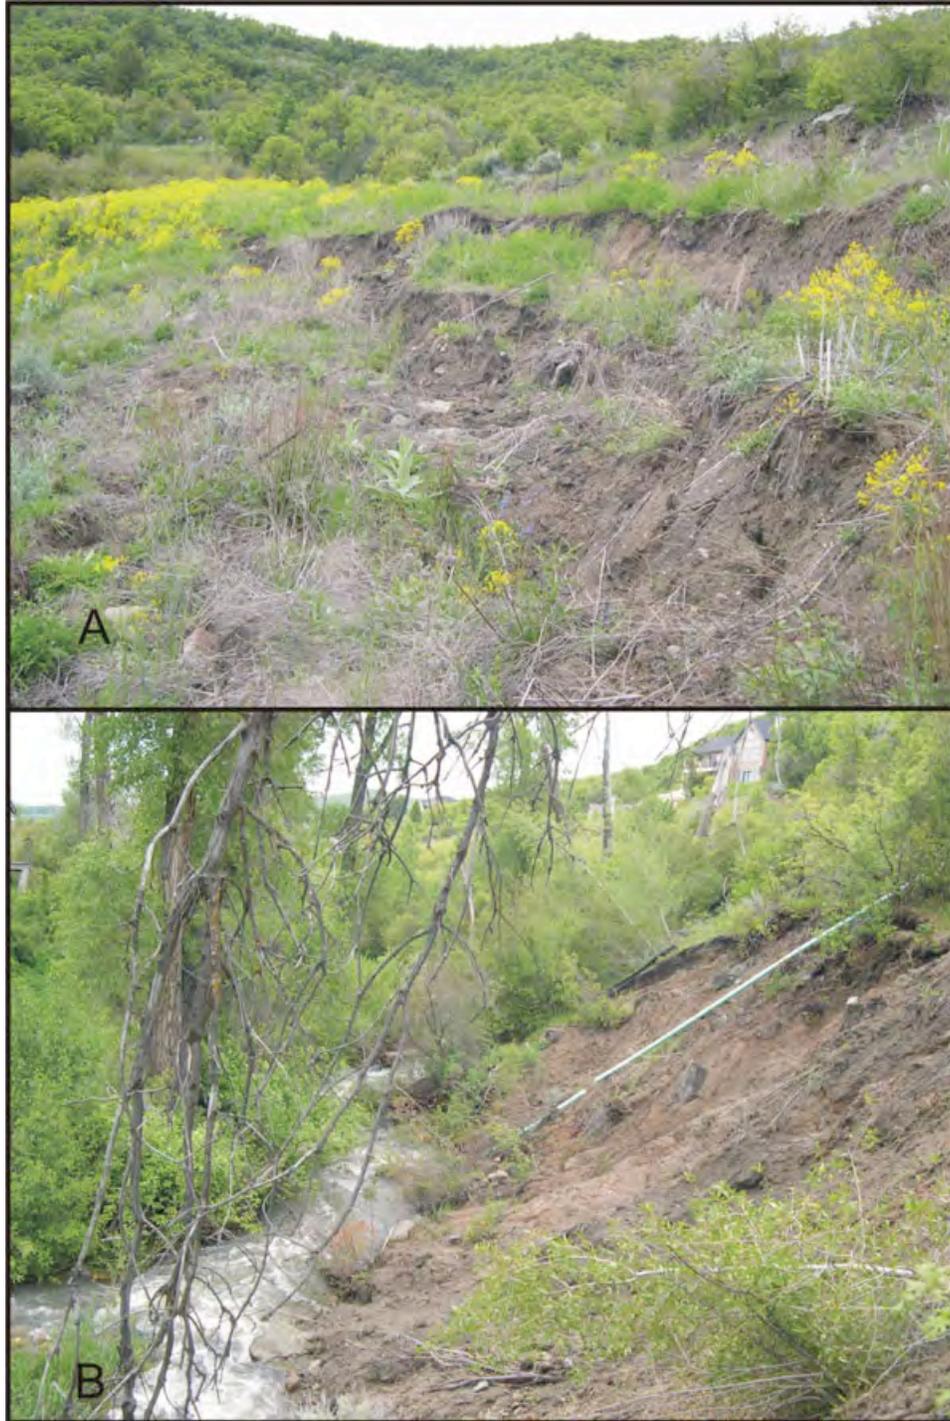
Figure 4. Northern Sewer-Line landslide. (A) View to the south-southwest of main scarp zone of the landslide. Top of main scarp was only a few feet from the east edge of the sewer-line corridor. (B) View to the south of toe of the landslide along Gordon Creek. Note drainpipe exposed along south flank of landslide.

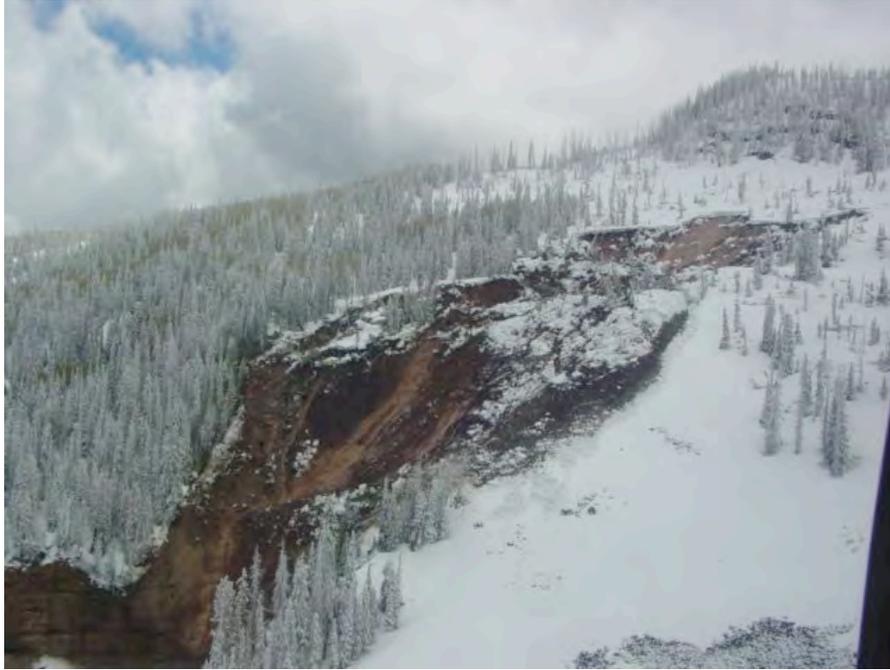
The upper landslide has a very rough surface and consists of clay-rich debris with angular cobbles and boulders of basalt and sandstone (figures 3, 7). Where exposed downslope from the main scarp of the upper landslide, the rupture surface beneath the upper part of the upper landslide is shallow and movement only involved the upper few vertical feet of slope (figure 7). The rupture surface dipped from 30 to 34°, and formed in weathered, soft, low strength, shale and mudstone. However the rupture surface becomes significantly deeper downslope, and we estimate it was 40 to 50 feet deep where the lower landslide catastrophically failed into the mountain channel (figures 5 and 6). Timber harvest and subsequent loss of root strength likely had little influence on landslide stability because of the deep rupture surface. Several springs were present in the evacuated area and were discharging from the exposed rupture surface.

Aerial photos and field observations indicate an approximate 3-foot-thick snowpack remained on Black Mountain on June 3, 2005 (figure 3). The remaining snowpack indicates that only partial snowpack melting was sufficient to trigger landslide movement. A rapid rate of snowmelt over several days may be a more critical parameter in triggering landslides than the total volume of snow melted and water added. Melting of an above average snowpack in 1983 triggered numerous landslides in Utah, and Wieczorek and others (1989) observed that most of those landslides triggered during the most rapid period of snowmelt.

Figure 3. The remaining upper landslide on the north side of Black Mountain. The upper landslide is perched above the narrow mountain channel (figure 4) that is out of view and below the photo. Photo taken on June 3, 2005, by Lt. David Excel, Utah Highway Patrol.

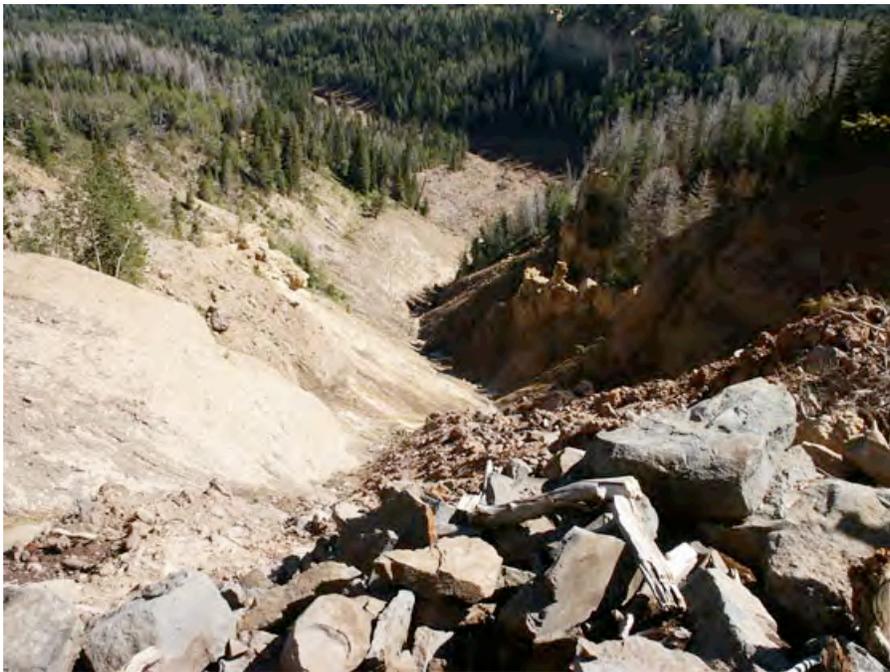
Figure 4. View down the steep, narrow mountain channel. The lower part of the landslide released into the channel and was transformed into a rapidly moving debris flow. Part of the debris-flow path is evident below the channel.

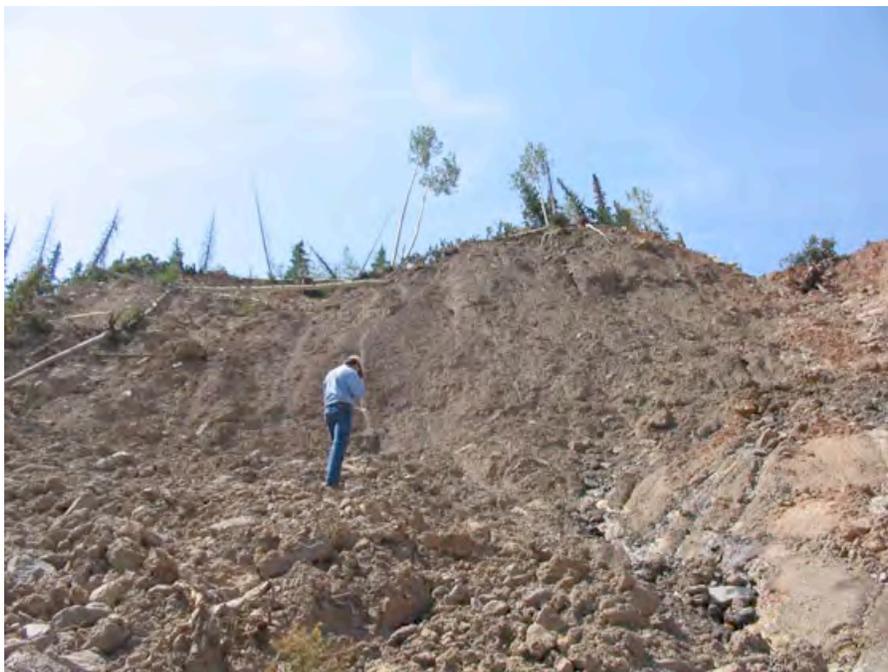
Figure 6. View is from the evacuated area of the lower landslide toward the remaining upper landslide. The upper landslide lies on a steep rupture surface.

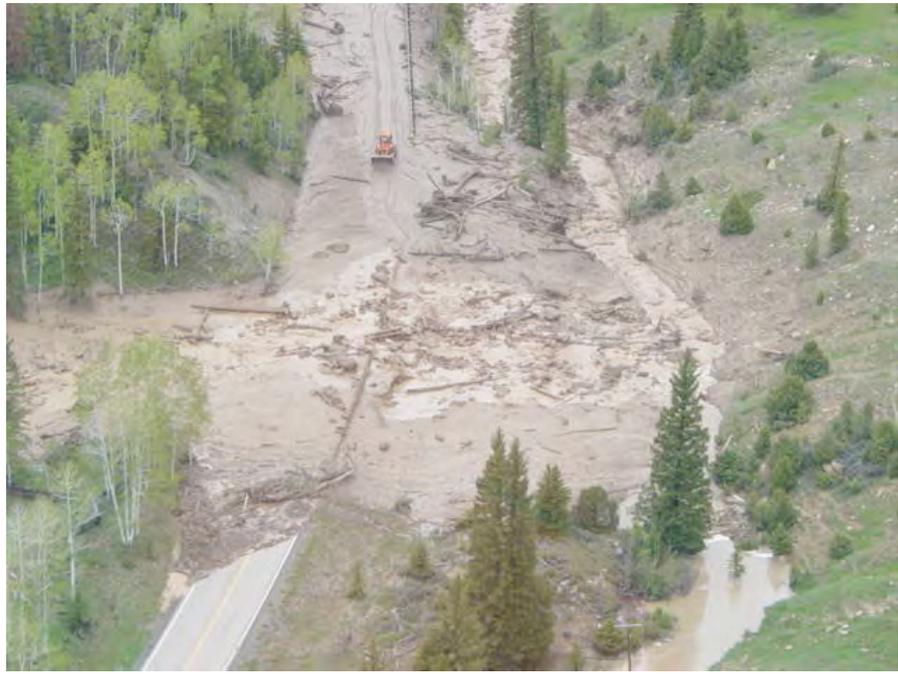
The major structure at risk from future debris flows originating on the north side of Black Mountain is SR-14, which is subject to culvert blockage, overtopping, erosion, and sediment burial. The unnamed stream valley above SR-14 is presently undeveloped, and building structures in the bottom of the valley is not recommended unless the debris-flow hazard is reduced to an acceptable level. Downstream from the unnamed drainage, potential impacts along Crow Creek and Cedar Canyon include further erosion and damage to SR-14, blocked

Figure 8. View northwest of SR-14 blocked by sediment from the Black Mountain debris flow. Crow Creek is on the right. Photo taken on June 3, 2005, by Lt. David Excel, Utah Highway Patrol.

culverts, potential creek blockage, and influx of sediment. A site-specific, detailed investigation is needed to determine possible highway risk-reduction measures and their cost. Giraud (2005) outlined methods for the geologic evaluation of debris-flow hazards.

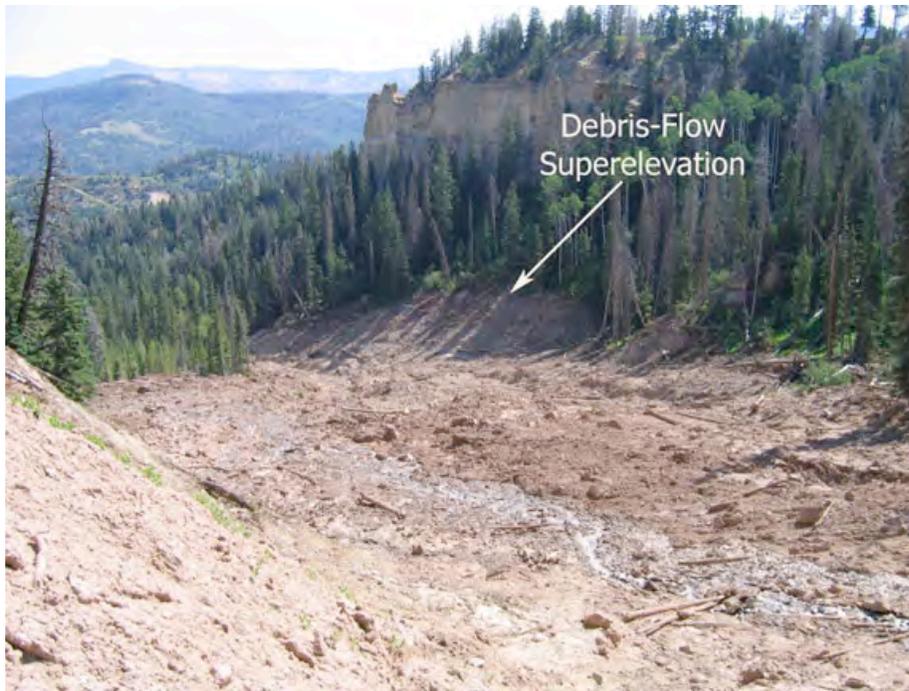
The upper valley debris-flow deposit below the mountain channel is up to 550 feet wide and locally up to 10 feet thick (figure 9). Below an elevation of 8800 feet the deposit narrows and from 8440 to 8400 feet elevation a small lobe of material was deposited along the west edge of the valley (figure 2). The upper valley deposit has an average slope of 16% (9°), an estimated volume of 55,000 yd³, and covers an area of 13.7 acres. The deposit thins downvalley and is only 1 to 2 feet thick immediately upstream from the lower valley deposit. The largest observed boulder in the deposit is 22 feet long (figure 10). The drainage channel along the upper deposit

Along the upper-valley deposit margins, the debris flow removed mature, similar-aged conifer trees, and left distinct tree trim lines (figures 9, 10, 11). Based on their size, these trees were a minimum of 100 years old and likely were older (Burrows and Burrows, 1976), which suggests that a minimum of 100 years has passed since the last large debris flow in this drainage. We observed pre-2005 debris-flow deposits at an elevation of 8800 feet along the west margin of the 2005 deposit. Relatively young conifer trees 4 to 5 inches in diameter are growing on this deposit, which suggests that the deposit is relatively young and possibly related to a small-volume historical debris flow. On aerial photos, we observed young debris-flow deposits immediately below the steep, narrow mountain channel. These small-volume deposits likely represent relatively high frequency, low-volume flows that occur more frequently than large-volume flows.

Figure 9. Northeast view down the upper stream valley at the debris-flow deposit below the narrow mountain channel. The debris flow had sufficient velocity to superelevate up onto the valley side below the sandstone cliff.

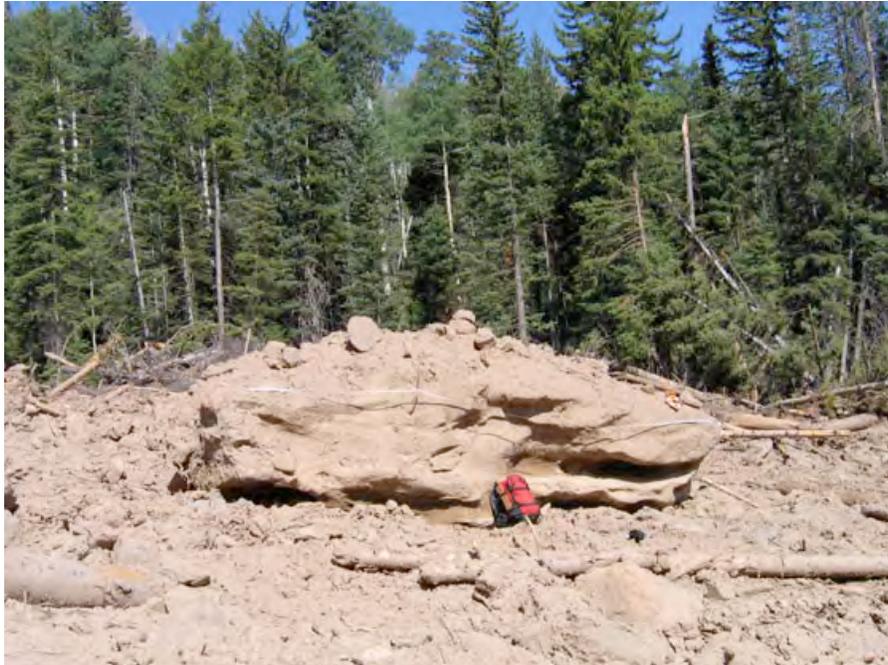
Figure 10. Large boulder transported by the debris flow now part of the upper valley deposit. The boulder measures 22 feet long, 9.5 feet wide, and 6.5 feet high. The tree trim line is evident in the background.

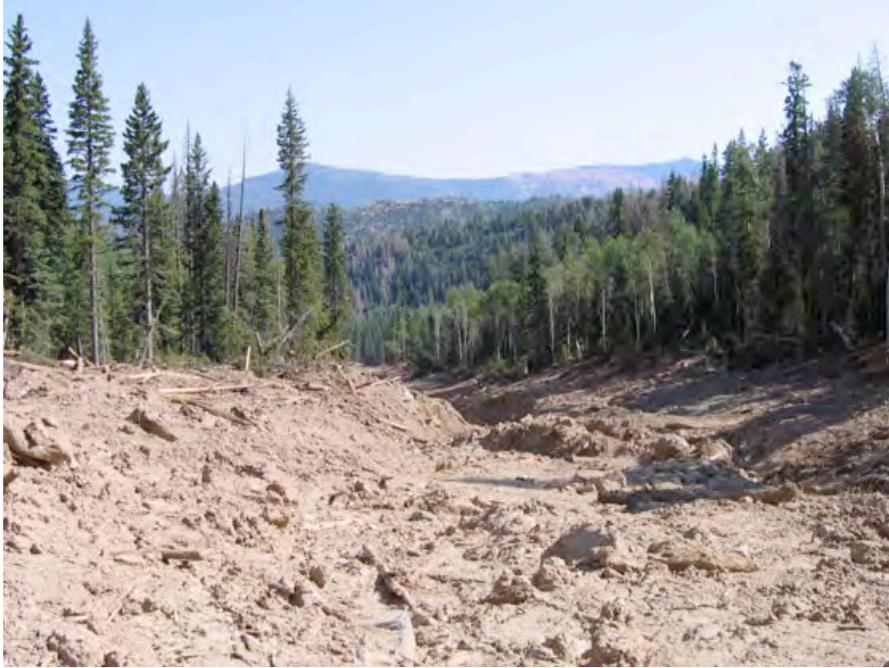
Figure 11. Upper valley debris-flow deposit showing the rough, wide, and thick deposit and distinct tree trim lines along the deposit flanks.

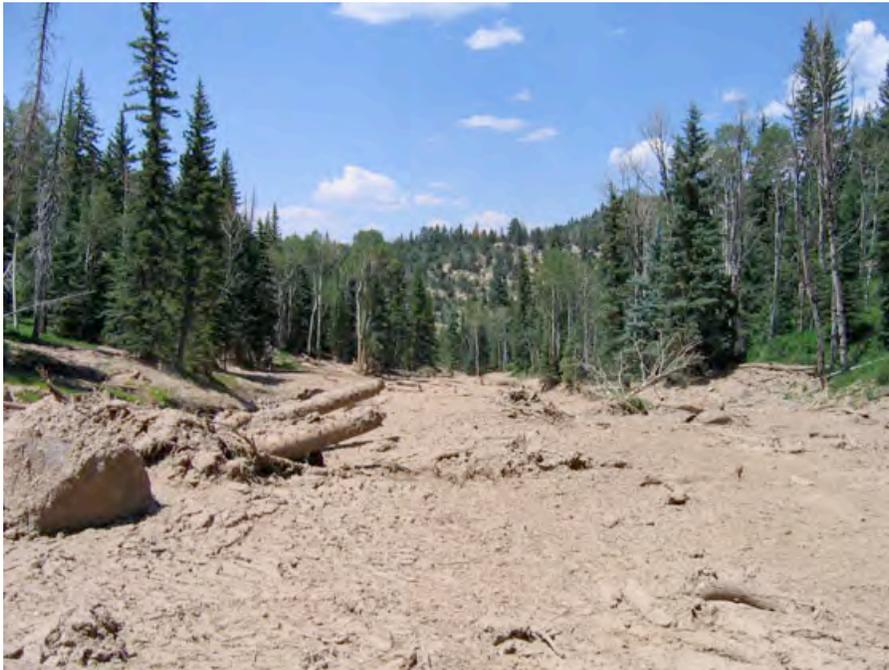
The break between the upper and lower valley deposits is at an elevation of 8360 feet (figure 2). Compared to the upper valley deposit, the lower valley deposit is narrower, thinner, smoother, and lacks the demolished forest and tree trim lines (figure 12). The drainage channel was locally scoured up to 3 feet deep, but erosion from the lower valley did not add a significant volume of material to the debris flow. The lower valley deposit is generally 1 to 2 feet thick, has an average slope of 9% (5°), an estimated volume of 18,000 yd³, and area of 12.9 acres.

Figure 12. Lower valley deposit showing the relatively smooth, narrow, thin deposit compared to the upper valley deposit.

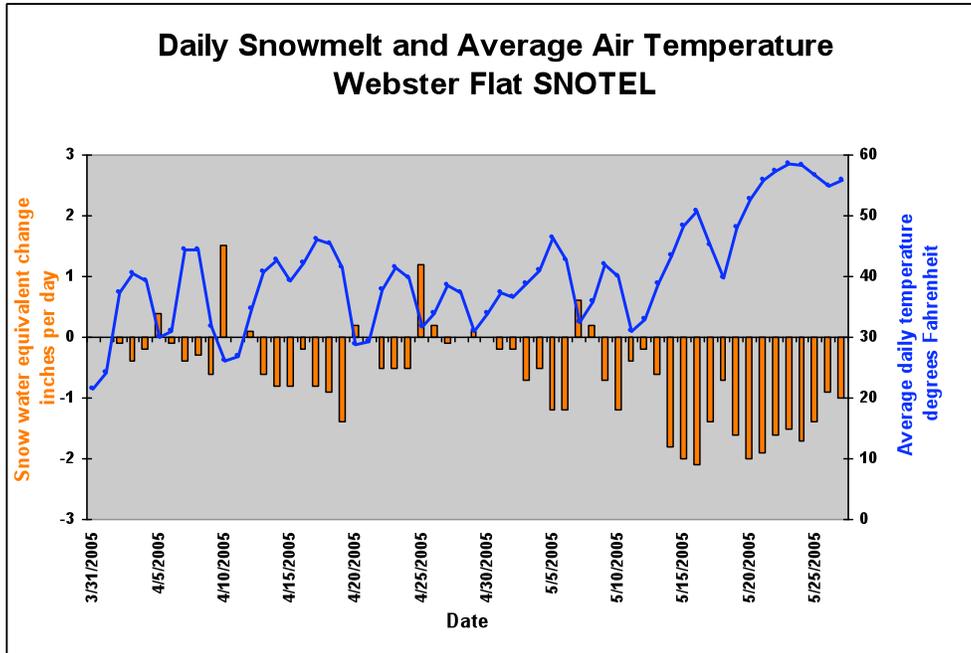
Figure 13. Daily snowmelt and average daily temperature at the Webster Flat SNOTEL site. From May 14 to May 27, 2005, an average of 1.5 inches of water per day melted from the snowpack.

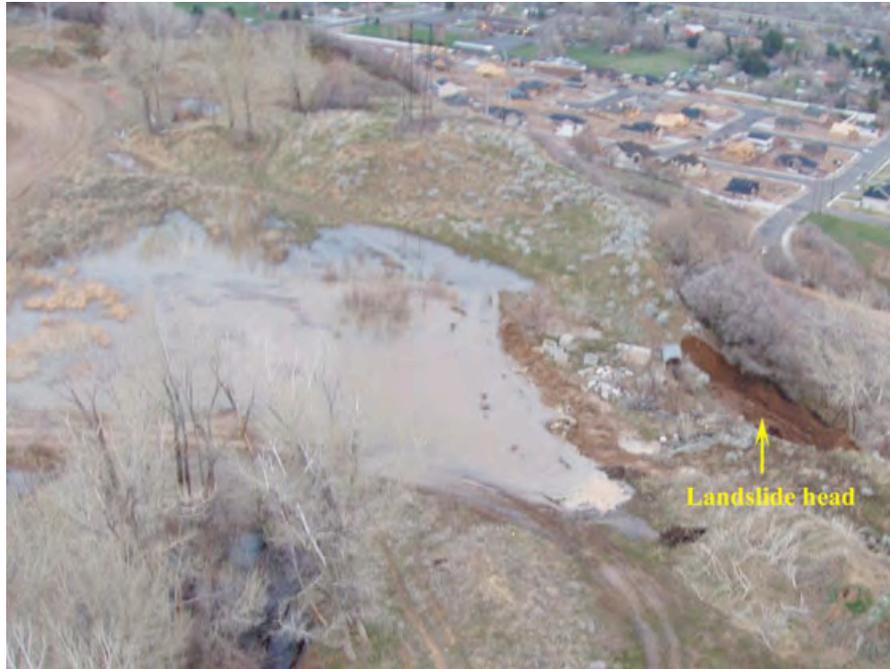
Figure 5. View looking northwest at the pond in the gravel pit and the landslide head (arrow). A berm was placed between the pond and the landslide to prevent water from flowing onto the landslide. Photo taken on the morning of April 10, 2005, by Davis County Sheriff's Office personnel.

the pond (figure 5) also indicate the presence of perennial shallow ground water since surface-water runoff alone would not sustain this vegetation. Cottonwood trees growing along the slope crest also indicate shallow ground water (figure 6). Following the landslide, a soil berm was placed between the pond and the landslide to prevent pond water from flowing onto the landslide head (figure 5).

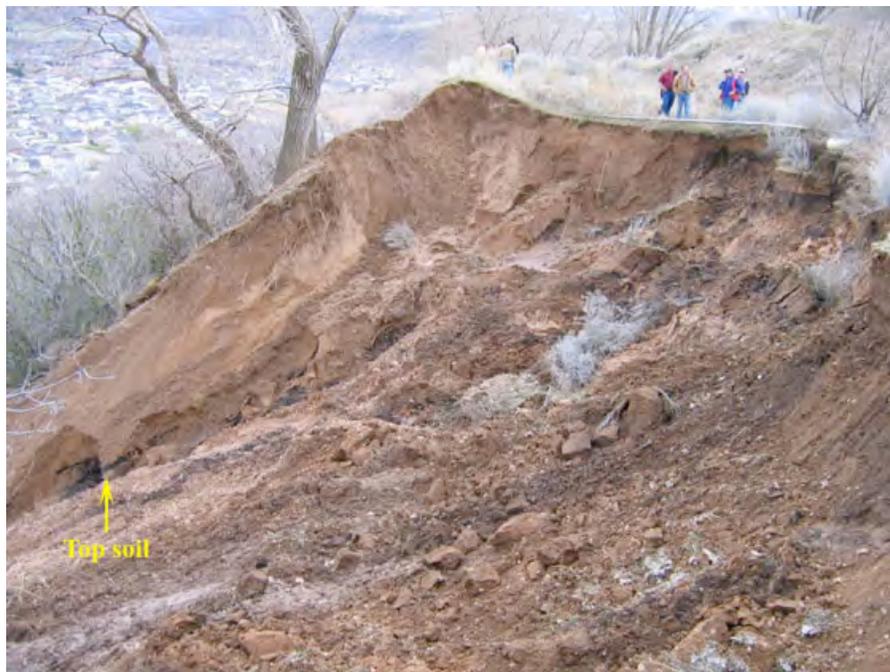
Figure 6. View to the southeast showing landslide main scarp and fill placed on the upper slope. Near the left edge of the photo, black top soil at the base of the scarp (arrow) underlying the brown fill is evident and indicates the original slope surface.

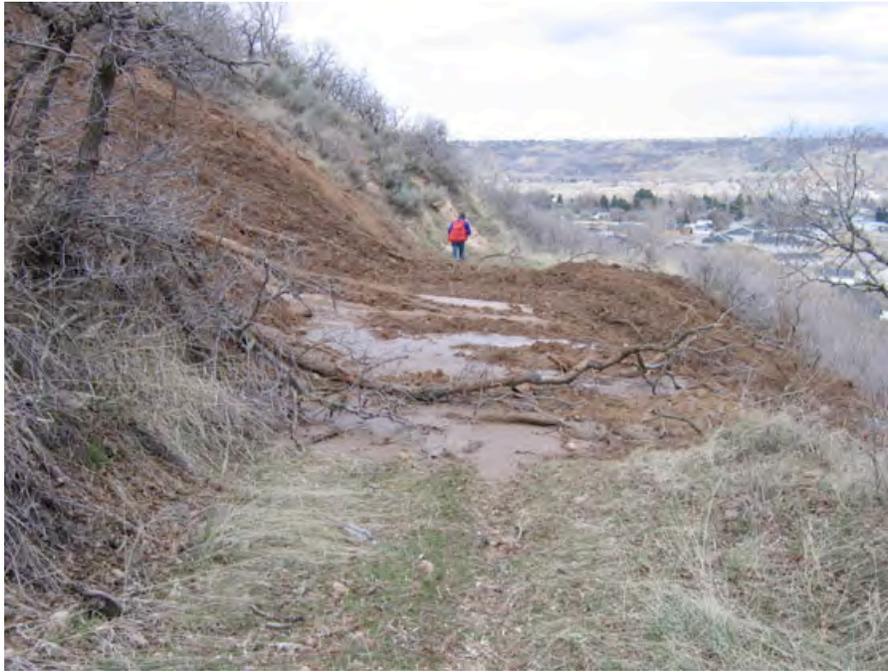
Figure 10. *Landslide material deposited on a dirt road midslope above the Davis-Weber Canal.*

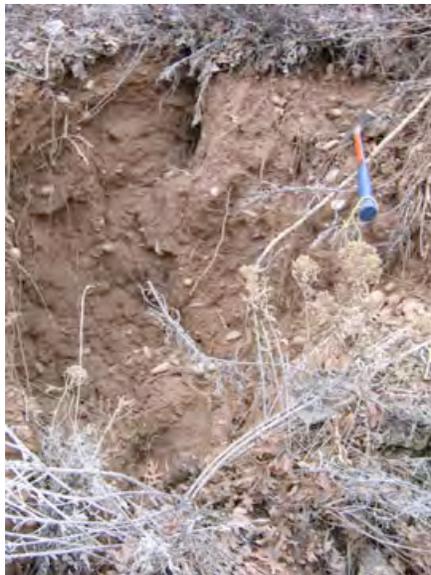
Figure 11. Piping holes in the upper slope near the landslide flanks. (a) Small piping hole near the landslide right flank. (b) Large piping hole adjacent to the landslide left flank.

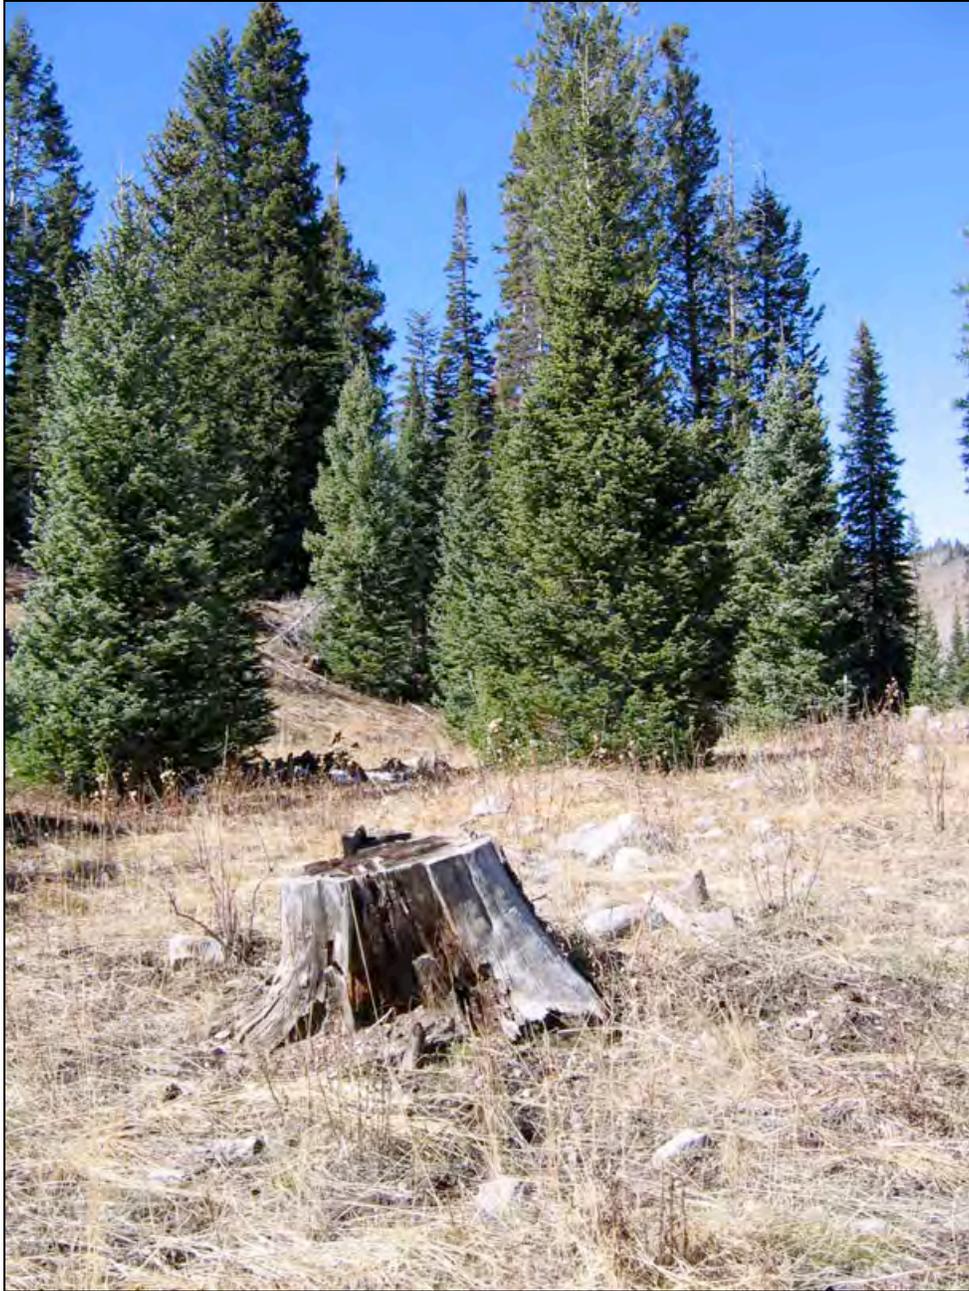
Figure 2. View toward the west of back-tilted surface in upper part of landslide. Note that whereas the living trees are vertical, the tree stump is tilted, suggesting back-tilting occurred during lifetime of tree.

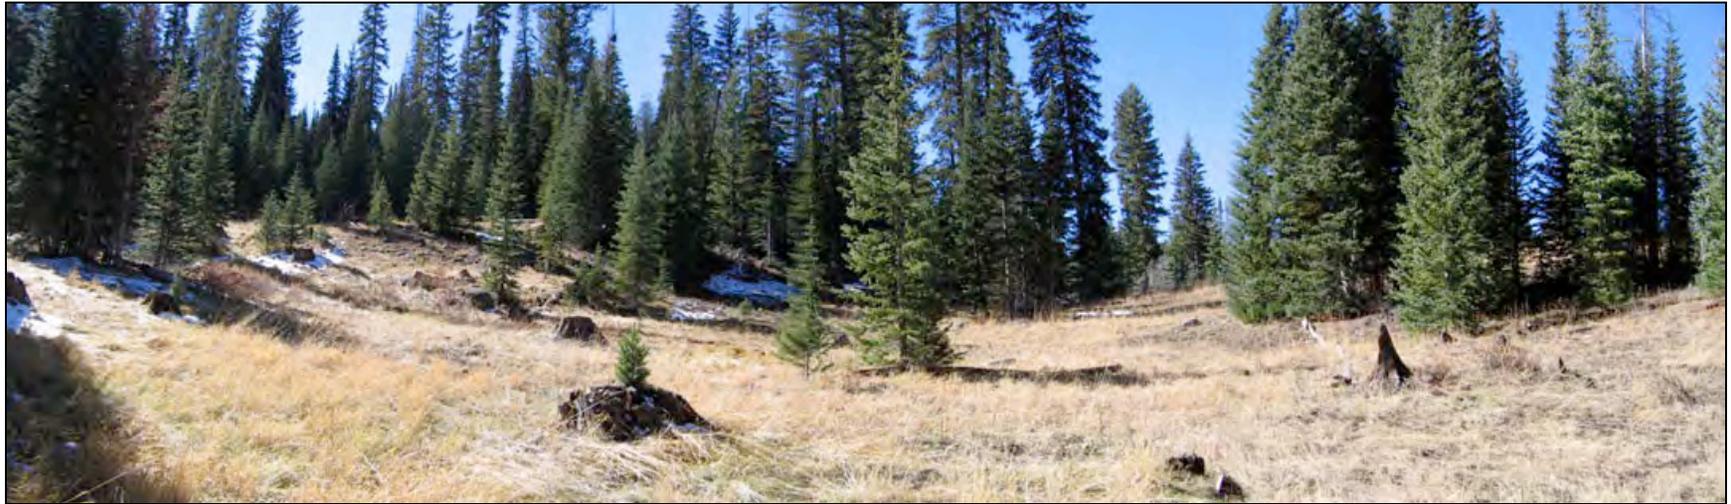
Figure 3. View toward the west from right flank of landslide showing back-tilted surface (right) at right step in right-flank shear zone. Note that the tree stumps are tilted, but the living trees are vertical.

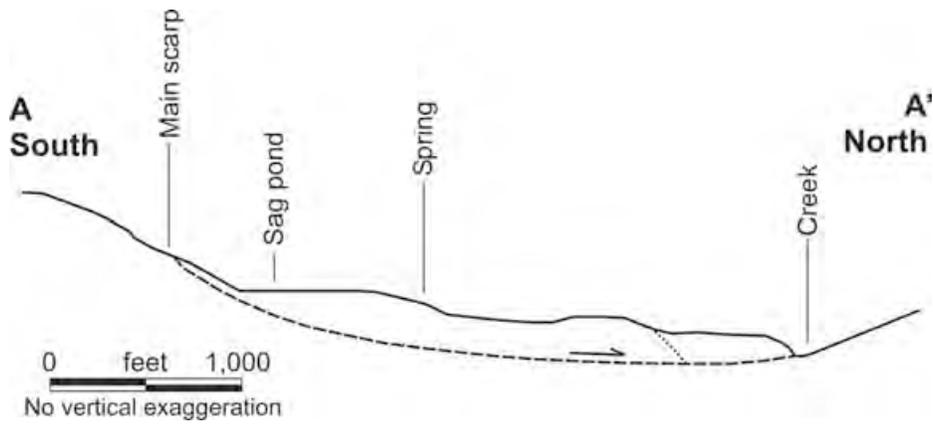
Figure 4. Profile A-A' across landslide showing approximate geometry. Dotted line is estimated pre-failure location of incipient toe. See figure 1 for profile-line location.
