TECHNICAL REPORTS FOR 2002–2009 GEOLOGIC HAZARDS PROGRAM

COMPILED BY ASHLEY H. ELLIOTT

Report of Investigation 269
Utah Geological Survey
a division of
Utah Department of Natural Resources
2010

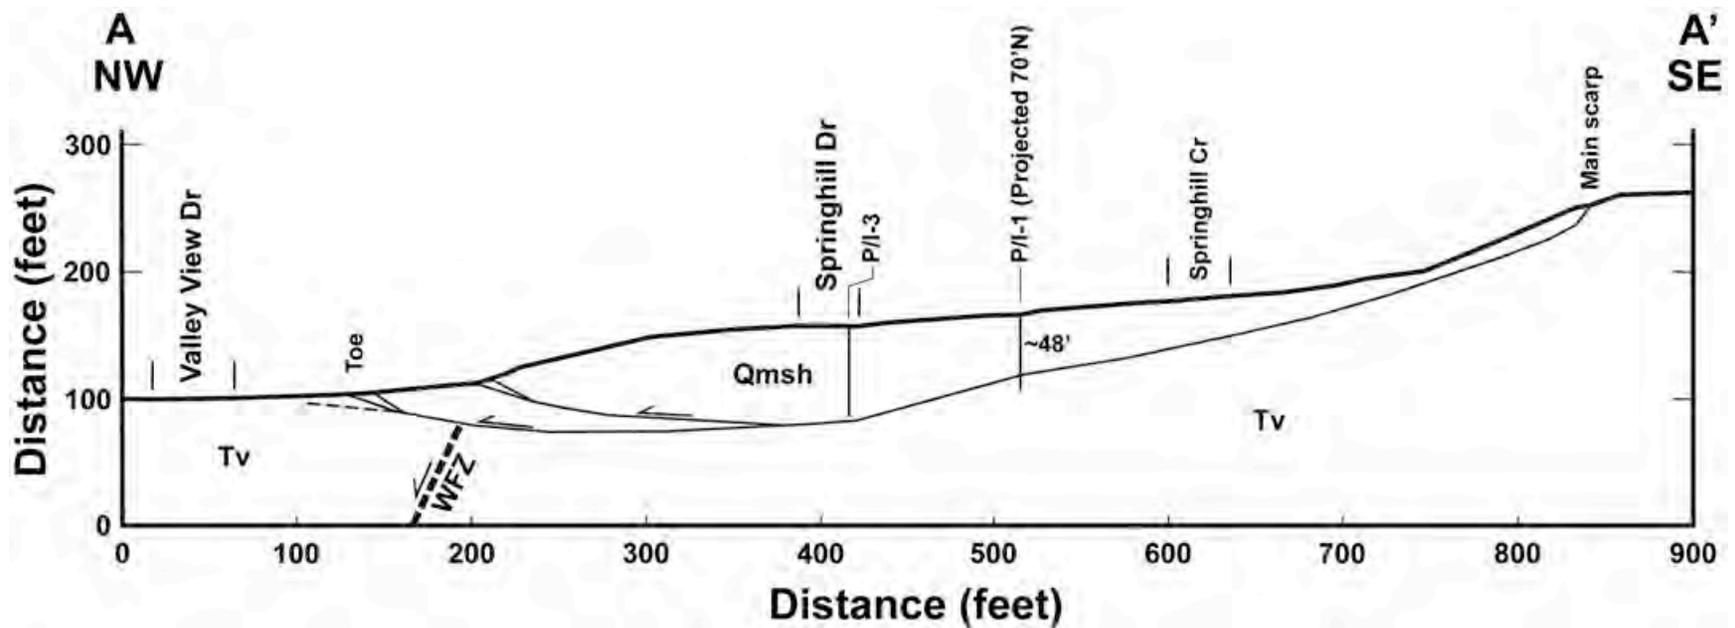
Figure 5. Geologic cross section of Springhill landslide based on depths from inclinometers and slope-stability analysis. Landslide (Qmsh) overlies weathered Tertiary volcanic rocks (Tv). Basal slide-plane splays intersect the ground surface at four locations (see figure 2). Approximate location of trace of Wasatch fault zone (WFZ) shown beneath toe of landslide. Inclinometer I-5 near northwestern edge of toe not shown for clarity because of its location immediately downslope of frontal toe thrust. See figure 2 for section line location.

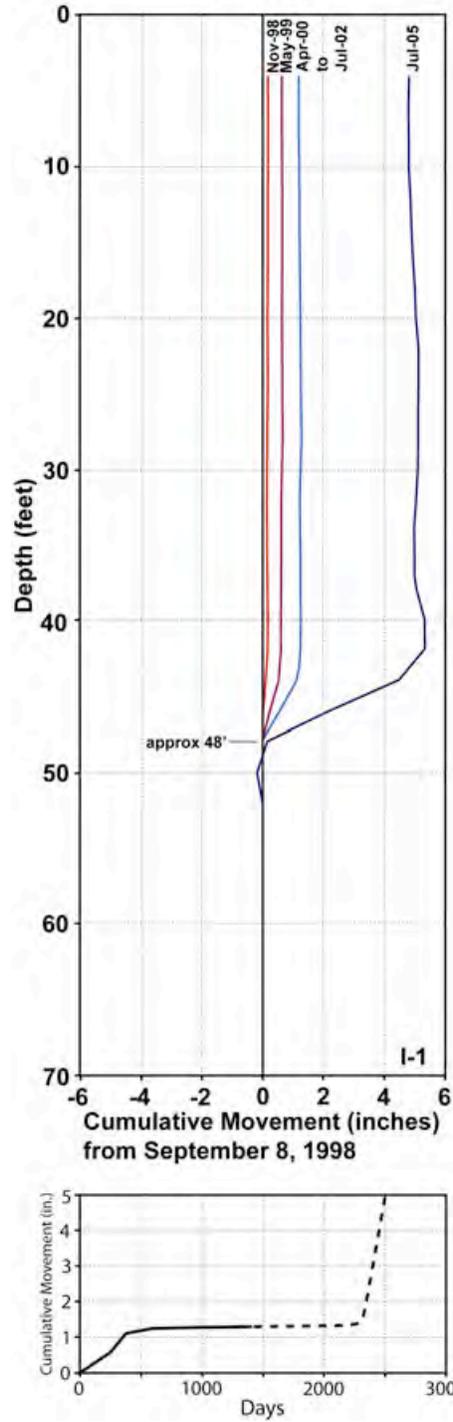
Figure 6. Plots for inclinometer I-1 in Springhill Circle. Upper plot shows cumulative movement versus depth between September 1998 and July 2005. Landslide depth is about 48 feet (15 m.) Lower plot shows cumulative movement versus time. Dashed part of curve is inferred based on surface observations between July 2002 and July 2005. Plots modified from Terracon (2005).

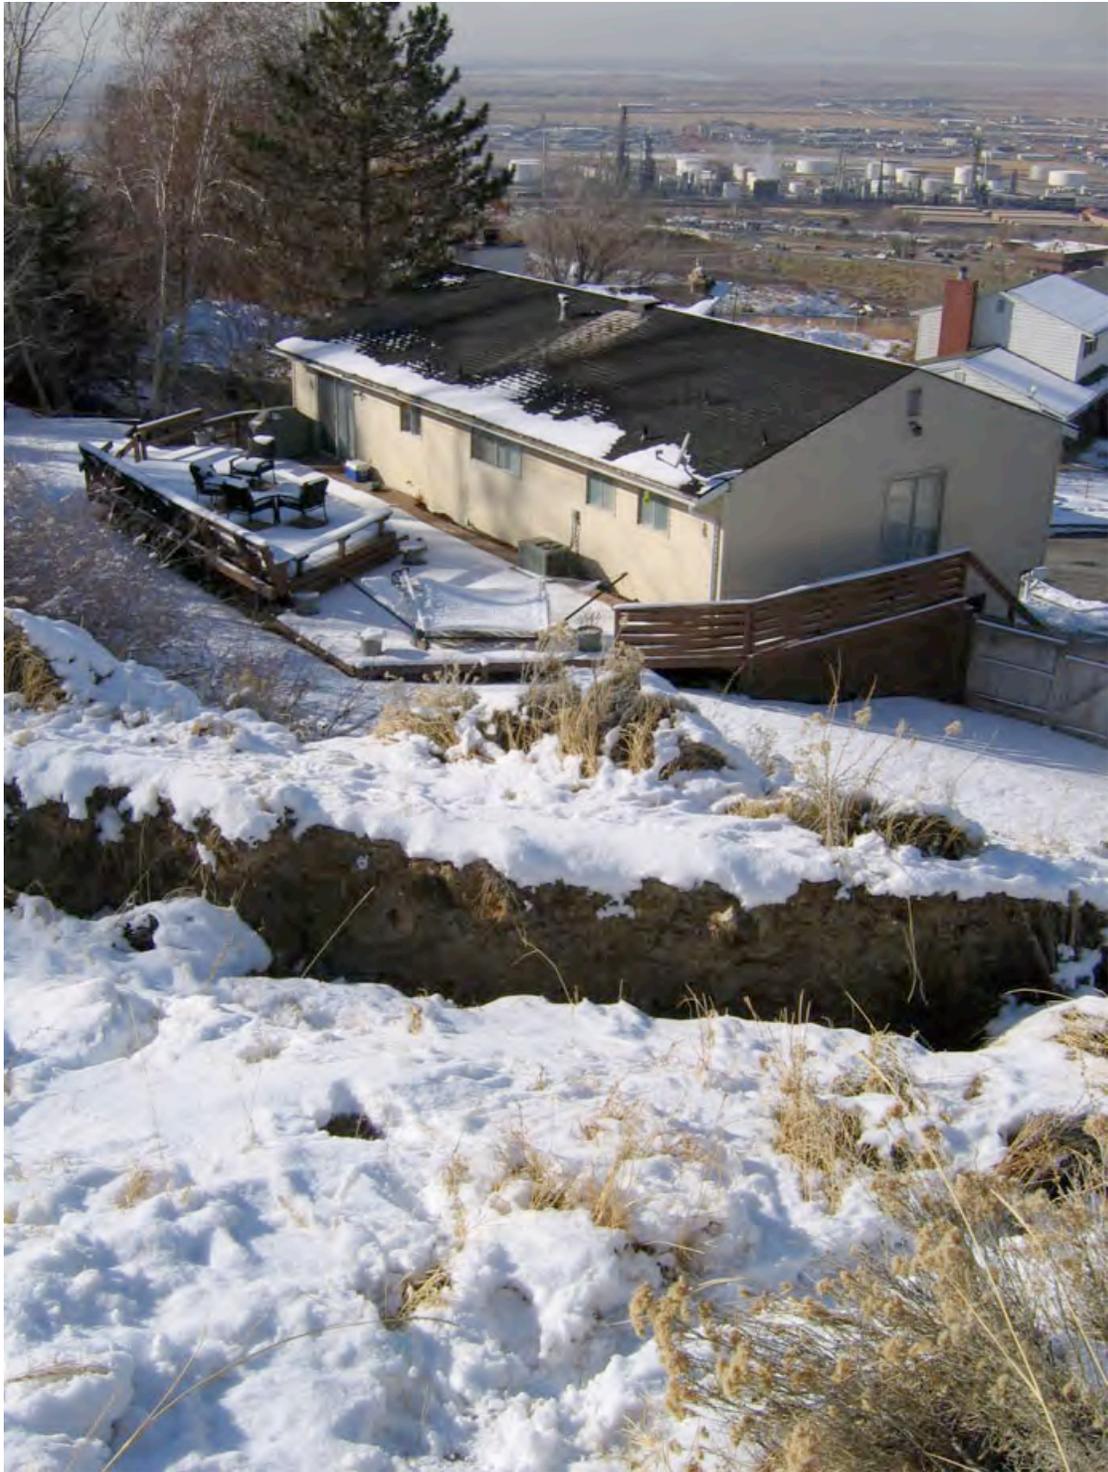
Figure 7. View downslope and to the west of lowermost antithetic (uphill-facing) scarp in the main scarp zone. Photograph taken in December 2008.

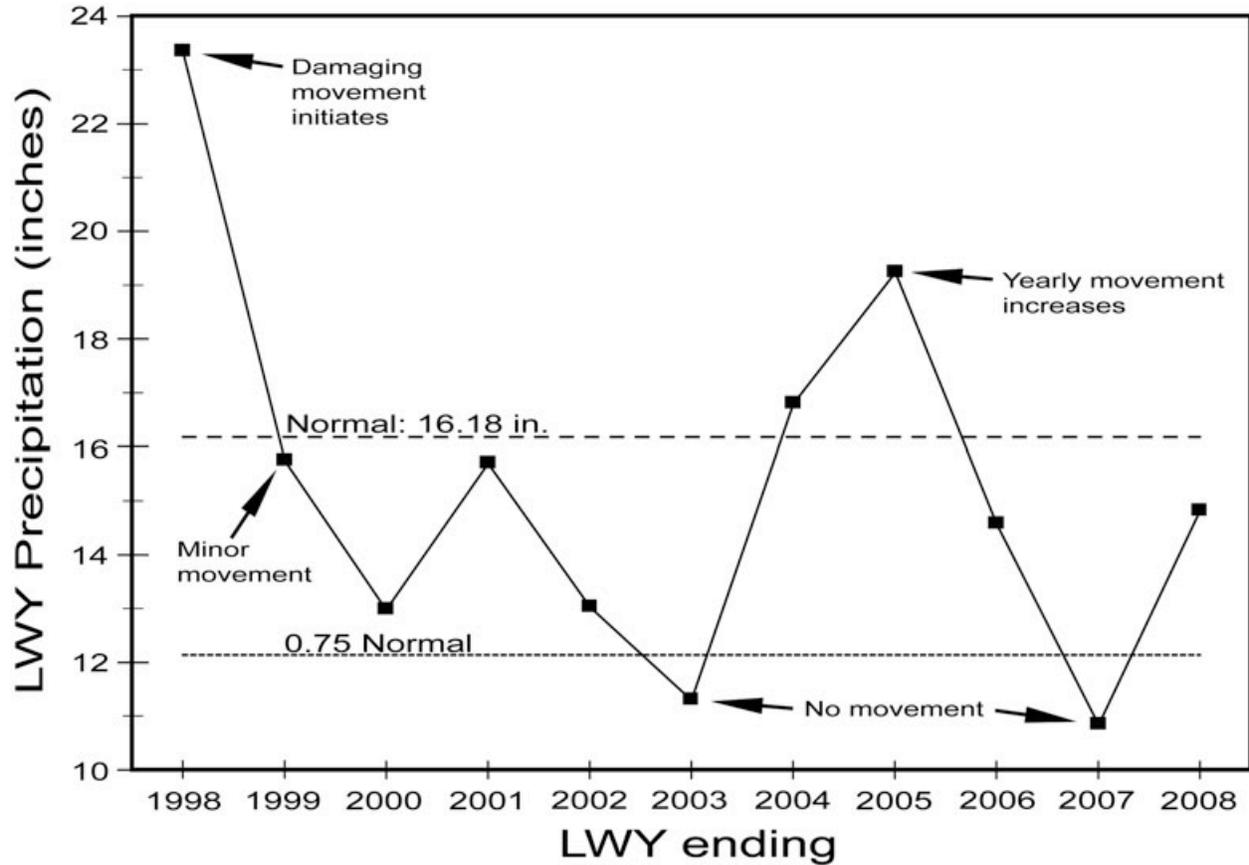
Figure 8. Salt Lake City precipitation for landslide water years (LWY) ending between 1998 and 2008 annotated with movement history of the Springhill landslide. Damaging movement initiated in 1998 during the second-wettest LWY on record dating back to 1875 in Salt Lake City. Minor movement of landslide occurred during drier-than-normal period between 1999 and 2002. By 2003, movement may have suspended during exceptional dry conditions (LWY precipitation was less than 75 percent of normal). Damaging movement started again in 2005 during the second-wettest LWY in the measurement period. Beginning in 2005, annual movement amounts reached 4 inches (10 cm) or more. Despite drier-than-normal conditions in the following years, movement continued and annual movement amounts increased, except in exceptionally dry 2007. Annual movement amounts reached as high as 9 inches (23 cm) by 2008. LWY precipitation data compiled from provisional data in monthly National Weather Service climatological reports. Normal precipitation for Salt Lake City from Ashland (2003).

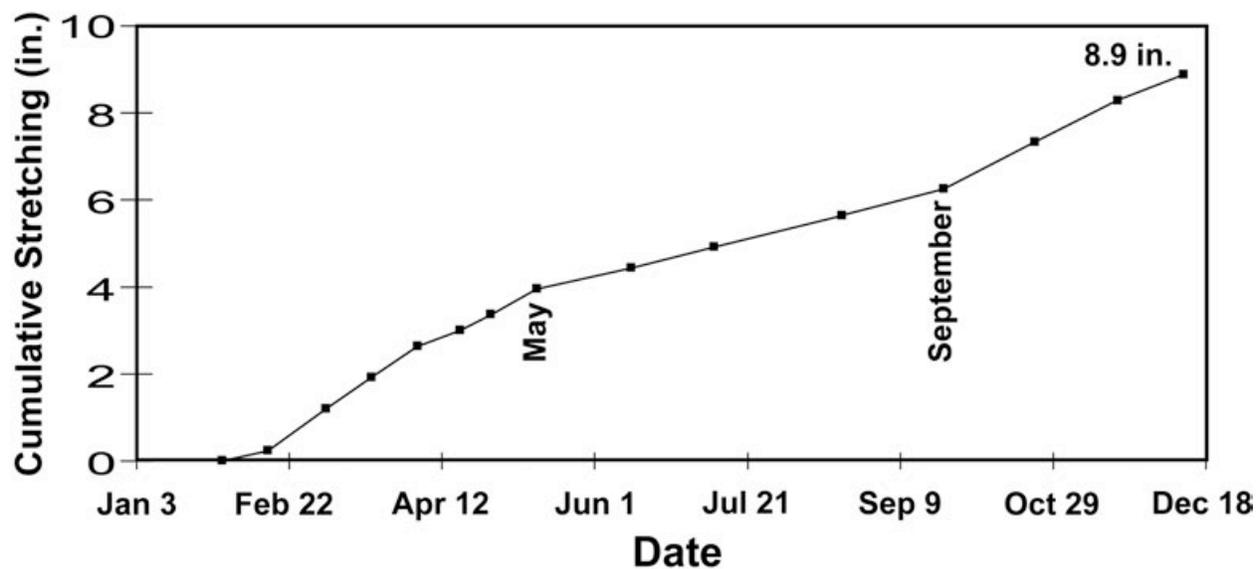
Figure 9. Cumulative stretching across main scarp zone in 2008. Total stretching was about 8.9 inches (23 cm). Changes in the rate of movement occurred in May and September, separated by periods during which movement occurred at a nearly constant rate. A gradual increase in the rate of movement also occurred in early February. Ground deformation measurements were taken between January 31 and December 11.

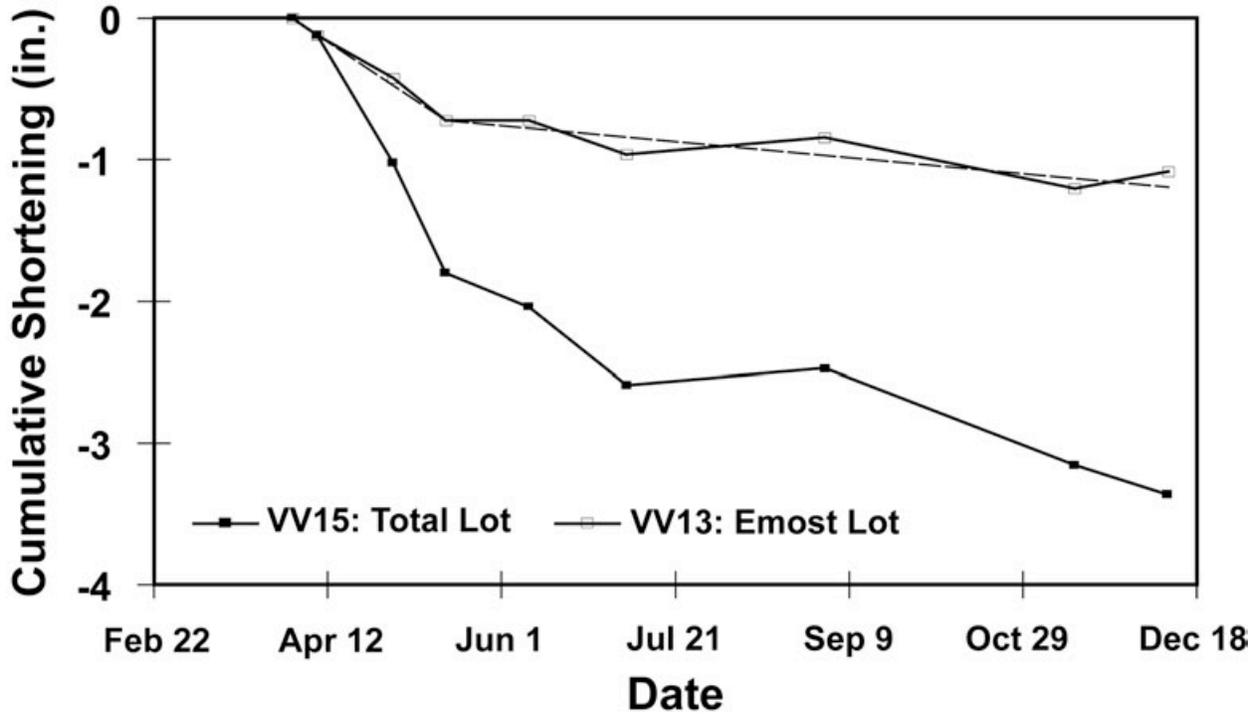
Figure 10. Cumulative shortening across the toe thrust system at lot 157 Valley View Drive between April and December 2008. Upper curve shows cumulative shortening across southeasternmost two toe thrusts (figure 2). Lower curve shows cumulative shortening across entire toe thrust system, which was about 3.4 inches (9 cm) over the eight-month measurement period between April 2 and December 10. A decrease in the rate of movement occurred in May, similar to that observed in the upper part of the landslide, likely in response to declining groundwater levels in the dry period between March and July 2008. Dashed line shows probable deformation curve removing measurement error.

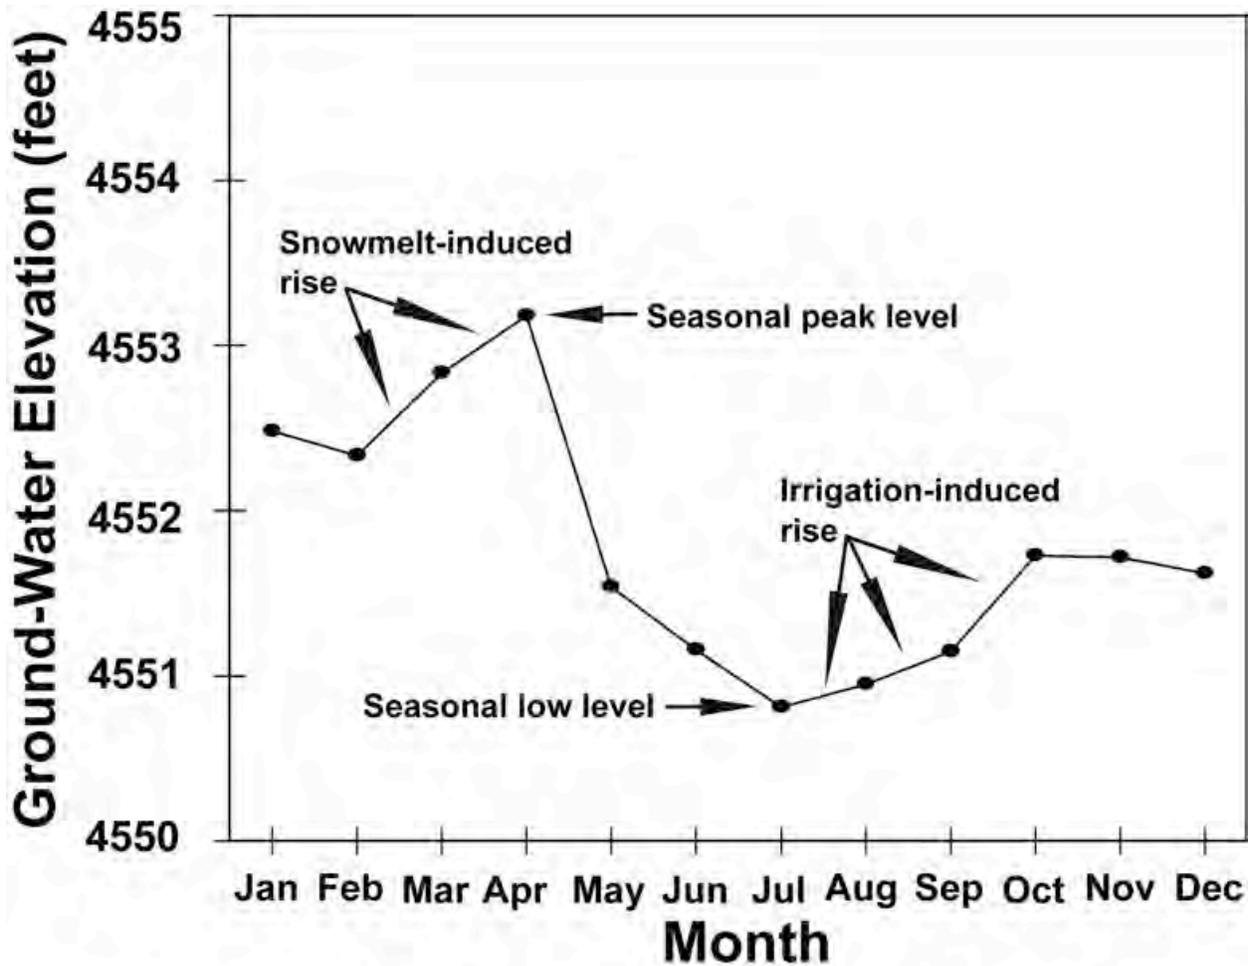
Ground-water levels in each observation well fluctuate seasonally (throughout the year) and generally are at their highest level during or shortly following the snowmelt (in the first half of the year) or later in the year (possibly as a result of local landscape irrigation) (figure 11). Between 1999 and 2004, the seasonal peak ground-water levels in the four wells in Springhill Drive typically occurred in the first six months of the year (figure 12), suggesting the ground-water levels rise in response to snowmelt and spring precipitation (generally the wettest months of the year are March through May). In the dry years between 2001 and 2004, the seasonal peak ground-water level in observation well P-1 in Springhill Circle occurred in either August or September, possibly in response to summertime landscape irrigation. Notably, lawns surround the observation well in every direction. The peak ground-water level in two of the Springhill Drive wells, P-3 and P-4, occurred three times, collectively, in the last two months of the year, possibly due to landscape irrigation in the summer or extreme (record) monthly precipitation in the fall.

Figure 11. Seasonal fluctuation in ground-water level in observation well P-4 in 2006. Rise in ground-water level between February and April to seasonal peak level is due mostly to infiltration of snowmelt. Seasonal low ground-water level occurs in response to dry hot weather and evapotranspiration. The rise in ground-water level between July and October is likely due to local landscape irrigation. Subsequently, the ground-water level declines in the fall and early winter. The rate of landslide movement typically increases with rising ground-water levels in the early part of the year and decreases as ground-water levels decline from the seasonal peak levels.

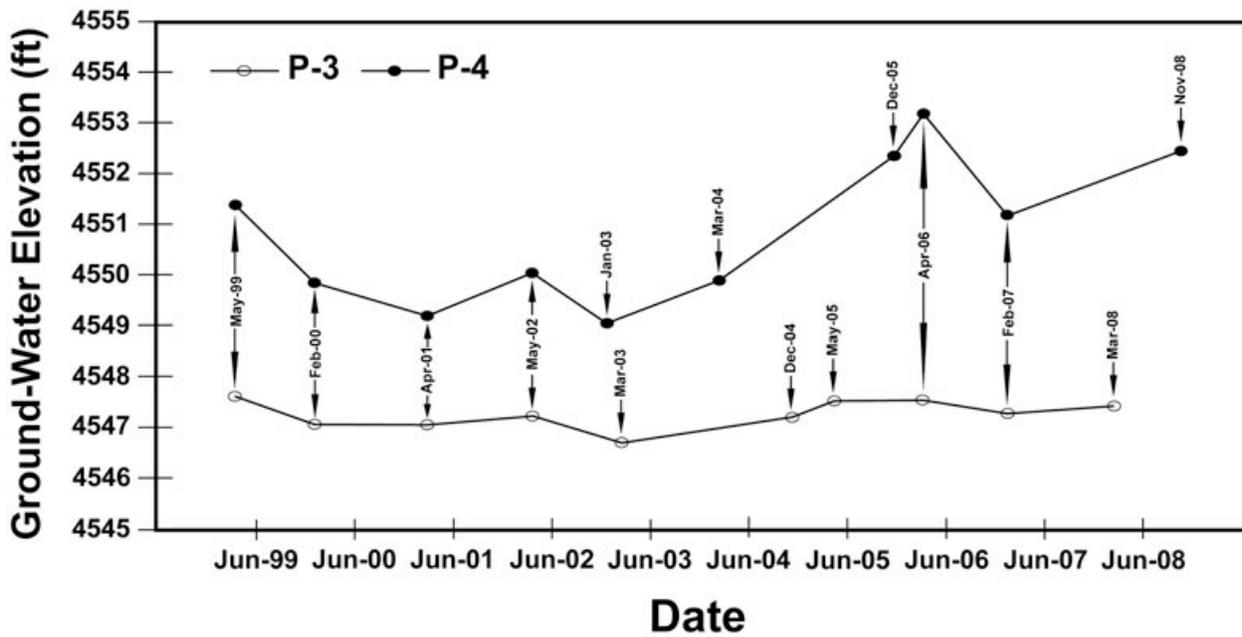
Figure 12. *Fluctuations in seasonal peak ground-water levels (SPGWL) in observation wells P-3 and P-4 between 1999 and 2008. The SPGWL coincides with the lowest stability of the landslide during the year, and thus is a basis for assessing the relative stability of the landslide. High SPGWLs since 2005, most evident in P-4, coincide with increased annual movement amounts, except in 2007.*

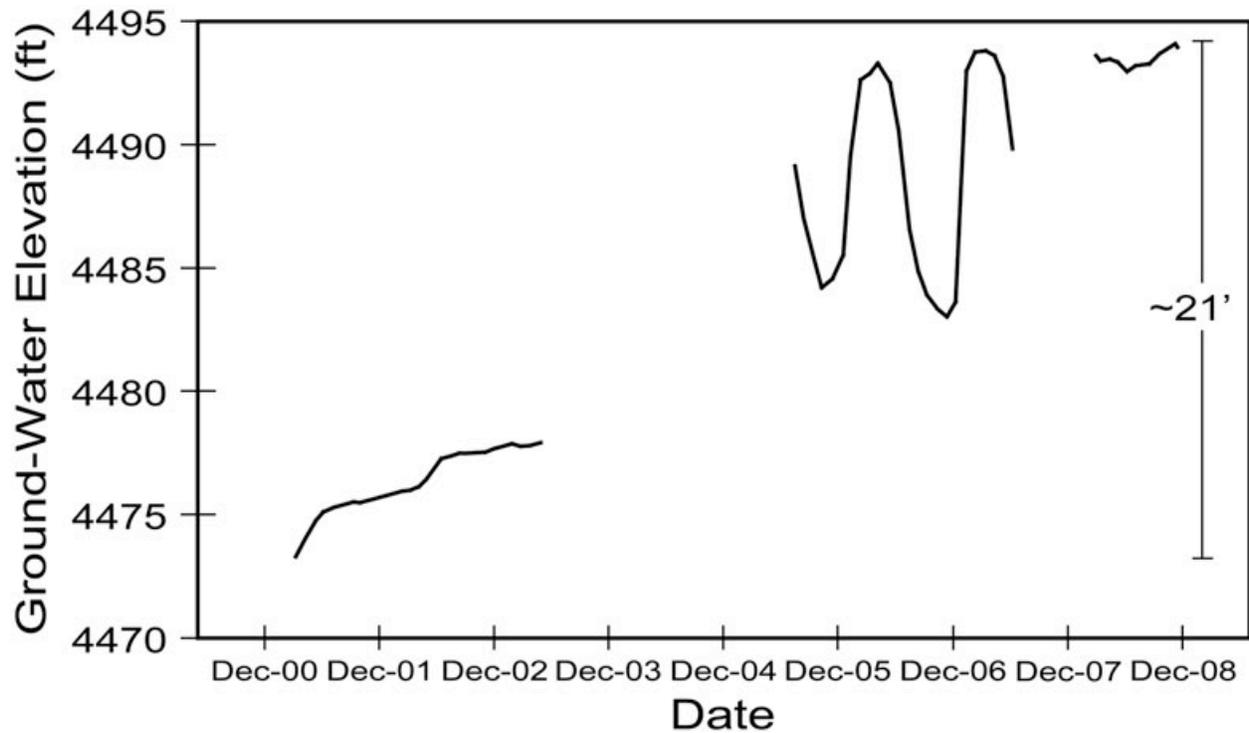
Beginning in 2001, the ground-water level in observation well P-5, near the toe of the landslide, began to rise (figure 13). By 2005, seasonal fluctuations in ground-water level were observed with the highest level occurring in the early part of the year likely the result of the infiltration of snowmelt. The ground-water level rose at least 20 feet (6 m) by April 2006, a significant rise for which the cause remains unknown, and in 2008 was sustained within a foot of this peak level throughout the year. By November 2008, the ground-water level had risen to its highest level, rising a total of 21 feet (6.4 m) since 2001. The rising ground-water level in observation well P-5 is a concern if it also indicates a similar rise in ground-water levels in the toe of the landslide because such a rise results in a reduction in the frictional forces acting to resist downslope movement. The sustained high seasonal peak ground-water level near (and possibly in) the toe of the landslide since at least 2006 may be the primary cause of the increase in annual movement, and the sustained high ground-water level near the toe in 2008 may explain the continuous movement throughout the year.

Figure 13. Rise in ground-water level in observation well P-5 near toe of the landslide since 2001. Observation well was dry when initially installed in 1998 until March 2001. Between March 2001 and April 2006 the ground-water level rose nearly 20 feet (6 m). Ground-water levels between 2005 and early 2007 fluctuated seasonally, with the peak levels following snowmelt. By November 2008, the ground-water level had risen to its highest level, rising a total of 21 feet (6.4 m) since 2001. Gaps indicate periods when observation well was not accessible.

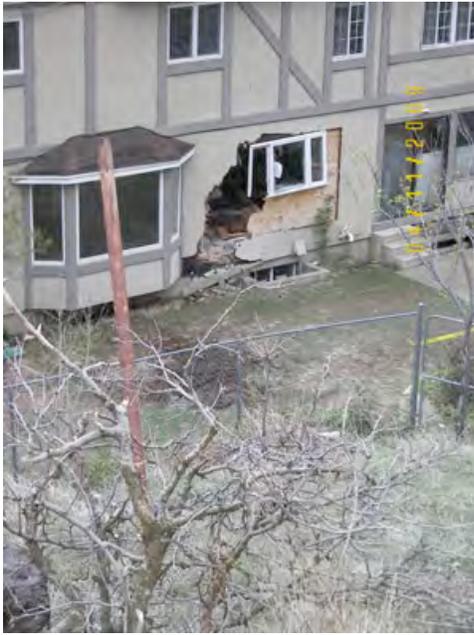
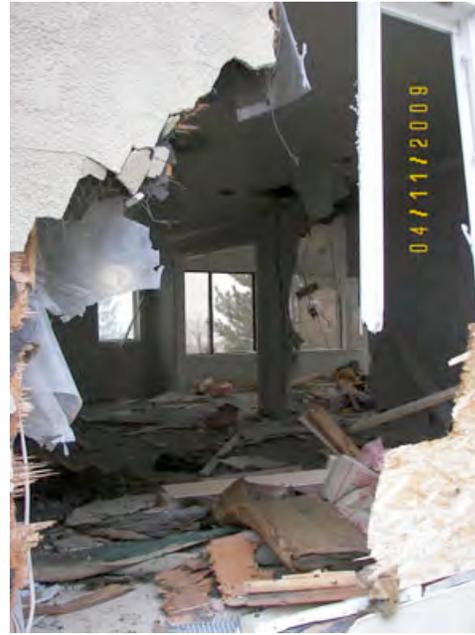
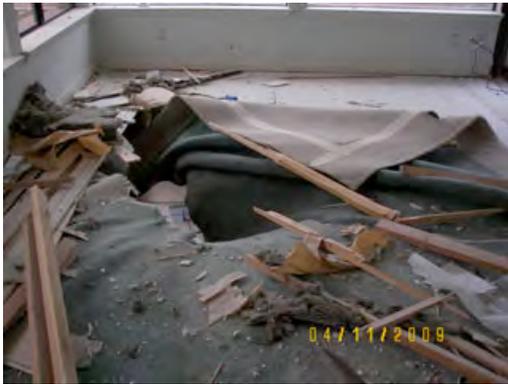
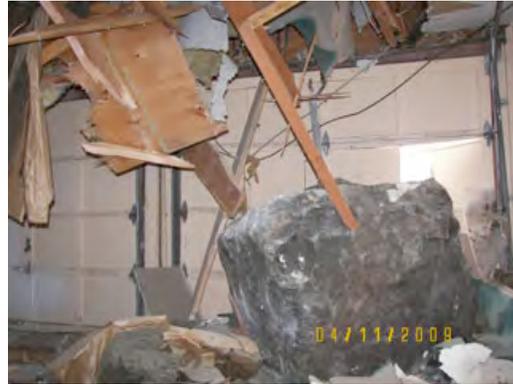
On April 11, 2009, rock-fall debris bounced and rolled downslope and damaged a vacant house and playhouse (figures 3 and 4). The rock that damaged the vacant house at 1496 North 1550 East traveled through the house and into the garage. Figure 3 shows house damage and figure captions describe the rock's travel path through the house. We estimate the rock's dimensions to be 4 x 5 x 4 feet (figure 3D) and weight to be about 6 tons. The dimensions of this rock are similar to other equidimensional to rectangular rock-fall boulders deposited on the alluvial fan to the south. The rock that damaged the playhouse at 1522 North 1550 East (figure 4) bounced into a chain link fence, pushing the fence into the playhouse. We estimate the rock's dimensions to be 2 x 4 x 3 feet and weight to be about 1.8 tons.

Figure 3. Rock-fall damage to a vacant house at 1496 North 1550 East (Provo Fire Department photos). **A.** The rock bounced downslope, impacted and bent the red steel post, traveled over the chain link fence, impacted the lawn leaving a bounce mark, and entered through the back wall with an upward bounce trajectory. **B.** Looking through the back wall into the house. Once inside with an upward trajectory, the rock impacted the ceiling and traveled downward through an interior wall and then down through the floor into the garage below. **C.** Hole in the floor where the rock traveled into the garage below. As the rock traveled through the floor it pulled carpet into the garage below. **D.** The rock stopped inside the garage. The rock size is estimated to be 4 x 5 x 4 feet and broke through part of a garage door.

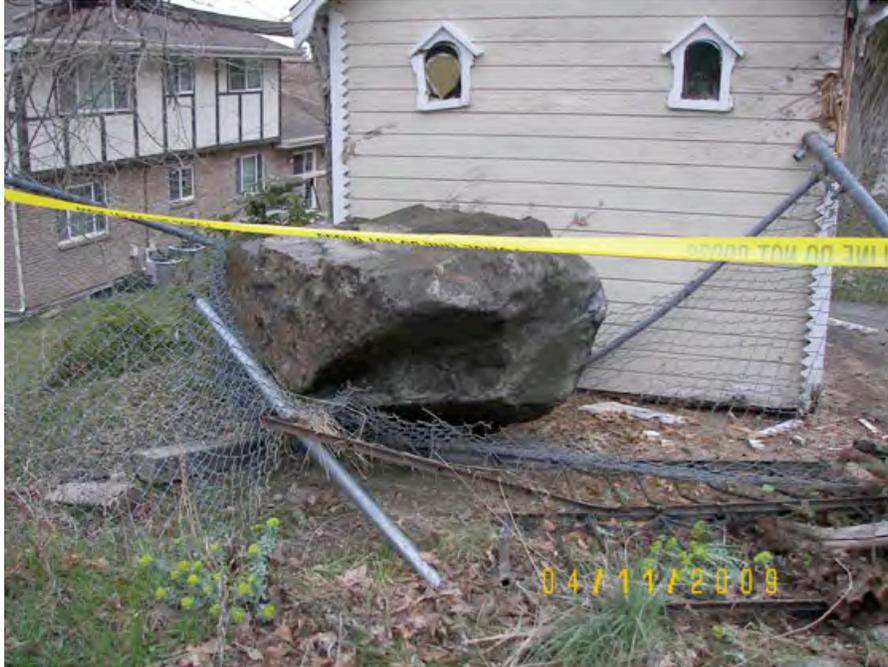
Figure 4. Rock-fall damage to chain link fence and playhouse at 1522 North 1550 East (Provo Fire Department photo). The rock size is estimated to be 2 x 4 x 3 feet.

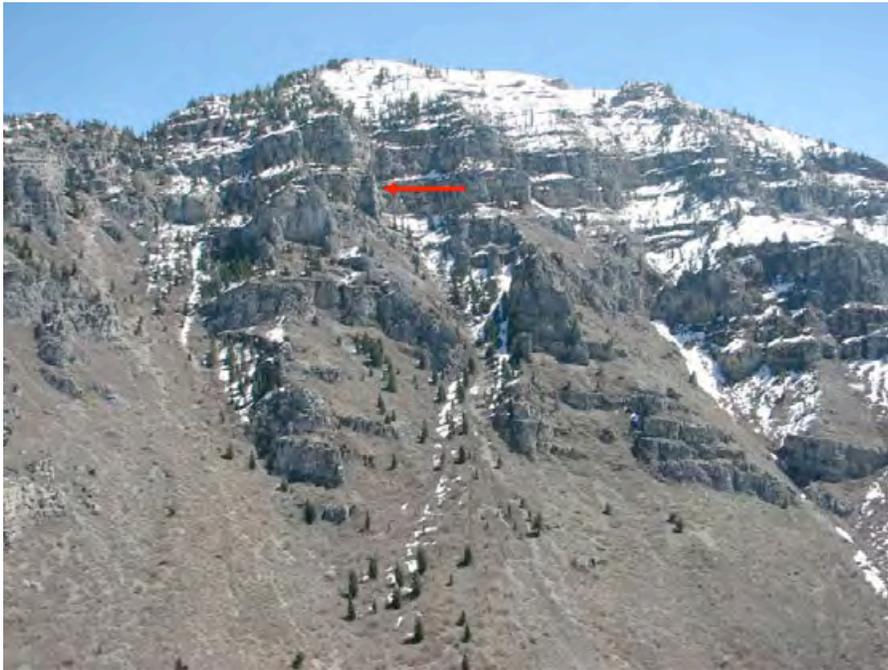
Figure 5. West side of Y Mountain and extensive rock-fall source cliff bands. Steep, smooth mountain slopes below the cliff bands promote high rock-fall velocity and long runout distance. Red arrow points to the 2009 rock-fall detachment location.

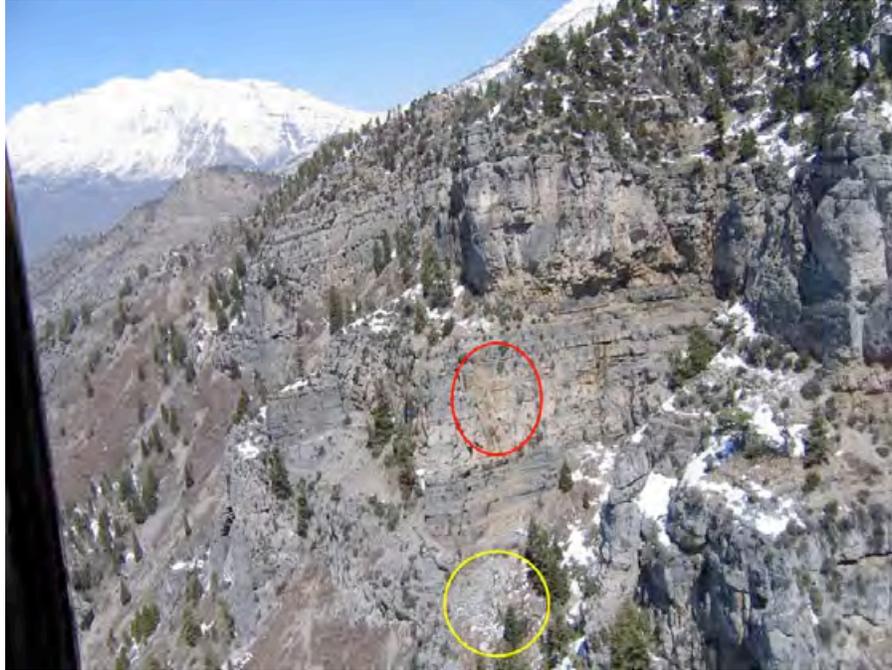
The rock fall initiated in Deseret Limestone (figures 5 and 6) at approximately 7,700 feet elevation. The limestone cliffs are massive beds broken by discontinuities or cracks that consist of joints, fractures, and bedding planes (figure 6). Weathering along these discontinuities weakens the rock mass and creates opportunities for triggering mechanisms such as frost and root wedging, rainfall, snowmelt, or earthquakes to initiate rock fall. The orientation and spacing of discontinuities determine the overall stability and generally the initial size and shape of rock fall produced. The limestone bedding planes are flat to gently dipping and joints are near vertical, widely spaced, and perpendicular to bedding planes. The orientation, spacing, and intersection of bedding planes and joints produce large, roughly equidimensional to rectangular rock-fall blocks. The rock-fall-detachment surface is above an undercut cliff face that likely

Figure 6. Rock-fall detachment surface (red circle), photo taken 9 days after April 11, 2009. Rock debris impacted the talus slope below the cliff band (yellow circle). Cliff face undercutting is apparent below the detachment surface.

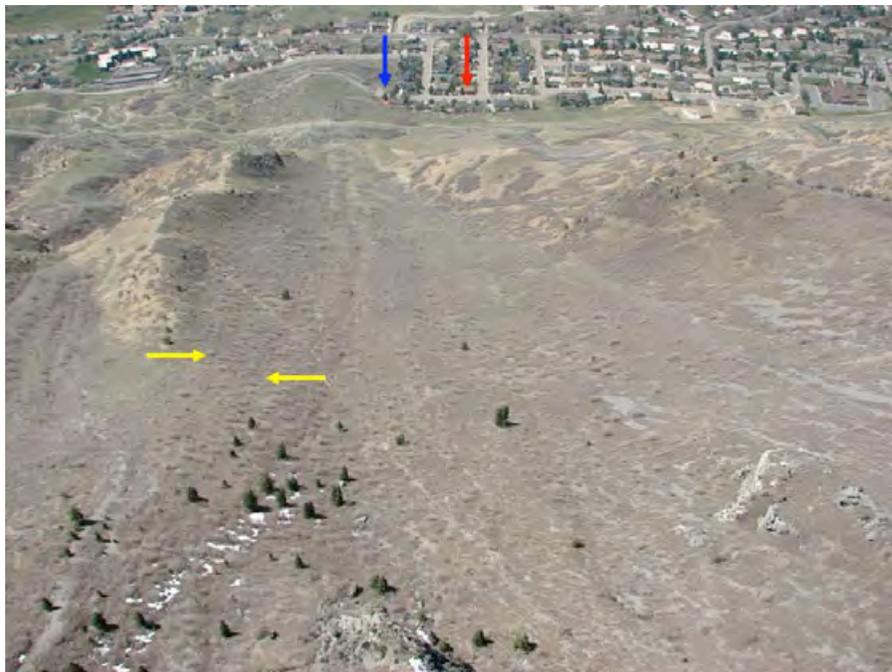
Following April 11, 2009, multiple fresh rock-fall paths were present on Y Mountain (figure 7, 8C, 8D). After detaching from the cliff face, rocks dropped vertically and then impacted the steep talus slope below, churning up talus, soil, and vegetation (figure 6). The rock debris then traveled down a small talus-lined gully. Freshly deposited rock was observed on the talus slope and in the gully. Rock debris continued rolling and bouncing down the mountain flank creating multiple linear rock-fall paths, shown by fresh bounce marks, or impact craters, and damaged vegetation (figures 7 and 8). The vertical drop along the cliff face and the steep 37° talus slope and gully likely provided a high initial velocity to rock debris. The firm mountain slopes that range from 27° to 35° maintained rock debris momentum, promoting the long runout distance into the subdivision. The rock debris traveled approximately 2,500 vertical feet and 5,000 feet slope distance to reach the affected structures. The mountain slopes are part of a small drainage basin that funnels rock-fall debris onto the alluvial fan below (figure 7).

Figure 7. View downslope showing rock-fall paths on Y Mountain above the subdivision. Yellow arrows point to two of multiple April 11, 2009, rock-fall paths. Older rock-fall paths are also evident. Blue and red arrows point to houses impacted in 2005 and 2009 respectively (also see figure 9).

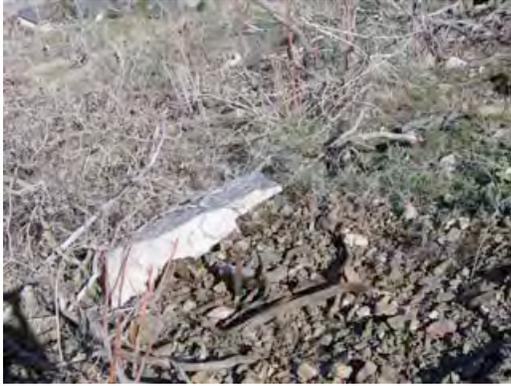
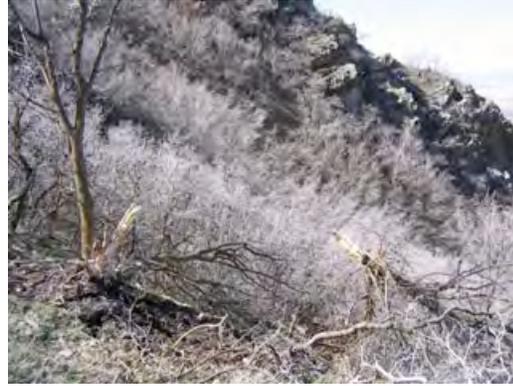
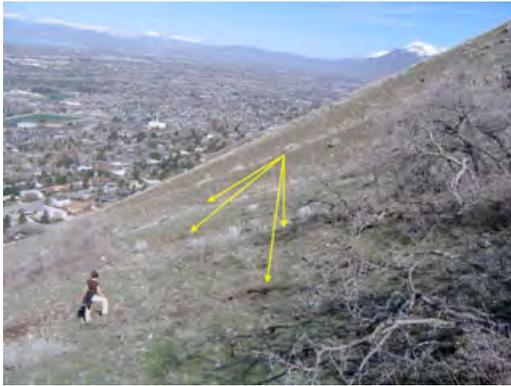
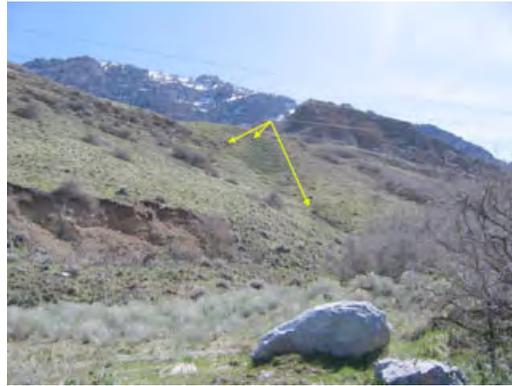
Figure 8. Rock-fall travel paths. **A.** A smaller rock that broke off a larger piece as it traveled downslope. **B.** Rock fall damaged oak brush. **C.** Multiple travel paths (yellow arrows). **D.** Multiple travel paths (yellow arrows) evident directly above the damaged house and playhouse.

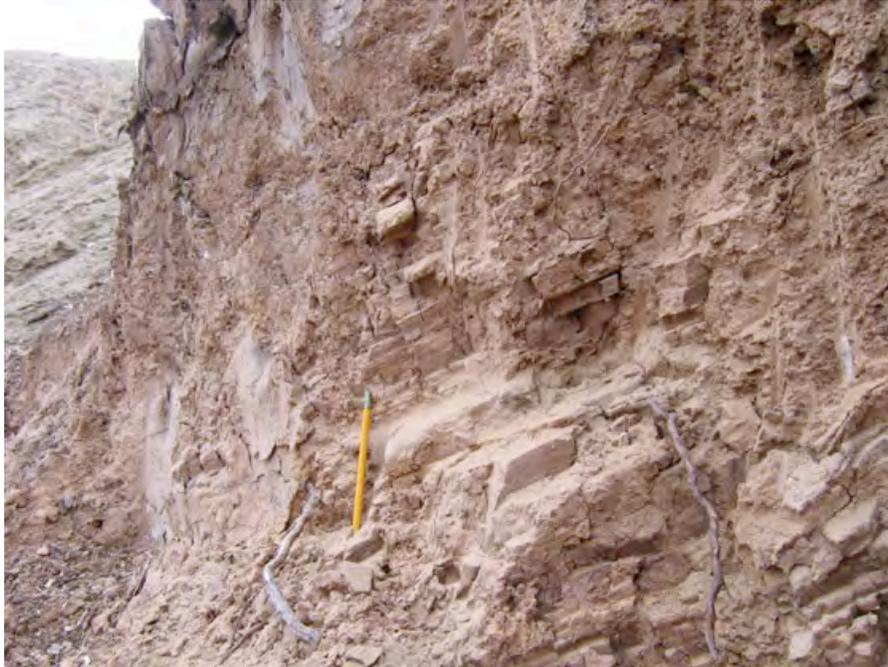
Figure 1. View of cut slope at 1681 East Hillsboro Drive showing tilted Lake Bonneville sediments. The bedding strikes N. 65° W. and dips 38° NE. Photograph taken on November 11, 2005.

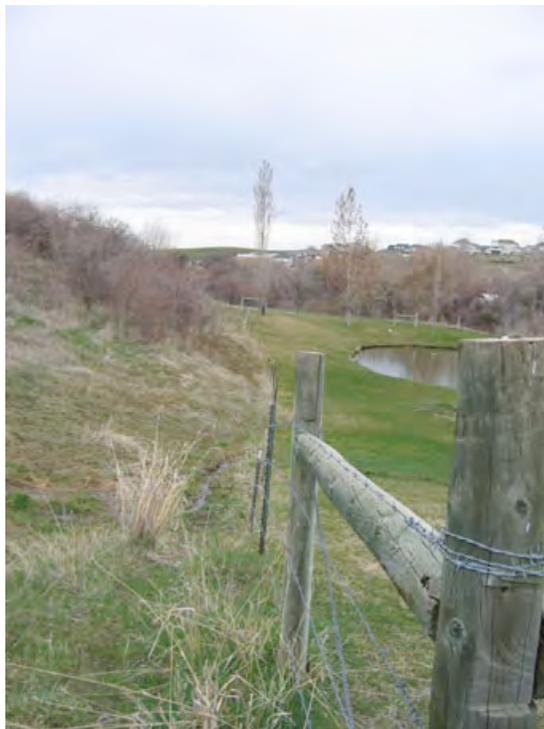
Figure 2. View west of fence displaced by landslide movement in lower slope north and downslope of 1681 East Hillsboro Drive. Photograph taken on April 10, 2006.
